Bonded Repair of a F-16 Bulkhead Flange

David Wieland, Southwest Research Institute

Matt Malkin, Boeing Phantom Works

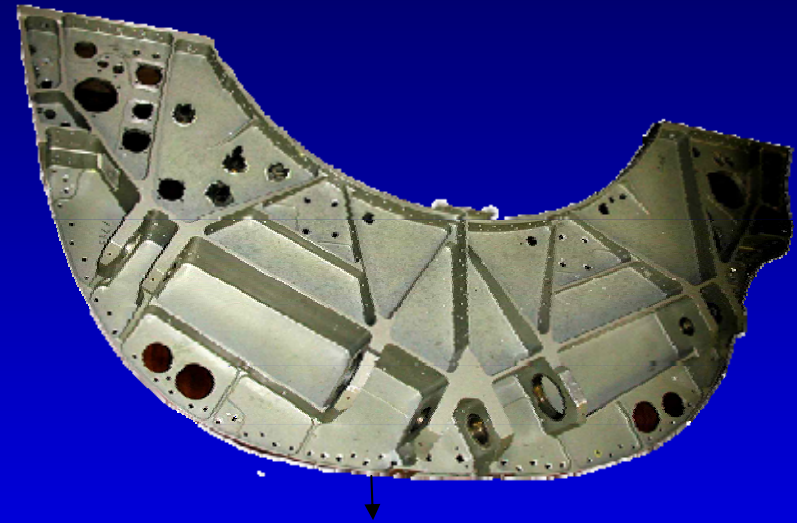
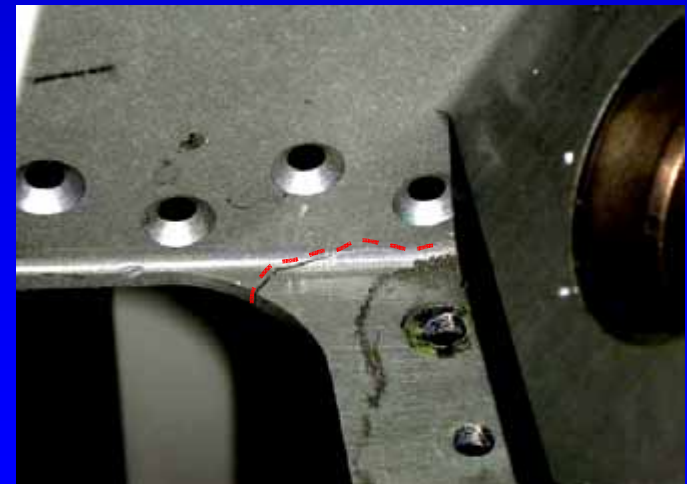
F-16 341 Bulkhead Longeron Attach Flange Radii

- Fatigue crack
- Small radii
- Current repair
 - Blend out crack
 - Replace fitting when cracks to large

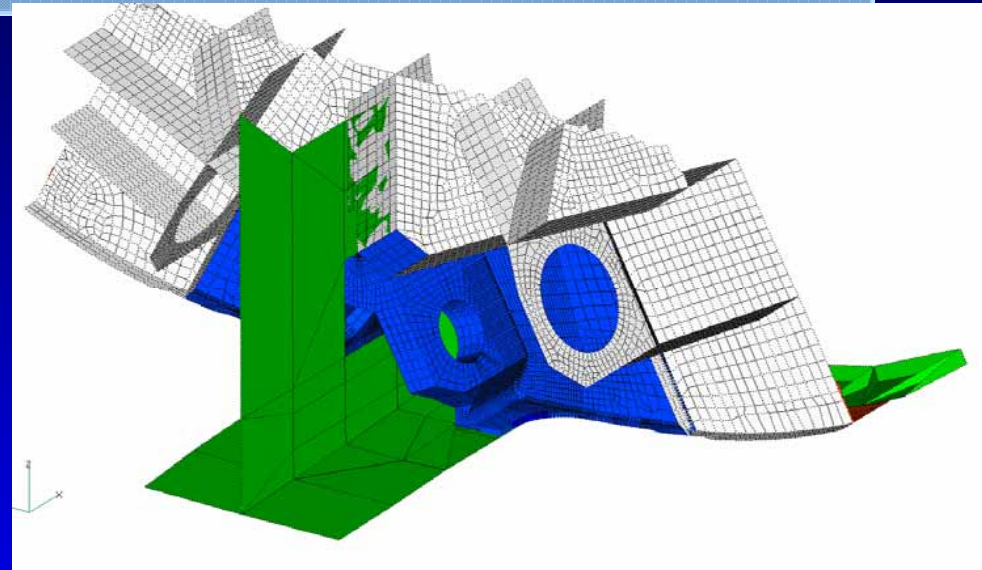
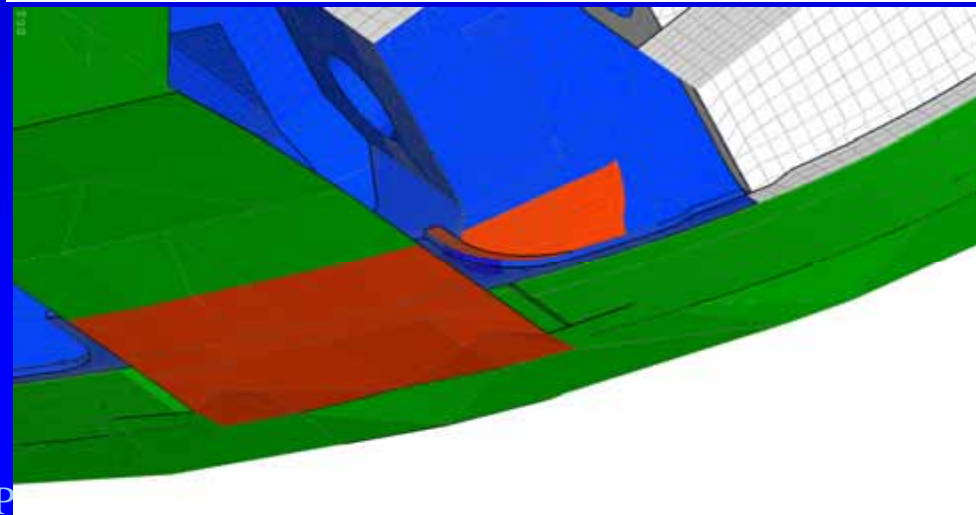
Updated FEM

- Baseline FEM updated
- Removed flange material
 - Simulate a blended repair with 1.5" Radius
- Aluminum doubler extended to original bulkhead geometry with 1.5" radius

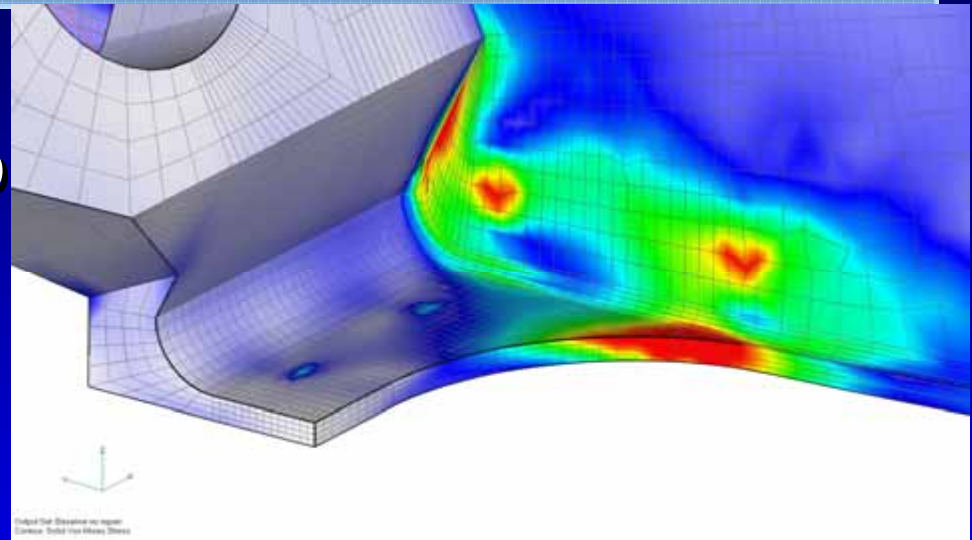
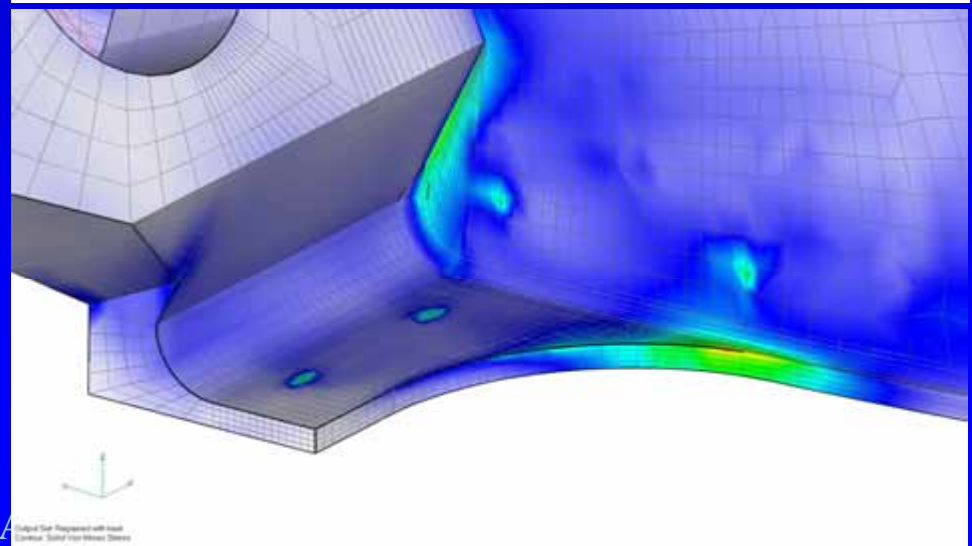
Updated FEM

- Reran FEM baseline to determine test radius target stress
- Compared baseline to repaired stress analysis
- 60% reduction of stress at crack
- Finalized design
- Repair not shown for clarity

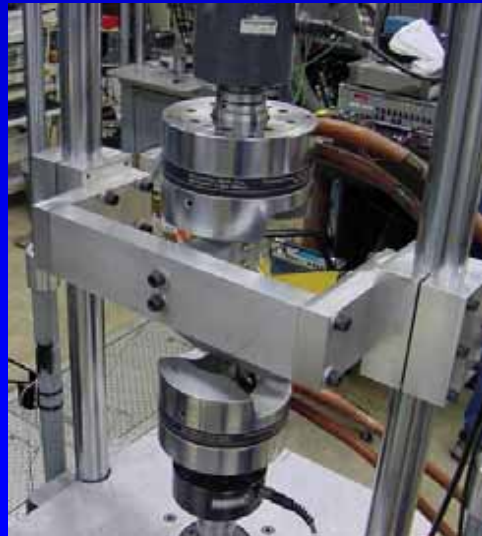
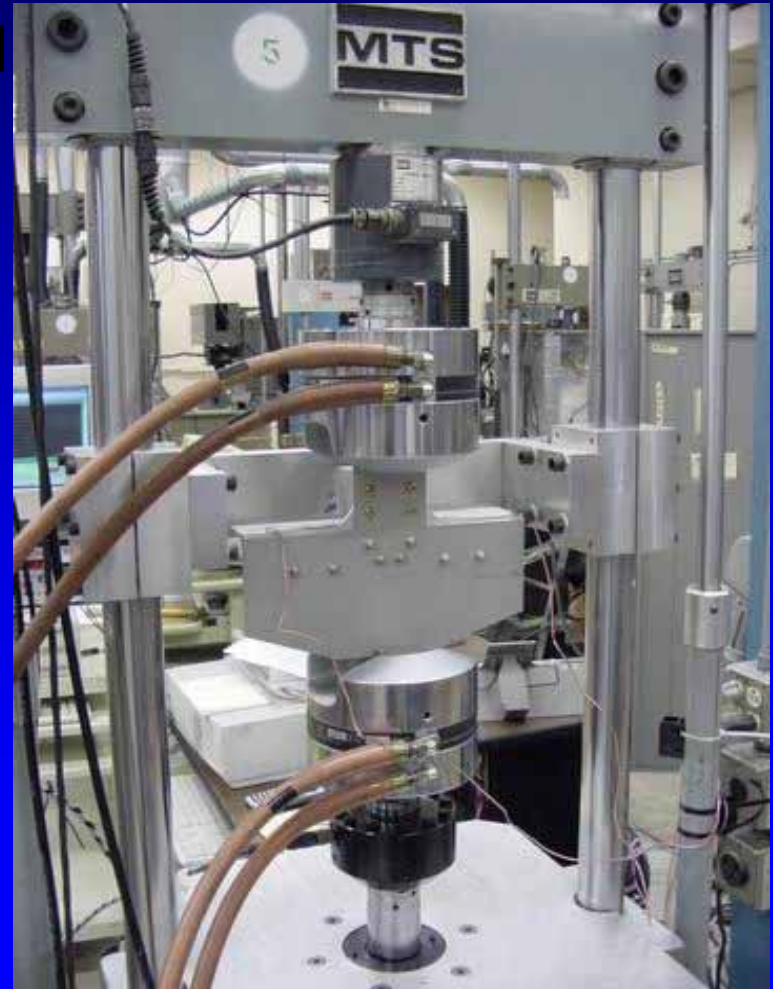
Repair Testing

- Coupons tested with 0.05 inch initial flaws
- Out of plane test constraints
- Spectrum loading
- 2 unrepaired baseline tests
- 2 repaired test

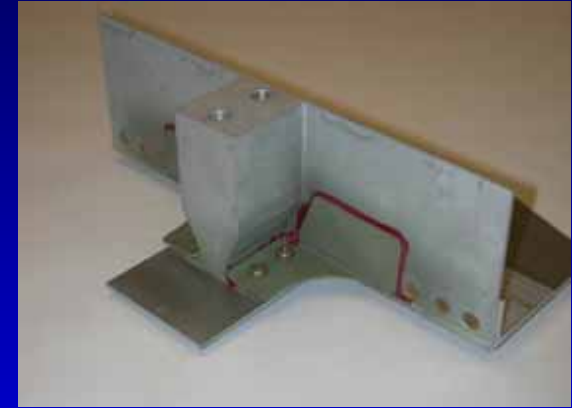
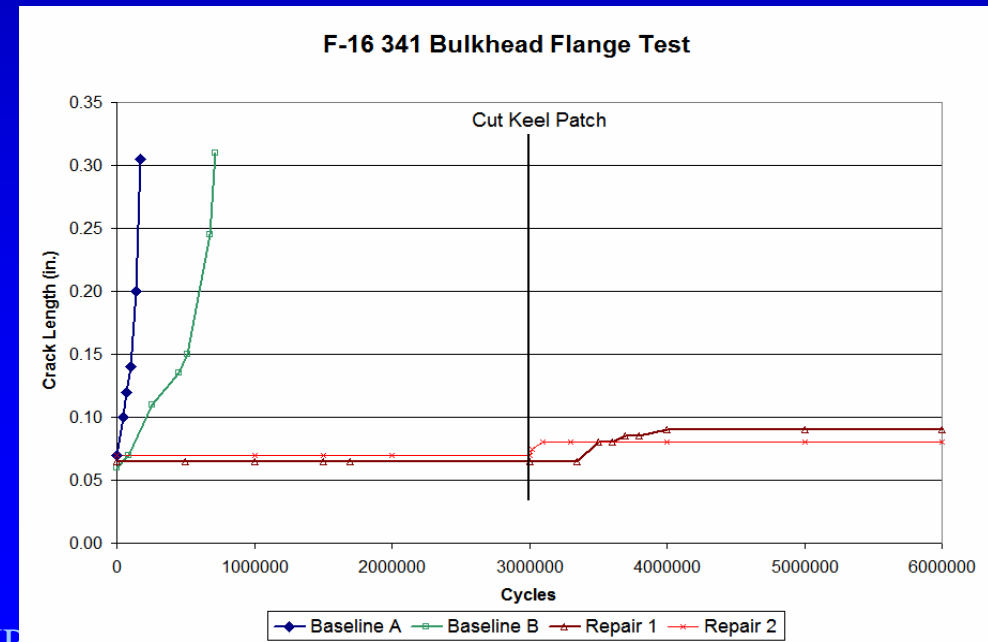
Repair Testing Continued

- Final Repair Designed
 - 0.08 inch thick 2024 aluminum doubler with 1.5 inch radius
 - Boron keel patch
 - Surface preparation
 - Grit Blast Sol-gel
 - AC130 Kit
 - Cytec BR 6747-1 Bonding Primer
- Testing Indicated greater than a 6 to 1 life improvement

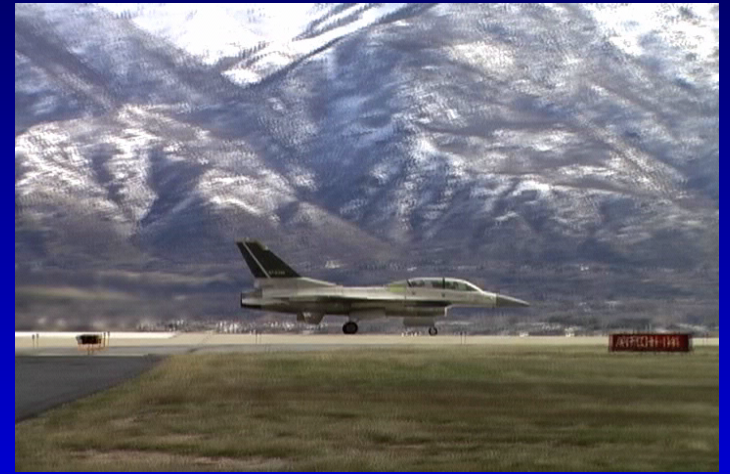
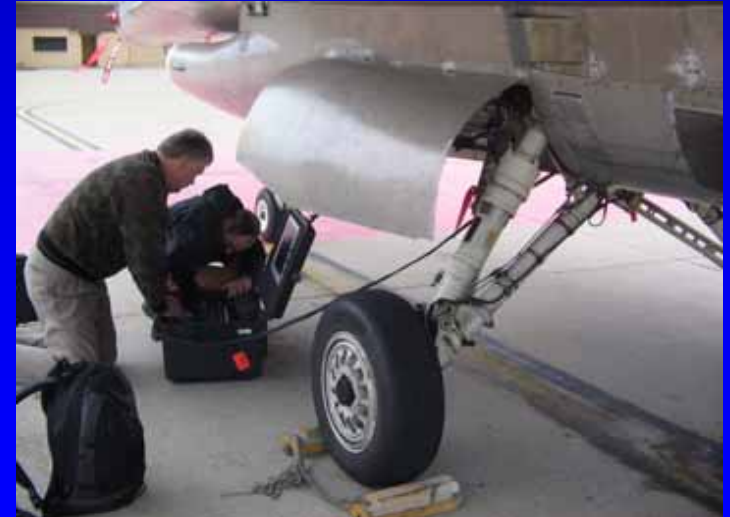
Bonded Repair First Flight

- SwRI, Boeing and Hill AFB engineers were present for first flight
- Repair inspected for indications of damage
