2006 USAF Aircraft Structural Integrity Program Conference

C-130 Center Wing MSD/MED Risk Analysis

28 November 2006

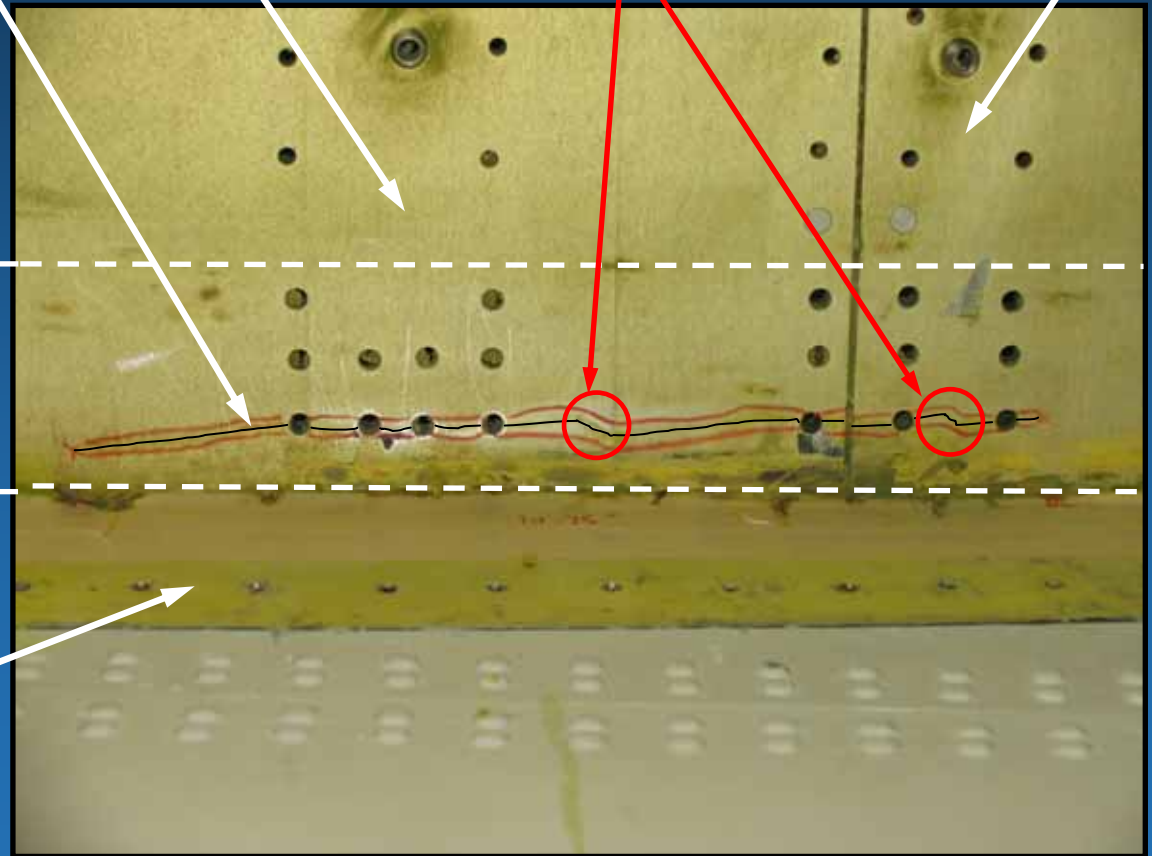
- **12 inch Fatigue Crack on L382 Commercial Aircraft:**

- MSD and MED
- 2 Internal Stringers also cracked at this location

MSD Link-up

This Wing Could Not Sustain Design Limit Load

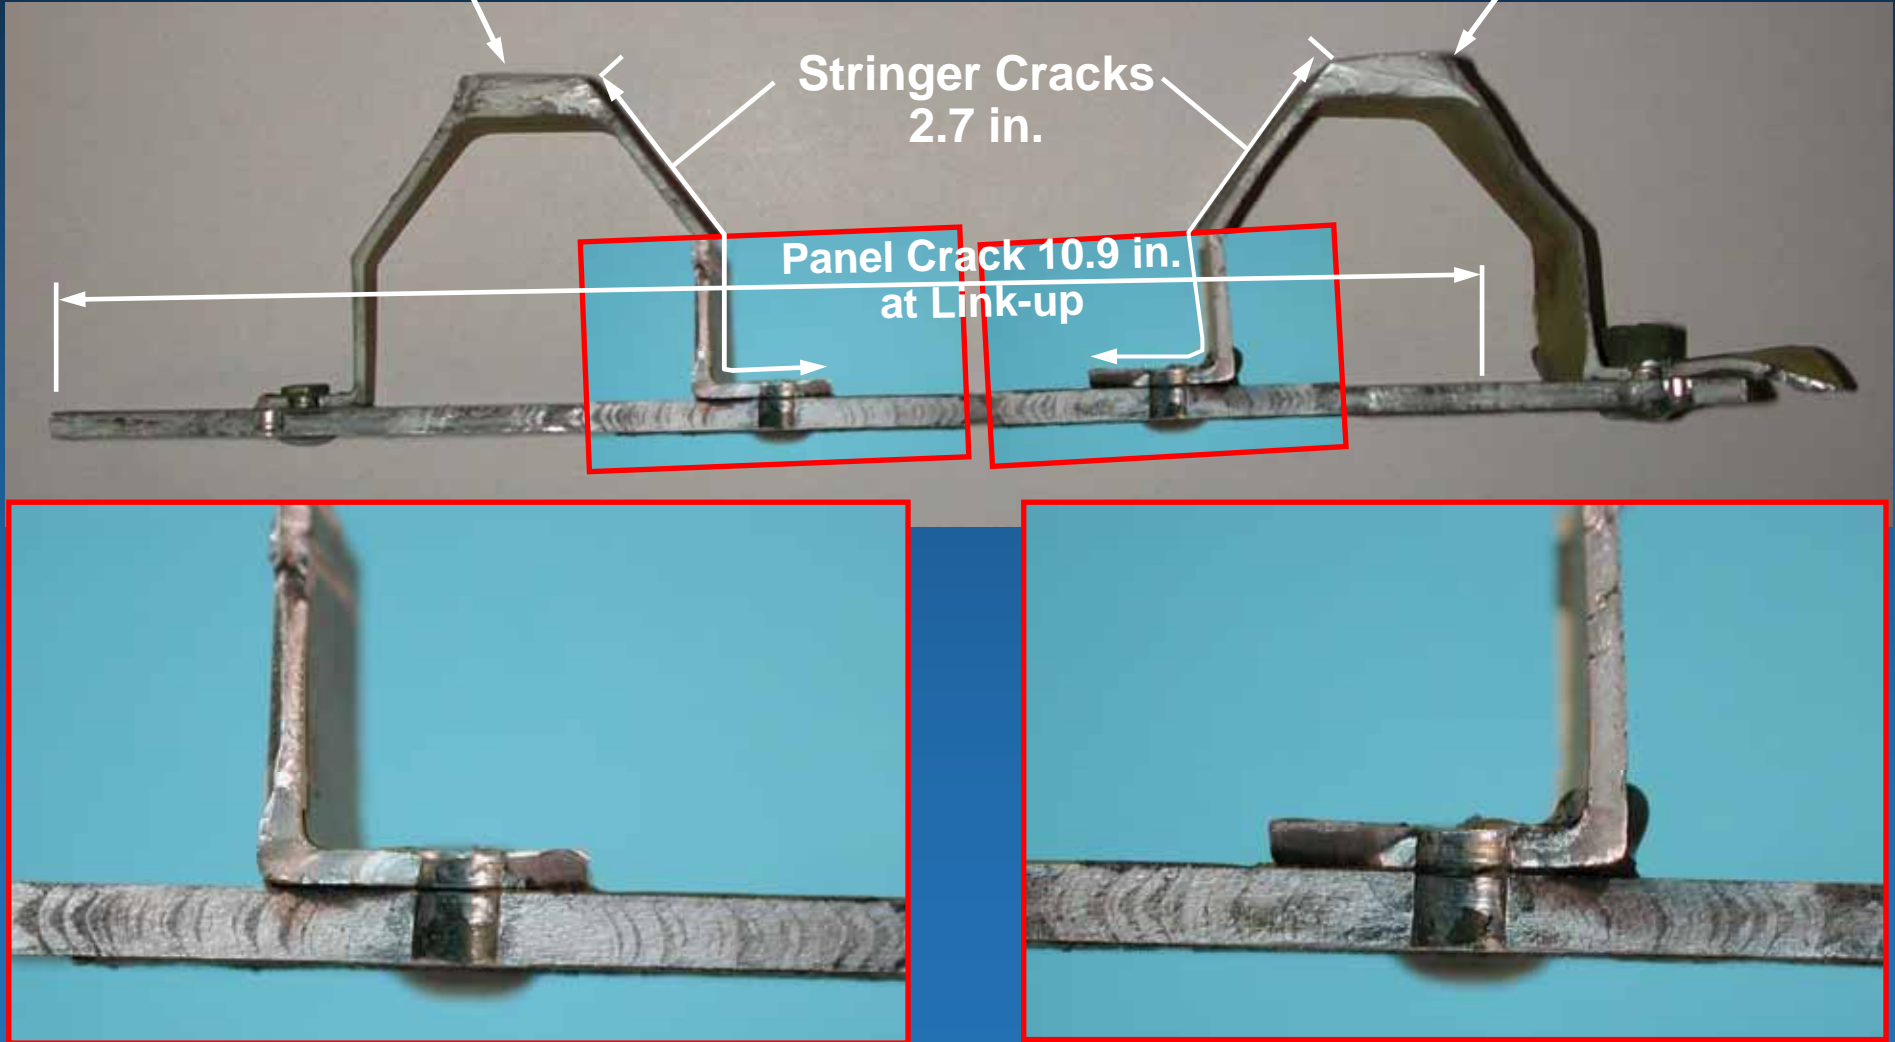
Zone 1 MSD and MED Cracking
Skin Panel No. 2

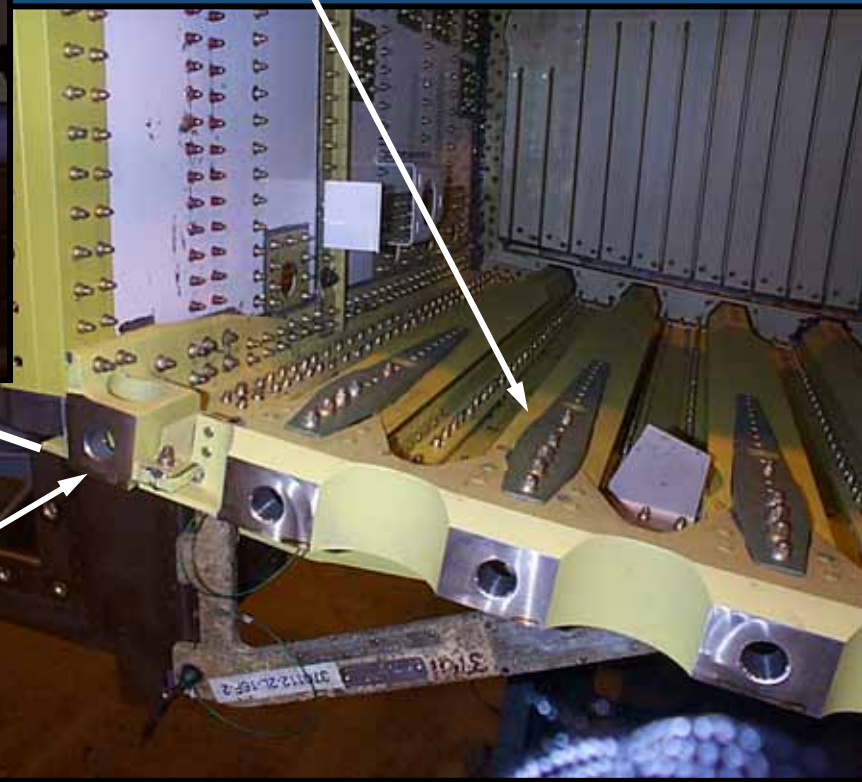
Typical Panel Crack

Typical Fitting Crack

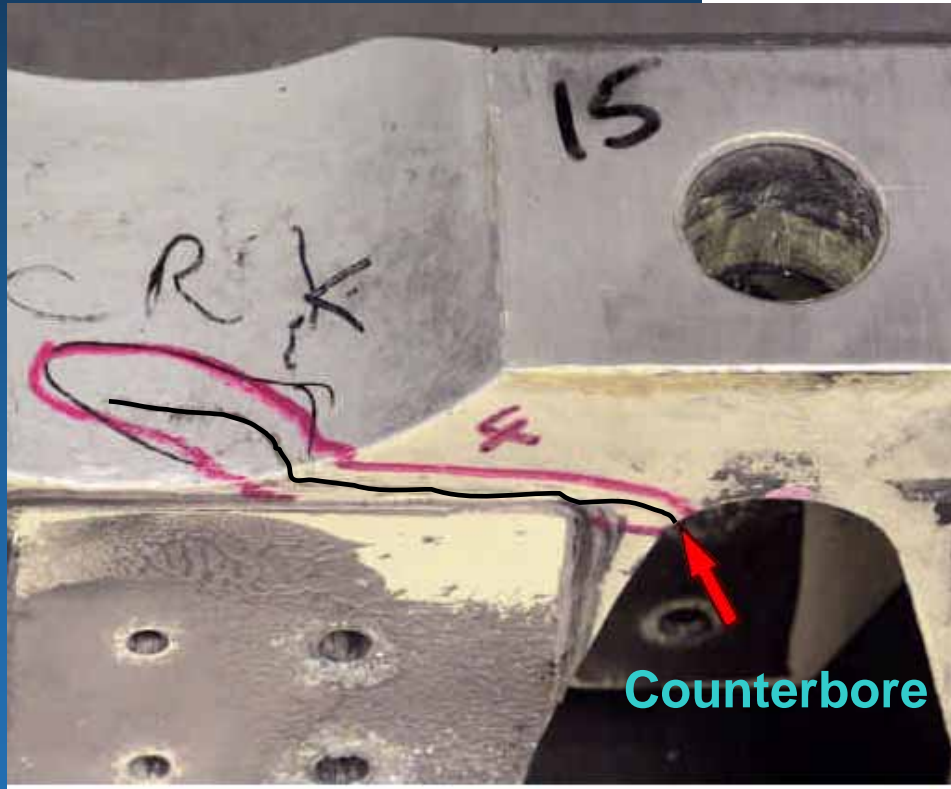
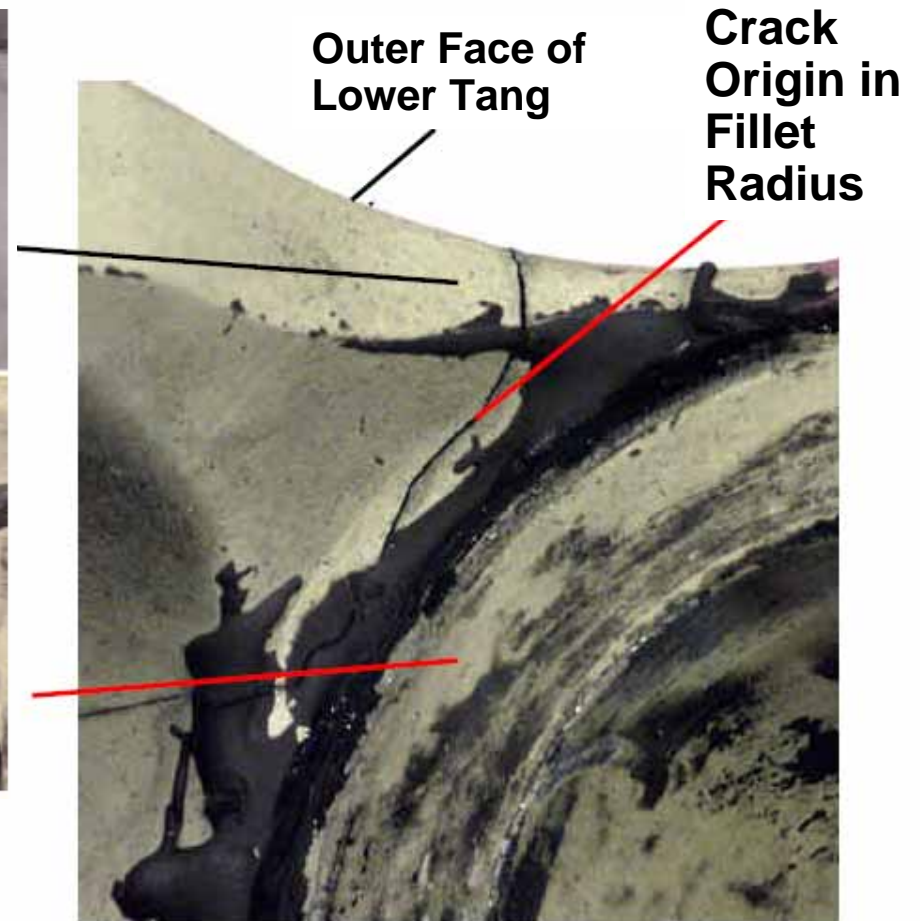
Crack Initiation at Node Bolt Hole Counterbore

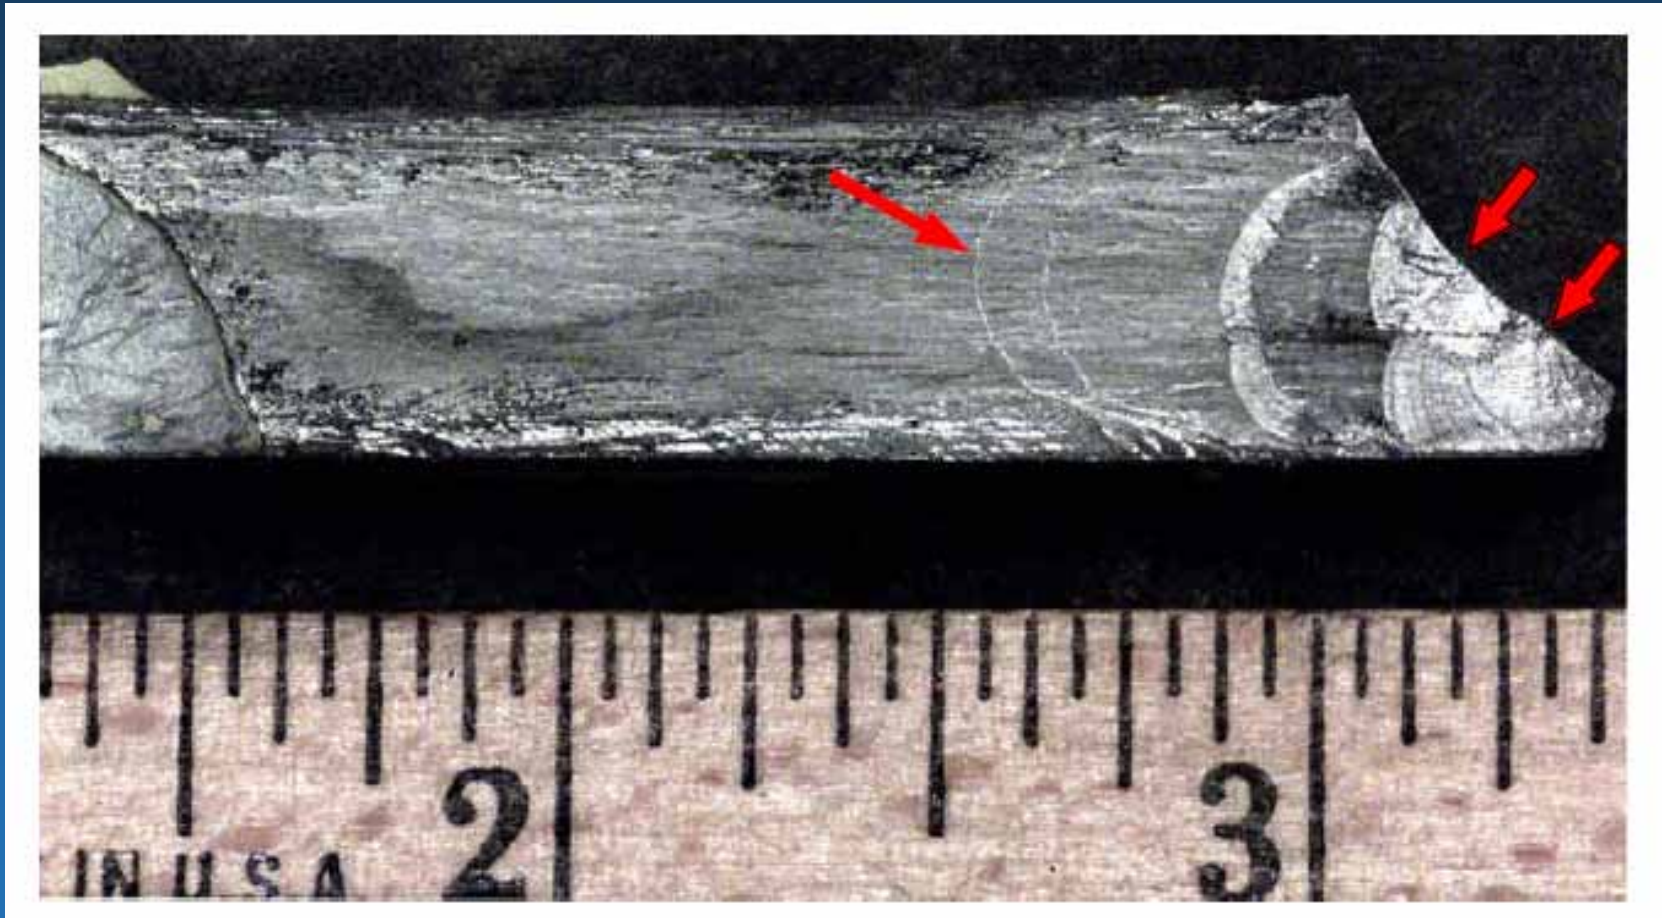
Typical Node Crack Fracture Surface
