# F/A-18E/F FULL SCALE STRUCTURAL FATIGUE TESTING

ASIP December 6, 2007

**Timothy N. Callihan**

The Boeing Company – Integrated Defense Systems

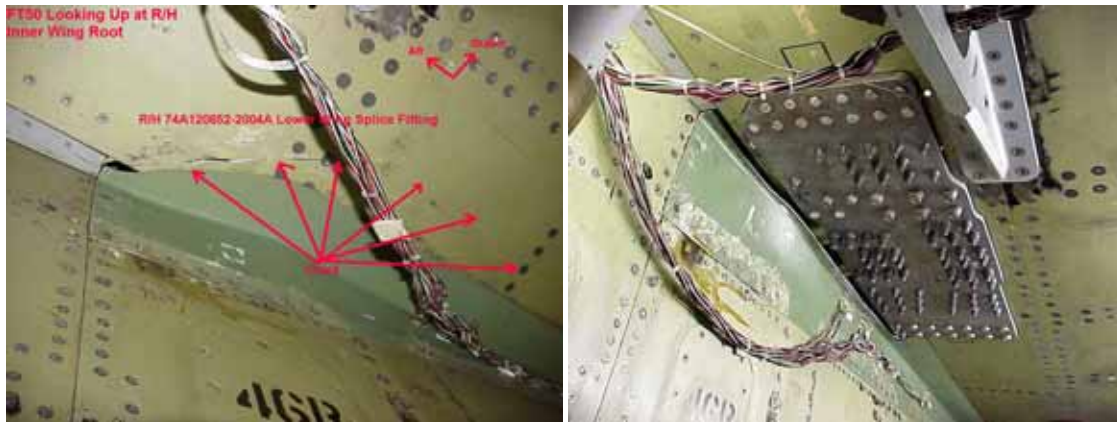
A few significant findings that were identified during the FT50 test program are presented in figures 6 through 9. The accumulated test life at the time of identification of the anomaly is noted in the title for the figures. Additional information regarding the analysis of the crack shown in Figure 6 is provided in Section 7.0 of this paper. The crack shown in Figure 9 required a redesign to the structure since this failure was determined to have occurred prior to 12,000 SFH which was the design life requirement for the F/A-18E/F program.

Figure 6 – Right-hand lower wing root skin 17” crack at 16,410 SFH (repair fitting shown at right)

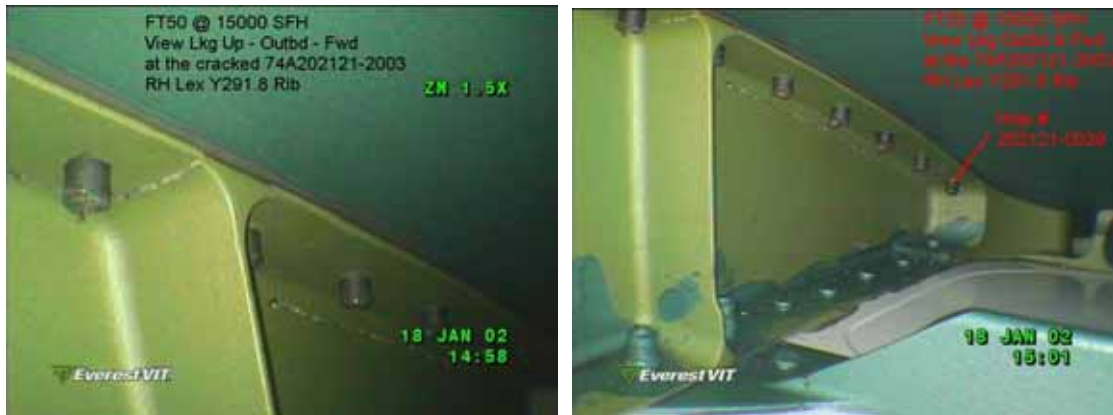
Figure 8 – Leading Edge Extension (LEX) cracks at 15,000 SFH

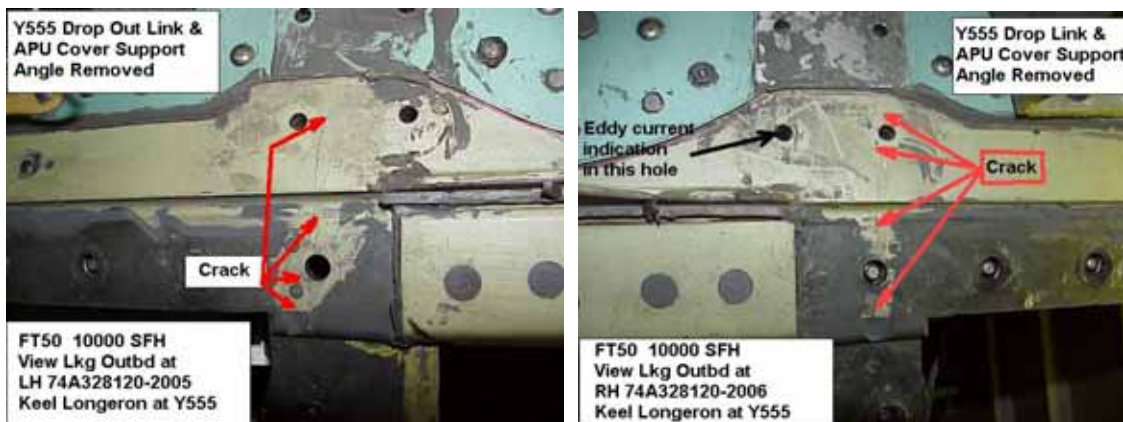
Figure 9 – Keel longeron Y555 cracks at 10,000 SFH

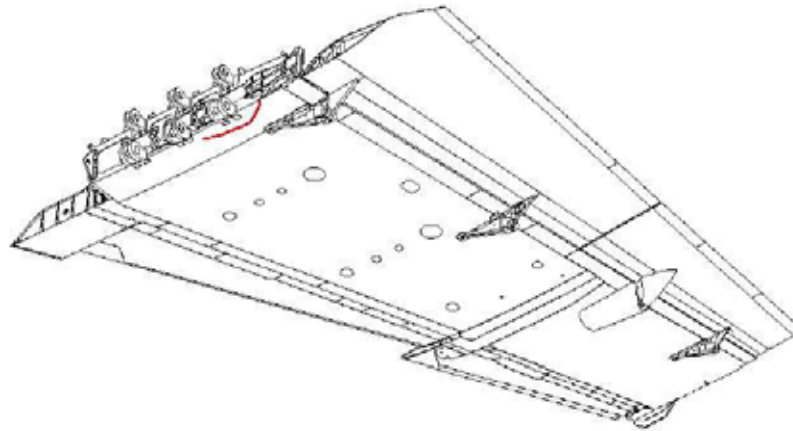
One of the most challenging cracks that was analyzed was the failure of the right-hand lower wing skin titanium splice place on the FT50 fatigue test article after 16,410 SFH of testing that is shown in Figure 10. The failure created a significant change in load path and activated the error detection system causing the load actuator system to experience an automatic shut-down sequence. The decision was made to excise the crack for failure analysis and install a repair fitting to establish a structural load path so that the testing could continue toward the goal of 18,000 SFH. The excised crack and failure surface are shown in Figure 11.

Figure 10 – FT50 lower wing root skin crack near aft lug at 16,410 SFH

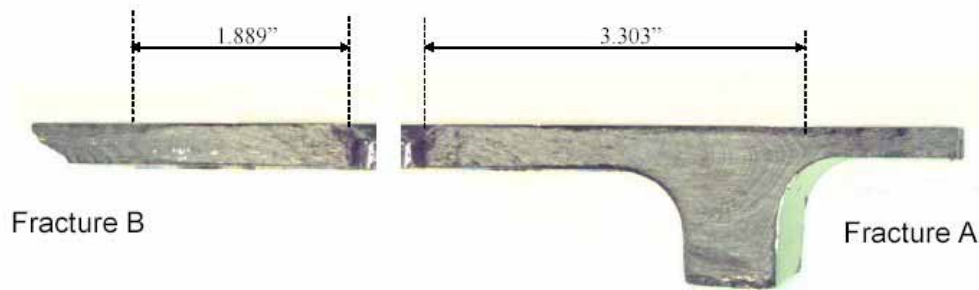
Figure 11 – Excised crack zone at fastener hole in wing root lower skin

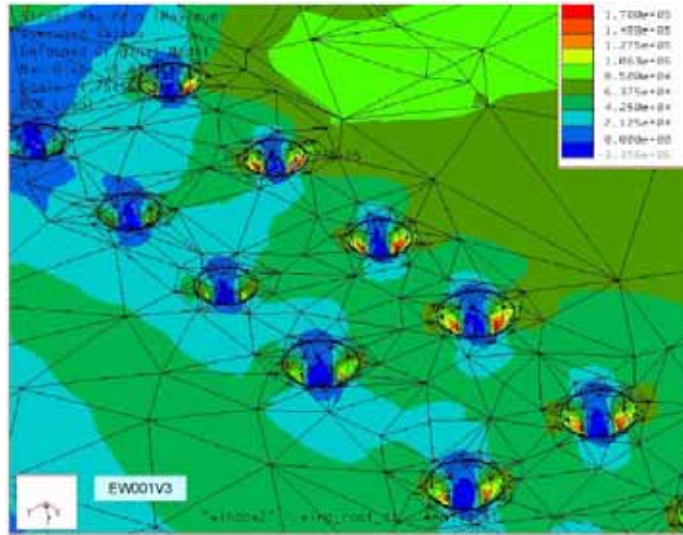
Figures 12 through 15) were constructed to confirm the stress state at the critical fastener holes in the failed part. The FEM results contributed to a predicted crack initiation life of 20,000 SFH and a 15,000 SFH predicted crack growth life – an indication that this was not a case of poor design or insufficient analysis. As part of the failure analysis process, the failed part was examined using a scanning electron microscope (SEM) to search for manufacturing defects or other anomalies. A 'rogue flaw' was found at the failed hole as shown in Figure 16. This flaw was determined to be a manufacturing induced scratch along the bore of the fastener hole.

Figure 13 – Detailed models were constructed to characterize the stress field at the countersink holes

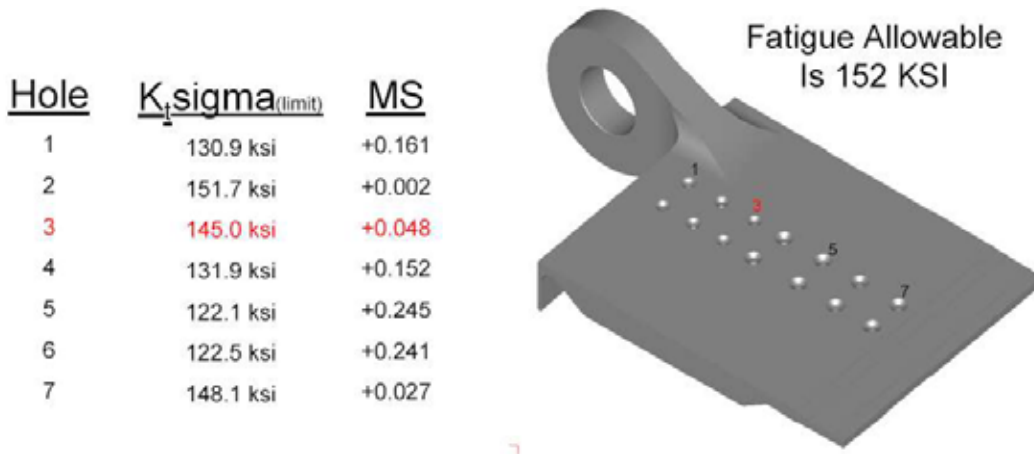
Figure 14 – The inboard adjacent hole (#2) had a higher stress than the cracked hole (#3)

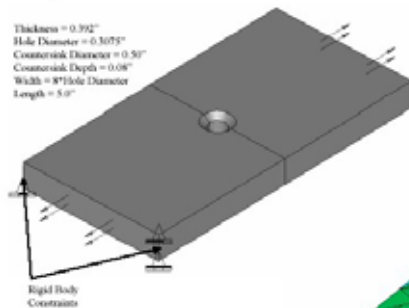
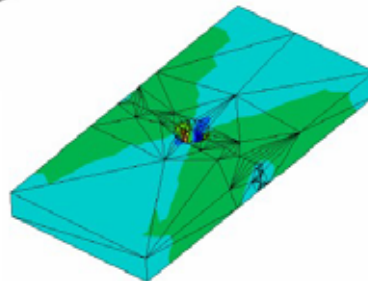
- The Root Fitting Mechanica Model shows that the maximum stress is at the base of the countersink in the hole inboard of the hole that cracked.
- A simple model was developed to investigate the stresses through the thickness of the hole and the gradient away from the edge of the hole.

Figure 15 – Maximum stress is at base of countersink rather than in bore of hole where crack initiated

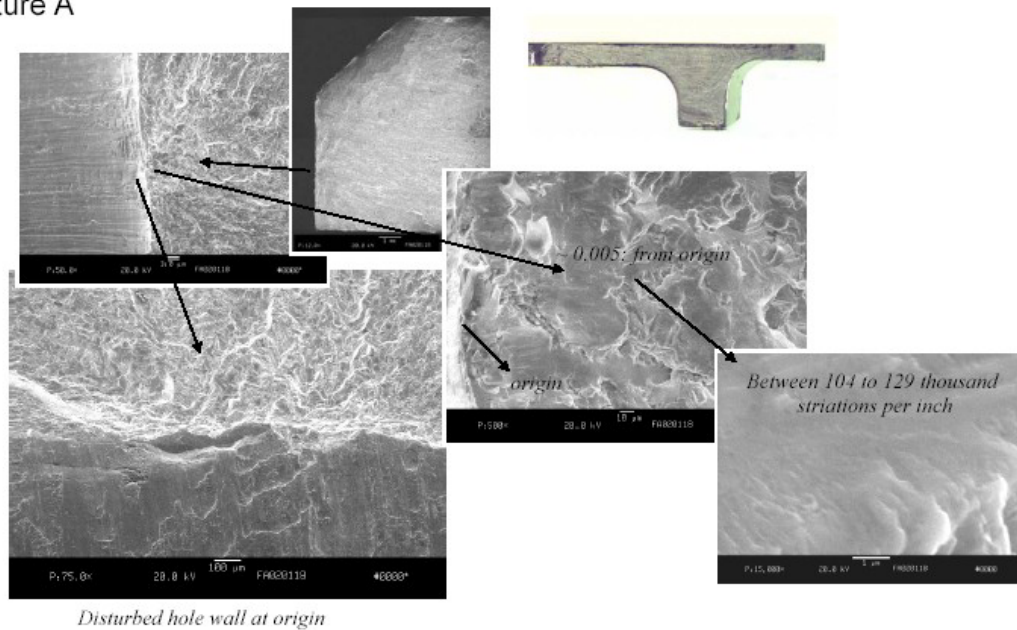
Figure 16 – Failure surface of crack emanating from flaw at fastener hole in wing root lower skin

The discovery of the manufacturing defect confirmed that a redesign was not required. The structural integrity of the original F/A-18E/F wing design was further confirmed by the following:
