Center for Aircraft Structural Life Extension

FY06 T-37B Teardown Analysis Program Results and Fleet Impact

Gregory A. Shoales, CASTLE

John B. Pendleton, T-37 Chief Engineer/ASIP Manager

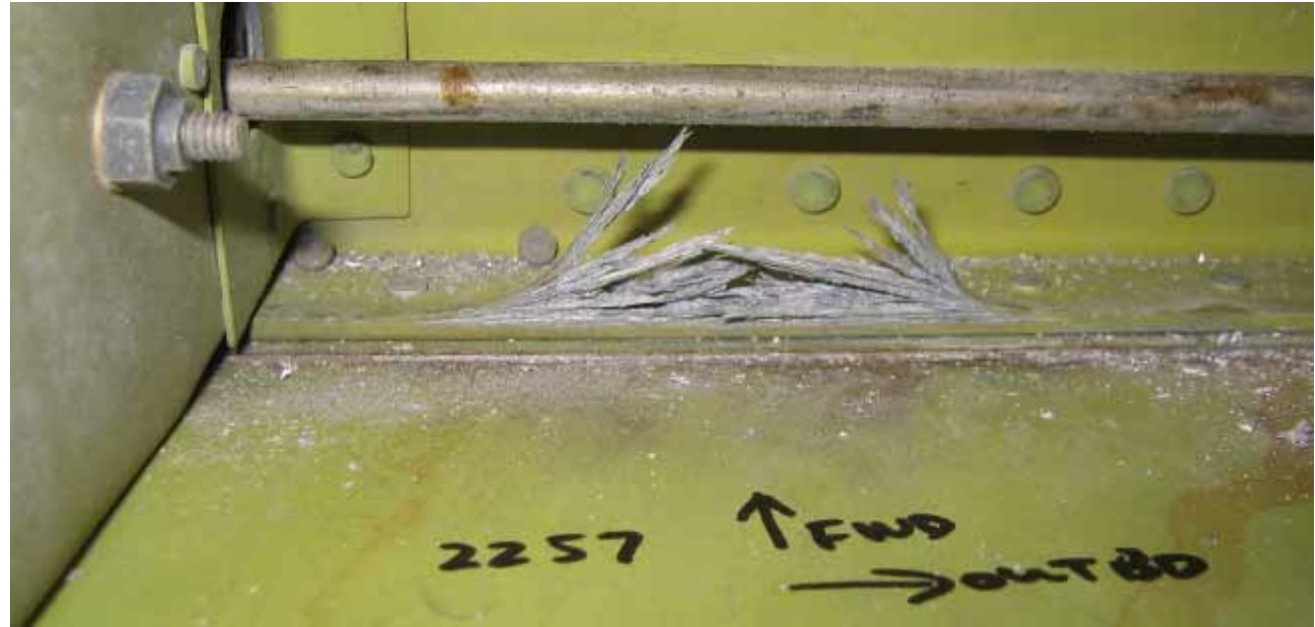
- Visual indication left upper aft spar cap of 1 aircraft

- Failure analysis finding
 - Exfoliation corrosion
 - Maximum of 47% thickness loss over 0.38 in²
 - Additional severe corrosion nearby

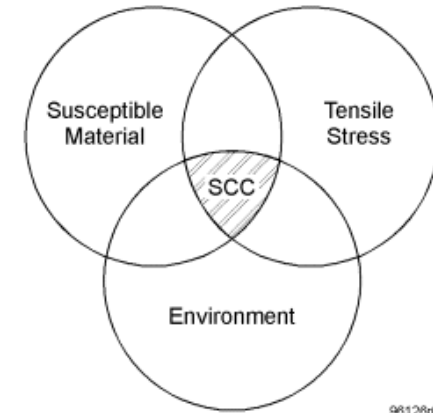
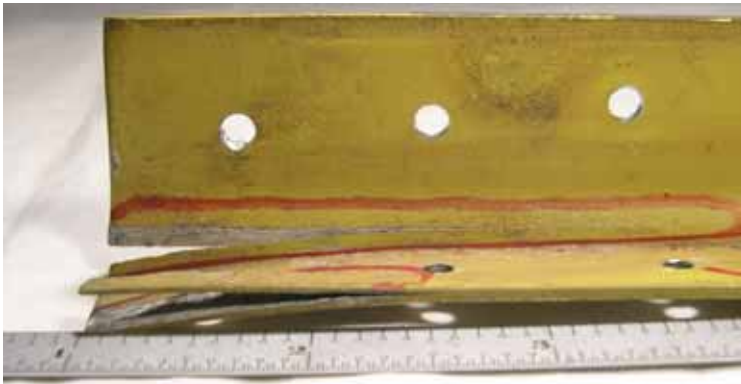
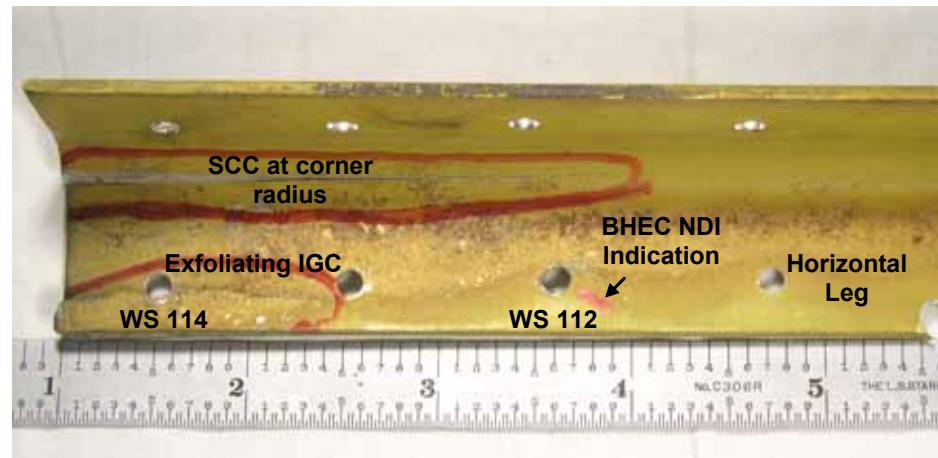
- 2.9 inch through crack
- Spar Cap Material: AA7075-T6
- Sustained Tensile Stress
 - Normal load bearing of spar cap
 - Evidence of residual stress

- Environment
 - Pooled water
 - Dark stains on spar caps observed on all aft spar caps

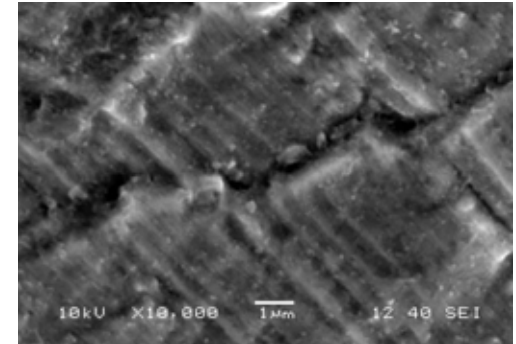
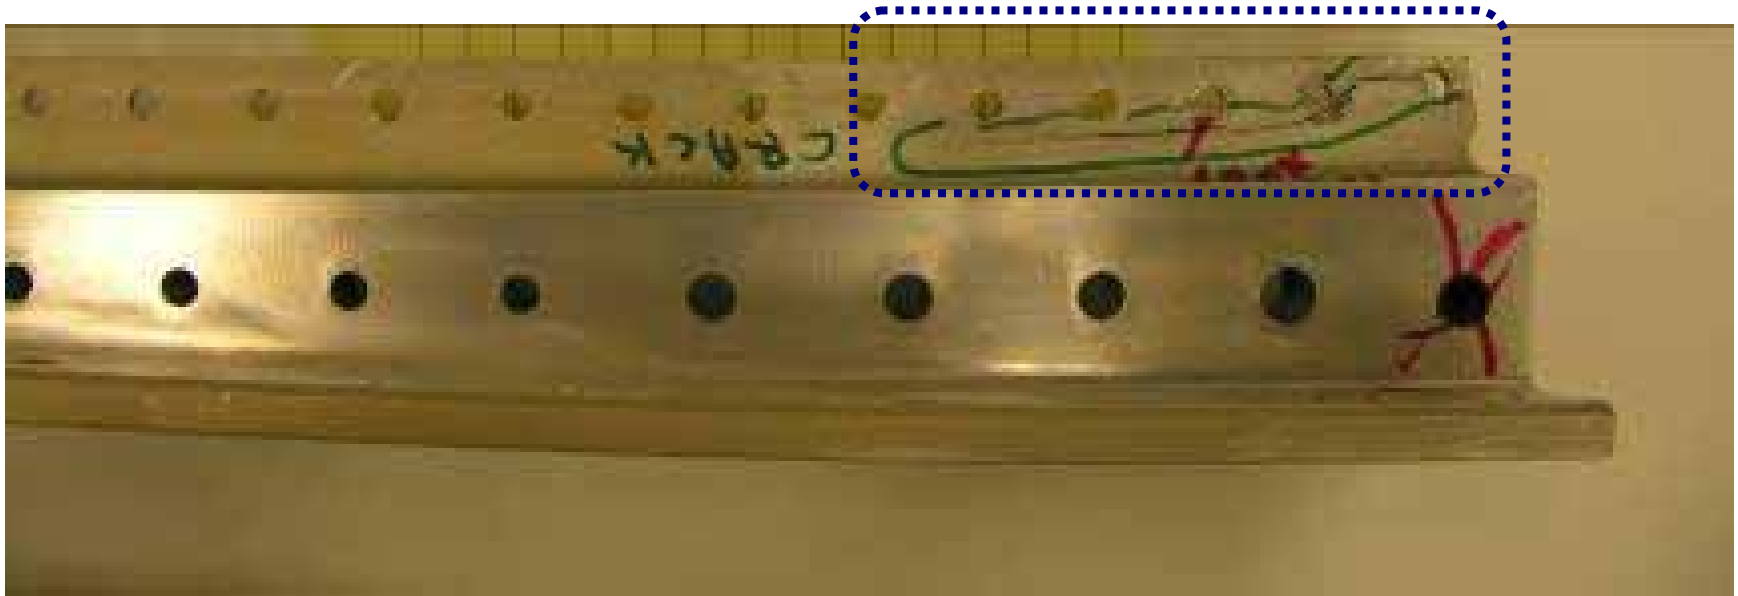
forward spar cap fatigue cracks

- Location: thin vertical leg which connects to spar web
- 18 findings at this location
 - 17 fatigue findings
 - Each with small fatigue region, ≤ 0.5 in
 - Final extension from overstress
 - One additional finding of overstress cracking only

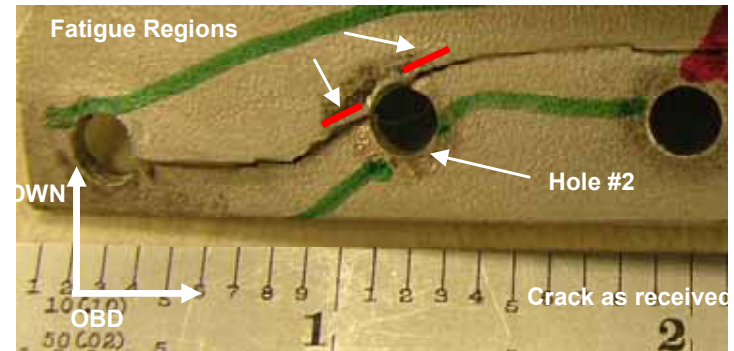
■ Specific initiation locations

- Radius between thick and thin vertical leg
- Fastener holes
 - 2:00 and 8:00 left wing
 - 5:00 and 11:00 right wing

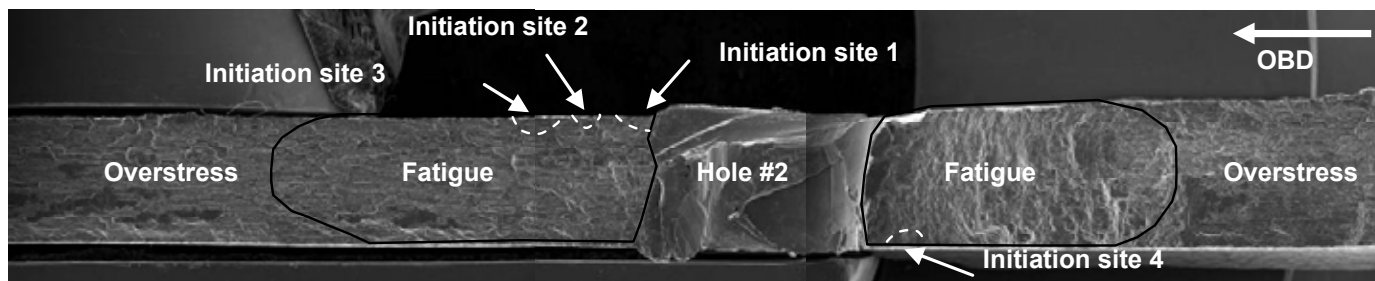
■ Fractography

- Multiple surface initiation sites
- Cracks propagate in thickness direction
- Out of plane loading—8 to 13 ksi√in
- Due to relative motion between spar caps?

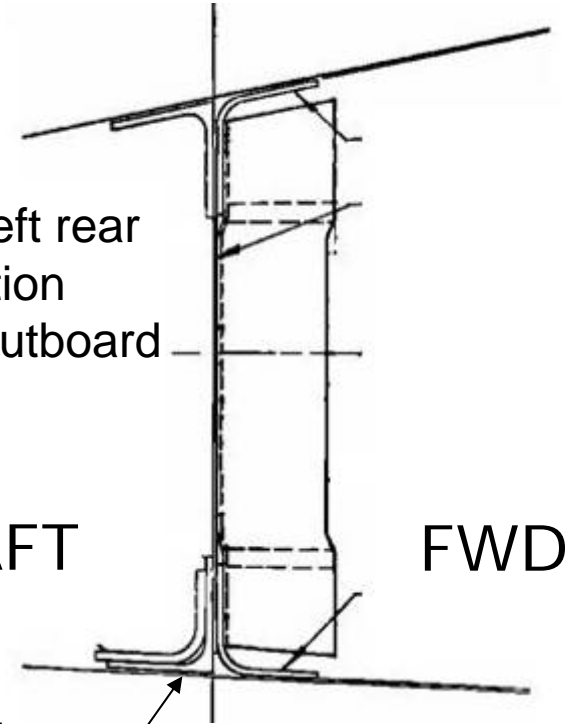
View of left rear
spar section
looking outboard

Crack location on
horizontal flange

Location of outboard flap
attachment fitting – WS111.5

- **Spanwise cracks in the Lower Rear Spar Cap Aft Extrusion Angle (AL 7075-T6 Alloy) between WS105 and WS117**
 - Failure analysis and fractography determined cause of crack to be **STRESS CORROSION (SC)**
 - No past projects (202's, 107's, etc.) found dealing with cracking in this area – We've never inspected in this area before
- **FY05 Wing Teardown inspected 4 high time wings**
 - L/H Crack approx. 12" (centered on flap fitting attachment)
 - R/H Crack approx. 6" (centered on flap fitting attachment)
 - Sheppard AFB
- **FY06 Wing Teardown inspected 4 high time wings (3 included area of interest)**
 - L/H Crack approx. 3" (at outboard end of extrusion)
 - Randolph AFB

- **X-Ray Inspection**
 - Will be able to see under splice without disassembly
 - Process already validated/verified for FY06 ACI
 - 2.75 hr duration
 - Further val/ver completed on wing section with cracked piece built in – minor mods to process/instructions
 - Done because of suspected POI/POD issues
- **Surface Eddy Current**
 - Surface Eddy Current inspection of spar cap inboard of Splice Overlap (WS105.75) – EC will catch cracks longer than 11”
 - Flap off
 - 1.25 hr duration for disassembly, inspection, reassembly, flap control check
 - Hill NDI did Val/Ver of the inspection process in August '06 at Sheppard AFB
 - Better POI/POD

- FY06 Analytical Condition Inspection (ACI) of 6 A/C
 - No findings
- Additional recurring -6/-36 TO inspection at next/each PE (500 hrs)
 - No findings to date (large percentage of fleet inspected)

- Entire fleet will be inspected by end of CY07
- 107 process if more cracks found – Repair developed
 - Move to TCTO for inspection of entire fleet within 3 month time period

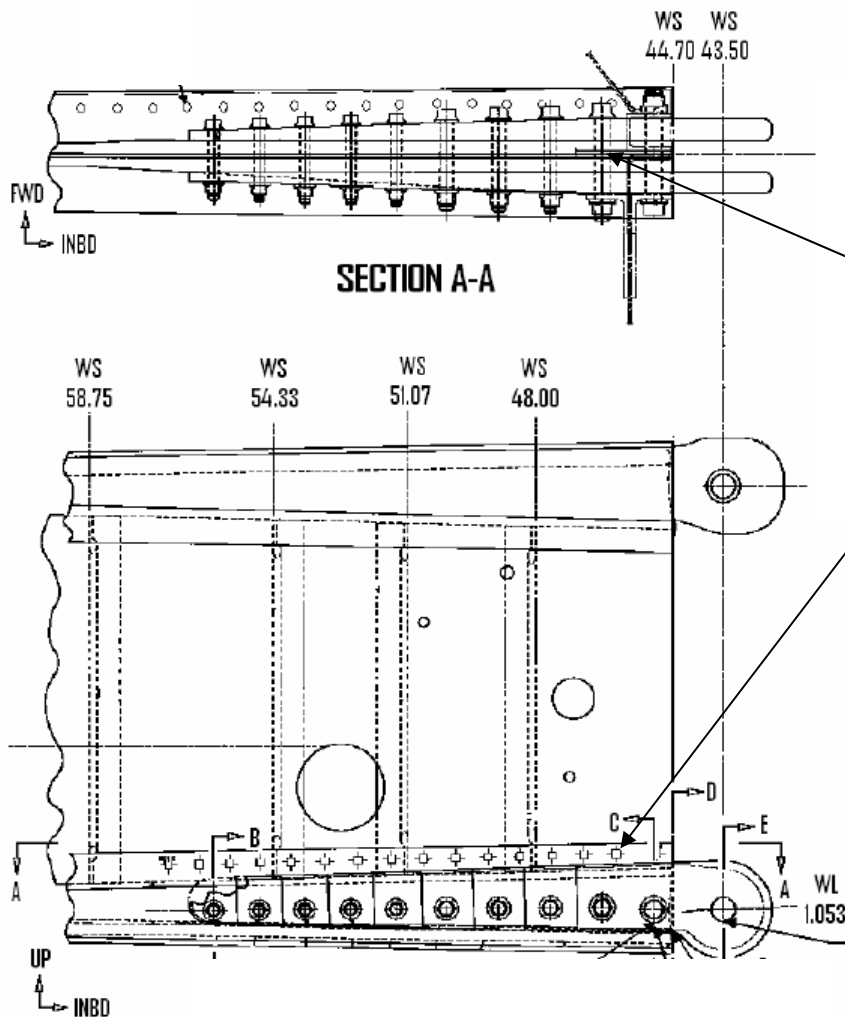
Lower forward spar cap vertical flange web attachment tab cracking location (old Cessna FCL 5B)

- **Result of Web shear load being transferred into fastener bearing & tension of thinner section of vertical flange at attachment holes and fillet radius**

- **Possibly a self arresting crack as it approaches the thicker section of the vertical flange**
 - **Two wing fatigue tests cracked at this location (~1988)**

- **Crack grew to 4 inches and arrested at second web stiffener**
 - **FY06 teardown crack is identical to this**
- **Crack could turn vertically to sever the spar cap**

- **Additional fleet wide inspection at next/each 500 hr PE**
 - **Eddy current around first 4 fasteners and in fillet radius - from aft side through access panel in landing gear bay – 1 hr**

- **Crack could be detected from the front side once it reaches the radius transition into the thicker section**
 - **Inspection interval to be modified after new DTA**

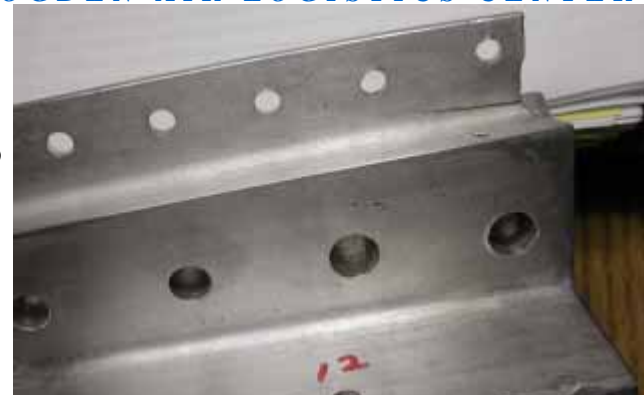
- One crack found on 2003 teardown
 - Also showed up in fatigue tests
- Found on all planes in FY06 TD and one in FY07 TD
 - 6 out of 12 planes – fleet issue
- Area not inspected in the past
- Cannot be accessed from the leading edge side
- Can be accessed for inspection by eddy current with difficulty from small access panel in landing gear bay
 - Routing of multiple tubes increases difficulty
