Test Demonstrated Damage Tolerance of F-22 Wing-Attach Lugs with ForceMate™ Bushings

M. Cayton, J. Bunch, P. Walker
Boeing Integrated Defense Systems

J. Brown, T. Brussat
Lockheed Martin Aeronautical Systems

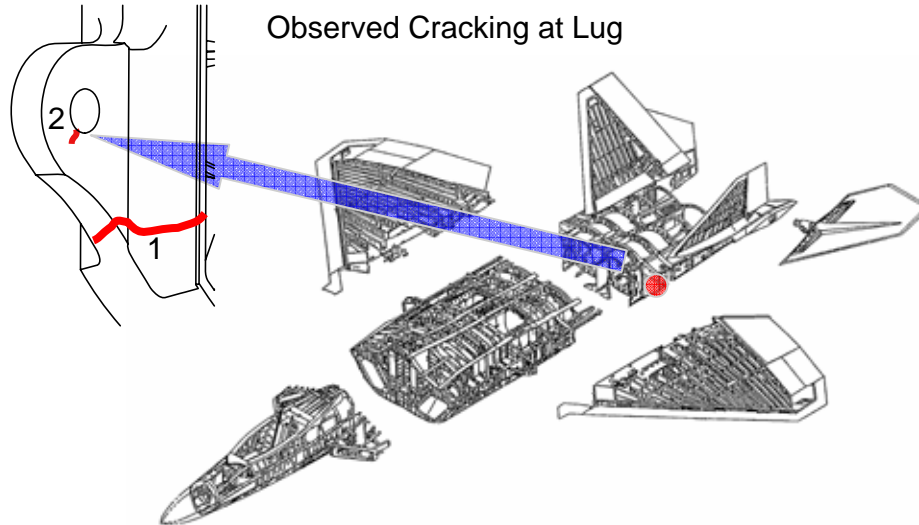
One such structural detail where a crack was discovered after the test was completed was one of the wing attachment lugs. The wings of the F-22 are attached to the aircraft by 6 pairs (per side) of lugs in an upper/lower configuration hence there are 12 lugs per side for a total of 24 wing attach points. The lower lugs are the most critical for durability and damage tolerance (DADT) as they react the wing up-bending loads in tension. During teardown, and after 2.5 lifetimes of testing, a crack was discovered on each lower lug at the STA657 attach point on opposite sides of the aircraft. These same lugs each experienced cracking at nearby lower profile locations that required repairs during the test. Figure 1 (taken from reference 2) shows the location of the cracks associated with the lug. During correlation of the lug bore crack (labeled as crack 2 in Figure 1), it was hypothesized that the crack at the lower lug profile (labeled as crack 1 in Figure 1) influenced the nucleation of the crack at the lug bore.

Figure 1 Cracking at frame lug. Location 1 discovered and repaired at approximately 1.2 lives.
Location 2 discovered at teardown after 2.5 lives.

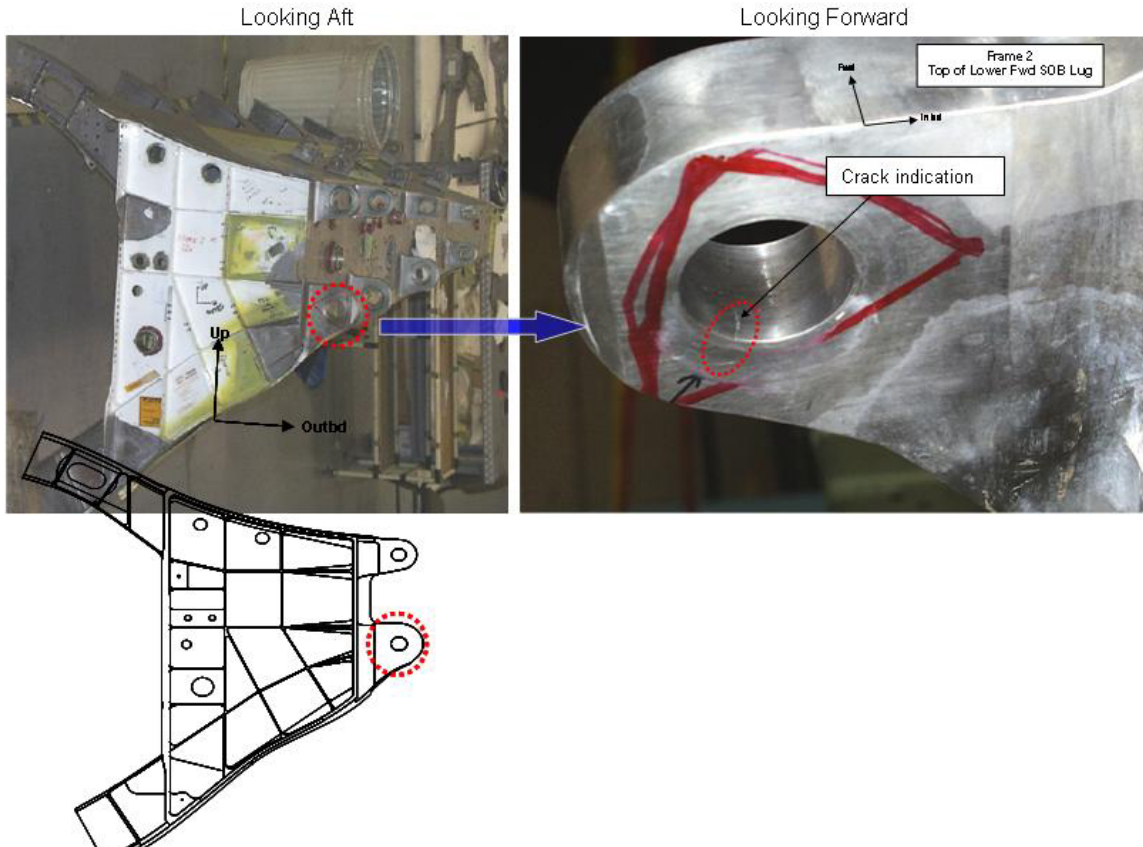
Figure 2 shows the bore crack found on the left hand side of the test aircraft. The crack shown in Figure 2 was the larger of the two lug bore cracks; however, the crack on the right hand side was also visually detectable. Prior to completion of the test, the test article, including the cracked lugs were subjected to full limit load so there was no question that the lugs continued to function as load carrying members for the full 2.5 lifetimes of testing, and correlation of the cracks to analysis indicated that the lug met full durability life requirements. The crack growth correlation analysis did result in additional damage tolerance inspections due to the possible occurrence of a rogue flaw.

Figure 2 Location of cracking observed on lug bore, left hand side shown, smaller crack at similar location observed on right hand side.

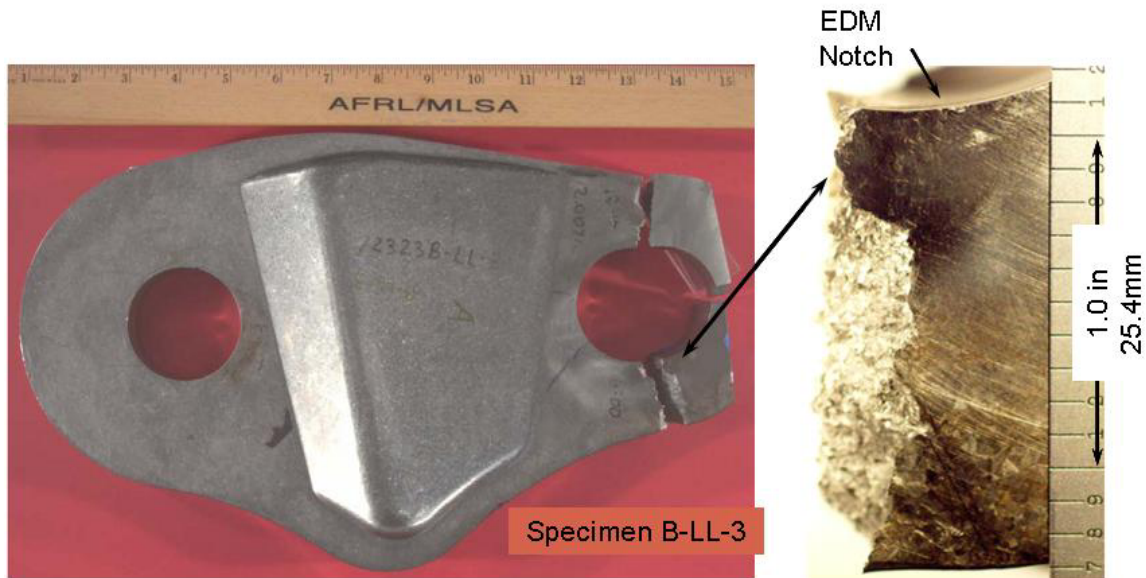
While comparing an average life of 2.5 lifetimes for the original 3 ForceMate specimens to the typical life of 1.0 for the net specimens appears to be an improvement, the location and mode of failure warranted further investigation. Figure 11 is a photograph of the profile of specimen B-LL-3 showing the location of the EDM notch relative to the fracture surface. A photograph of the fracture surface is shown in Figure 12 where multiple initiation sites are marked. Examination of

the bore surface revealed evidence of both fretting and galling, and large deposits of fretting debris collected on the bore surface.

Figure 11 Specimen B-LL-3 after failure, photo on right shows the location of EDM notch relative to fracture face. EDM notch was originally at the 64.3 degrees from the 12:00 location main fracture is a few degrees closer to 6:00.

Examination of the failed specimens B-LL-3, A-UL-2 and A-LL-1 all revealed similar characteristics, namely in all cases, the primary failure initiation was due to internally initiated flaws along the lug bore. That is, in none of the 3 specimens did the flaw initiated from the EDM notch contribute to failure, and all 3 specimens exhibited evidence of both fretting and galling. Fretting debris was present in both the lug bore surface between the bushing and lug. It is postulated that as the fretting debris accumulated between the lug and the bushing, the more aggressive material removal associated with galling occurred.

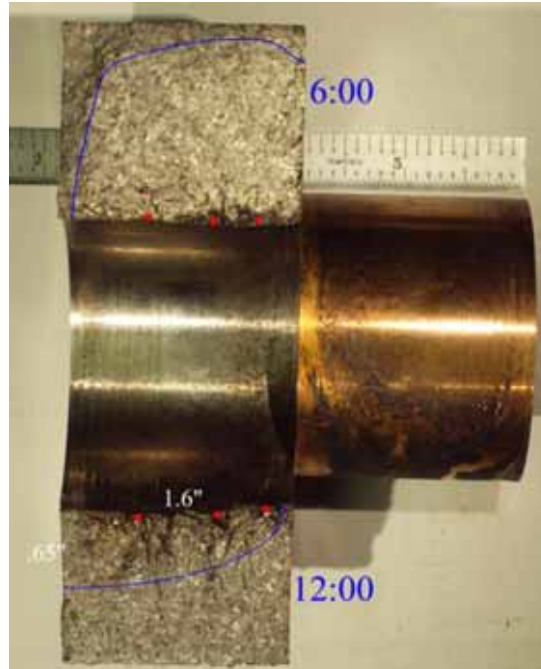
Figure 12 Fracture surface of B-LL-3 showing multiple initiation sites along lug bore. Thin blue lines show the approximate extent of fatigue cracking.

At the load levels tested, the results that fretting was a significant contributor to crack nucleation suggested that the applied interference levels in the bushing were not sufficient to prevent gapping and relative motion between the lug and bushing. This gapping indicated that the applied expansion during installation did not provide sufficient preload for the level of applied stresses and deflections the lug experienced during testing. It was also desirable to eliminate fretting or mitigate its effects to the greatest extent possible.

A bushing that applied a higher level of expansion was designed and installed into two test specimens. The specimen identified as B-LK-7 in Table 1 and Table 2 had this increased expansion bushing installed at the start of the test. This specimen was tested in this configuration for the duration of the test, and it achieved a life greater than 10 lifetimes. This test configuration is representative of an aircraft lug with this bushing installed "in the factory". A second specimen, identified as B-UL-4, had a bushing installed to the original configuration for the first 0.5 lifetimes of testing. After 0.5 lifetimes, this bushing was removed and replaced with the increased expansion bushing and testing was continued until 8.9 lifetimes.
