OKLAHOMA CITY AIR LOGISTICS CENTER

Improving Depot NDI Capability

Mr. Jeff Catron

76th MXW, Technical Director

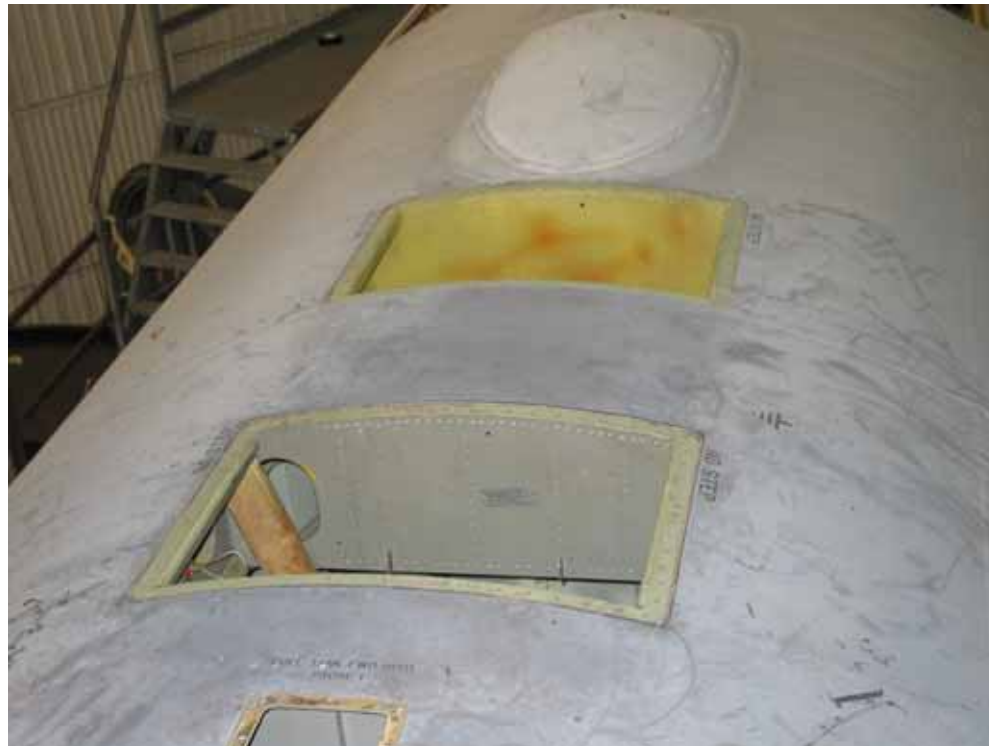
Airbrake Assembly

- **Crown Skin at Fuel and Forward Access Doors.**
 - T.O. procedure calls for inspection around both the Aft Fuel and Forward Access doors
 - 173 card and work spec specify inspecting around Aft Fuel door only

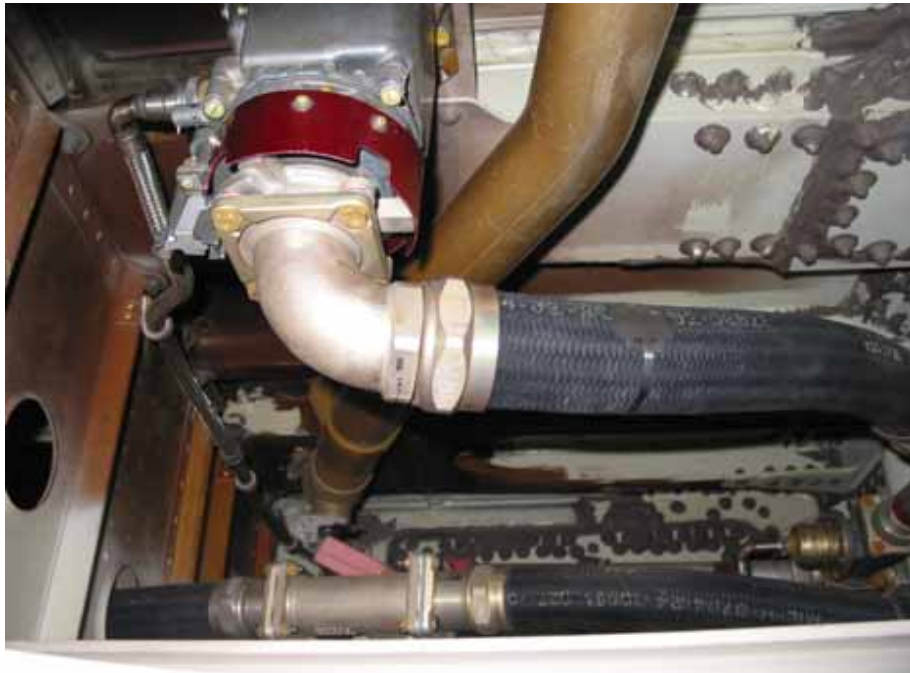
Fuel Pump Assembly

- **Stiffener S-2 Lower Flange at Lower Wing Skin Attachment**
 - Inspection areas on these procedures appear to overlap by 20”
 - Procedure lacks requirement to remove fuel pump assemblies
 - Access to inspection area is not possible with fuel pump assemblies in place
 - Guidance may intend for the lower wing skin to be inspected in this area— not the stiffener flange as written
