B-1 Dorsal Longeron Repair Concept Case Study

2006 USAF Aircraft Structural Integrity Program Conference November 30, 2006 - San Antonio, Texas

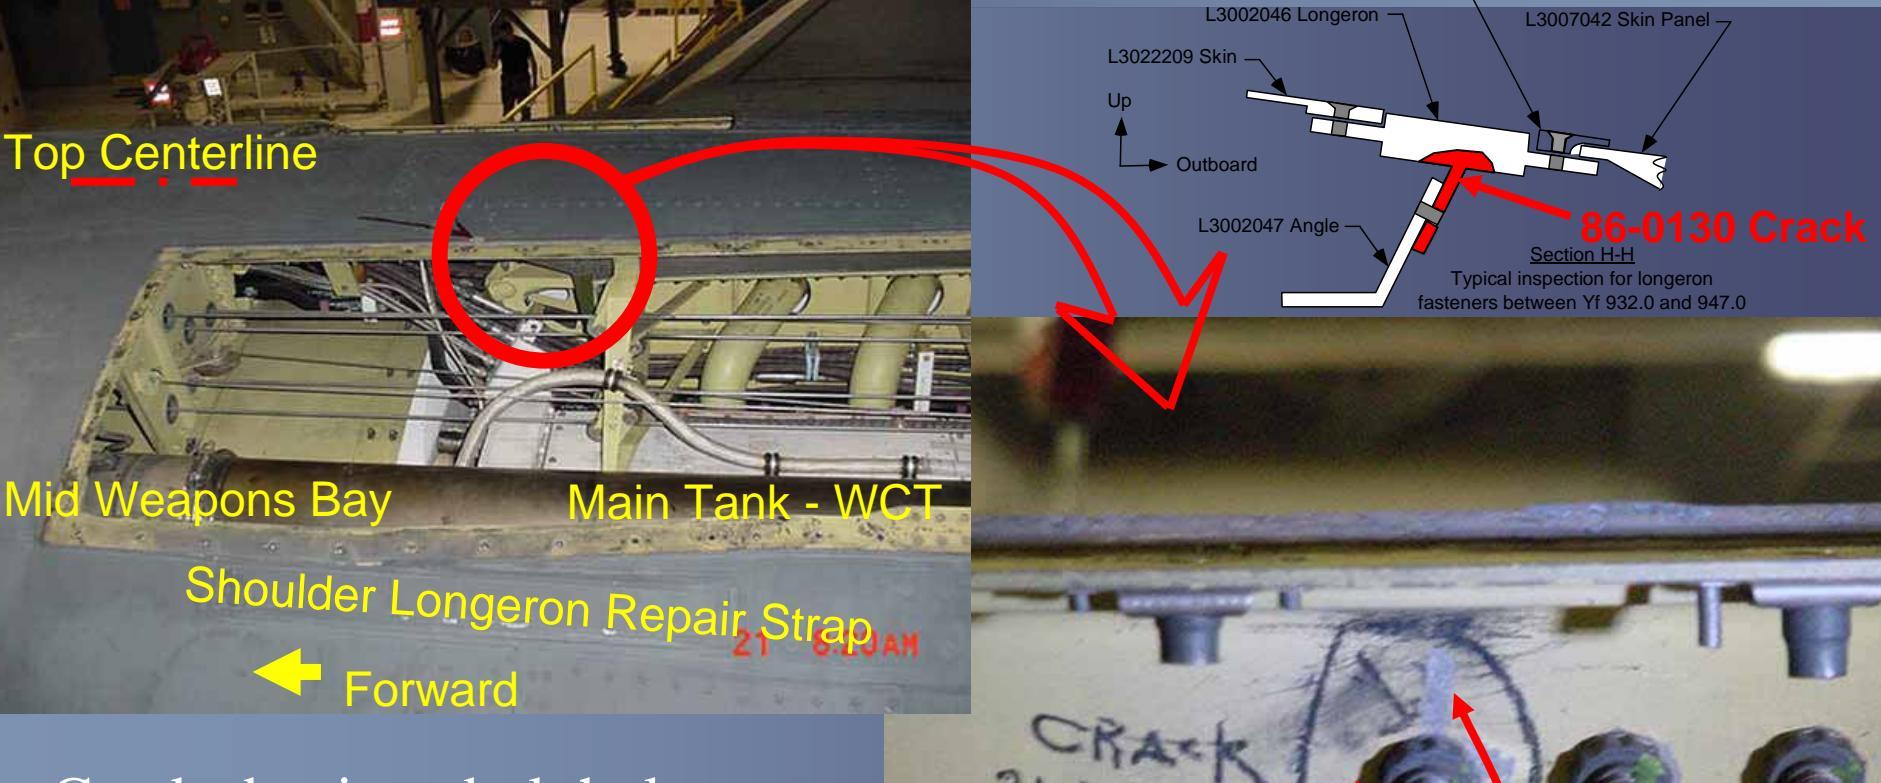
Background of Dorsal Longeron Cracks

Cracks begin at bolt hole and run to bottom of flange. Cracks growing up from bolt hole advance rapidly.

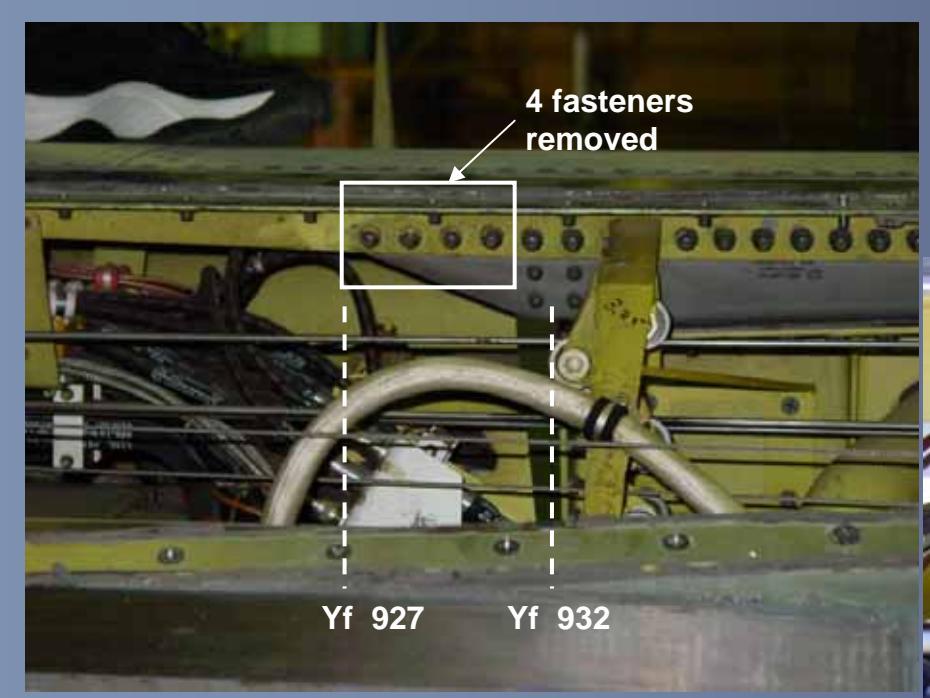
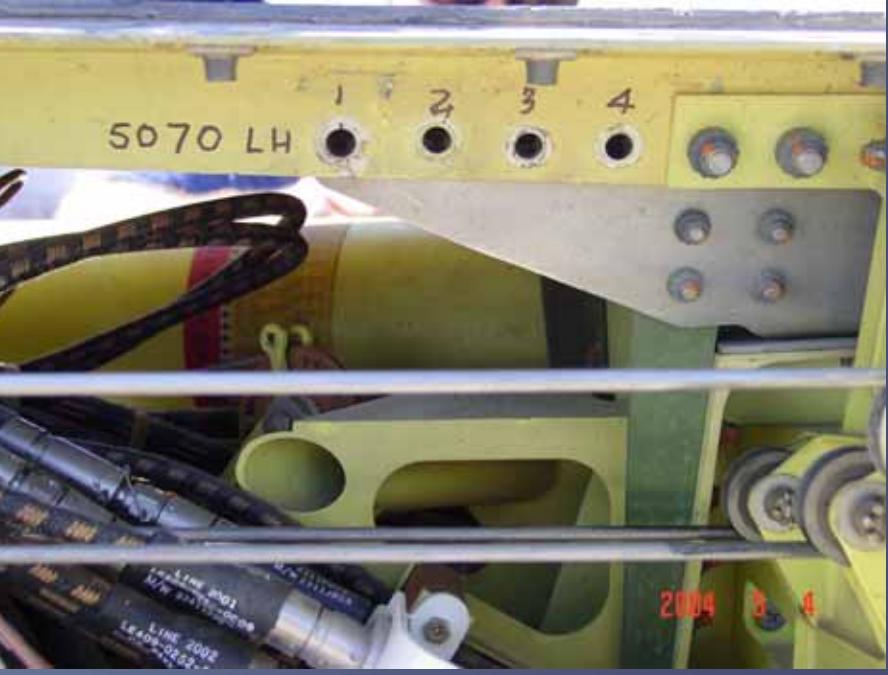
• Fastener Removal

- Fastener Removal
 - Full A/C NASTRAN model used to verify concept and effectiveness
 - Local load distribution only
 - No global effect on rest of A/C
 - Fasteners not reinstalled
 - Currently all A/C in force have fasteners removed
- Cold Working 4 holes (TCTO 1B-1B-1337)
 - Remove 5-7 o'clock crack by reaming up to .50"
 Dia if E.D. is sufficient prior to cold working
 - Fasteners not reinstalled
 - To date three A/C have been cold worked

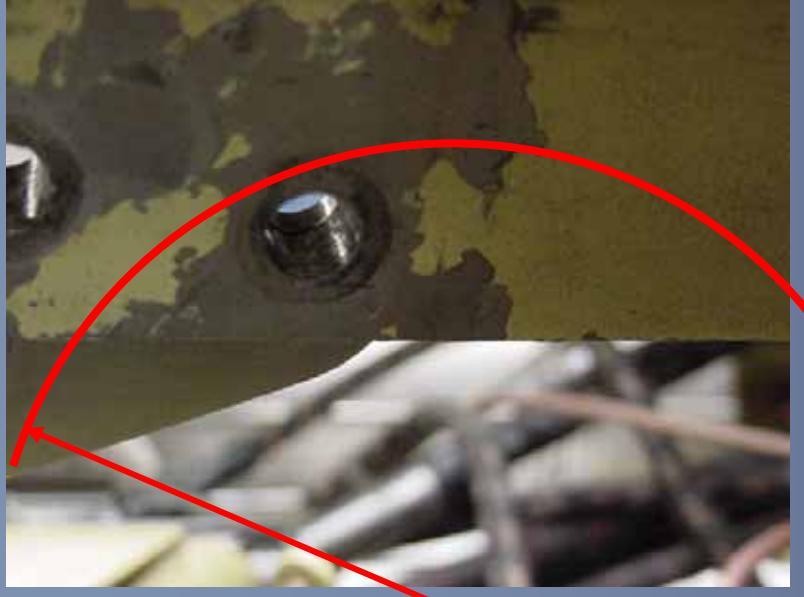
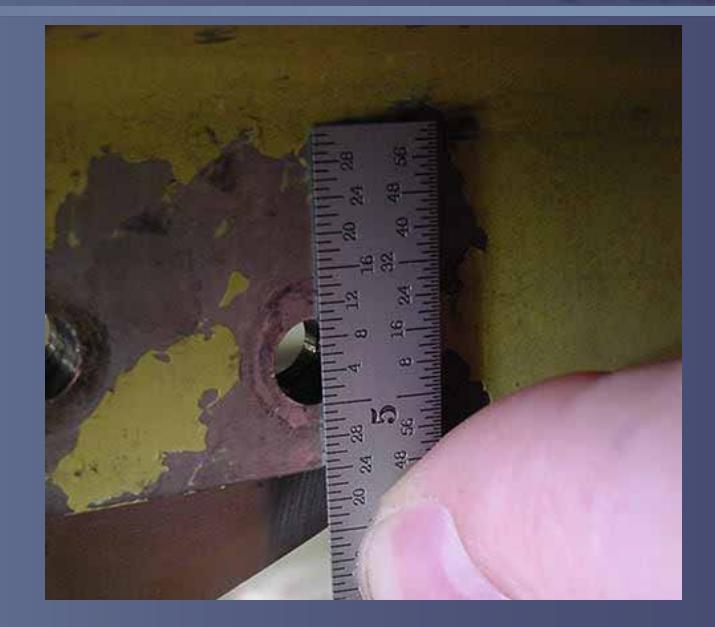
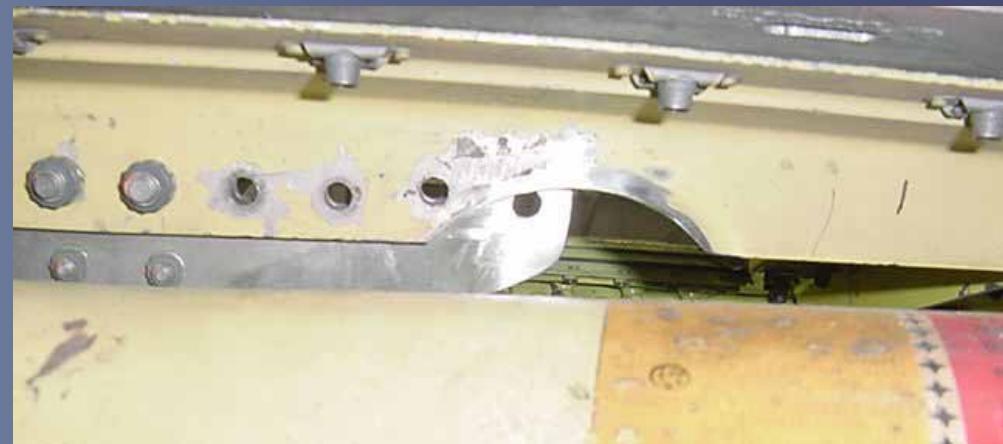
Scallop Repair (A/C 85-0065 RHS)

- Mechanica model shows large reduction in stress concentration
- Crack growth analysis demonstrated sufficient life
- Used when crack length beyond that which can be removed by over-sizing hole but no exit crack growing up
- Three A/C have this repair

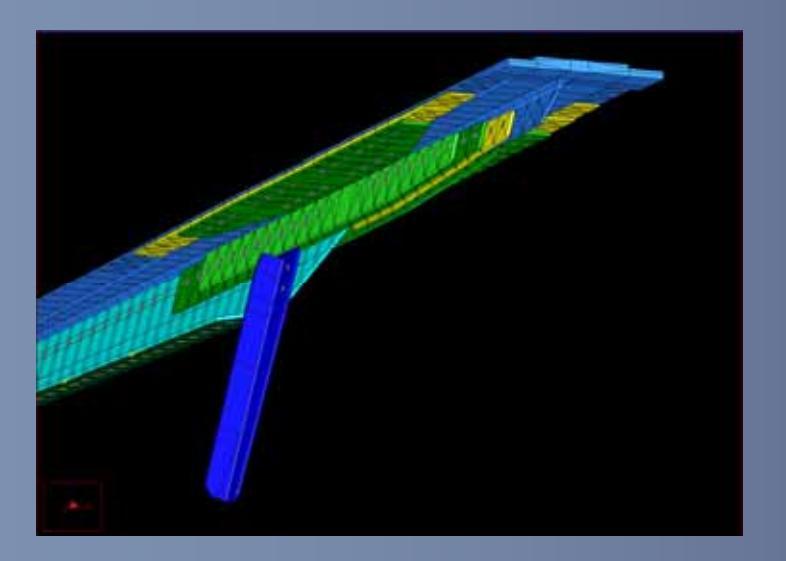
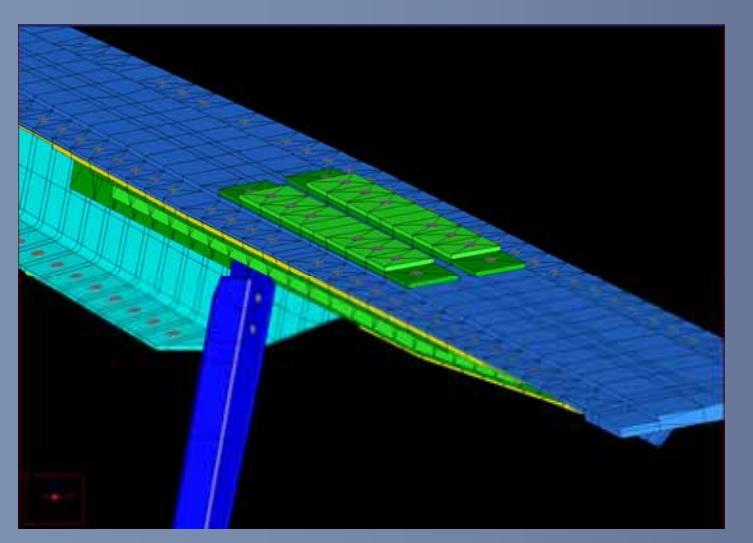
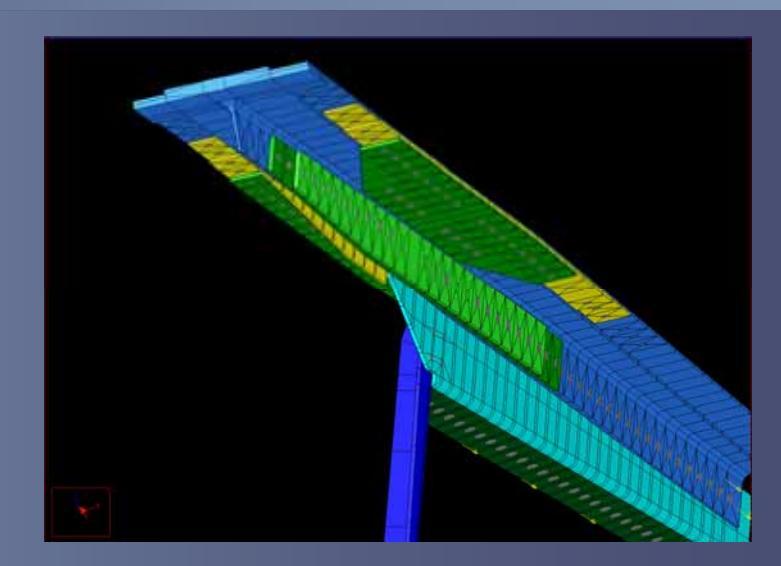
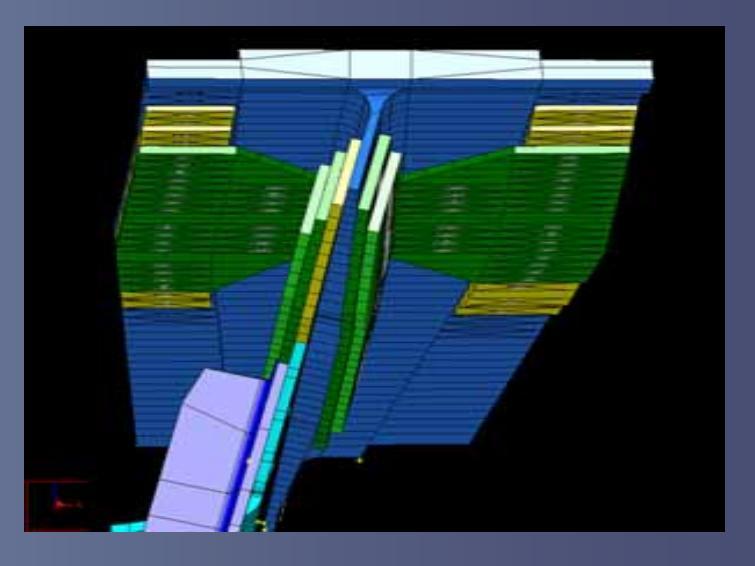
Interim Longeron Repair

- Used when exit crack exists
- Extensive Mechanica modeling to verify repair
- Sufficiently restores strength of longeron
- Relatively low predicted life for doublers
- Two A/C have this repair

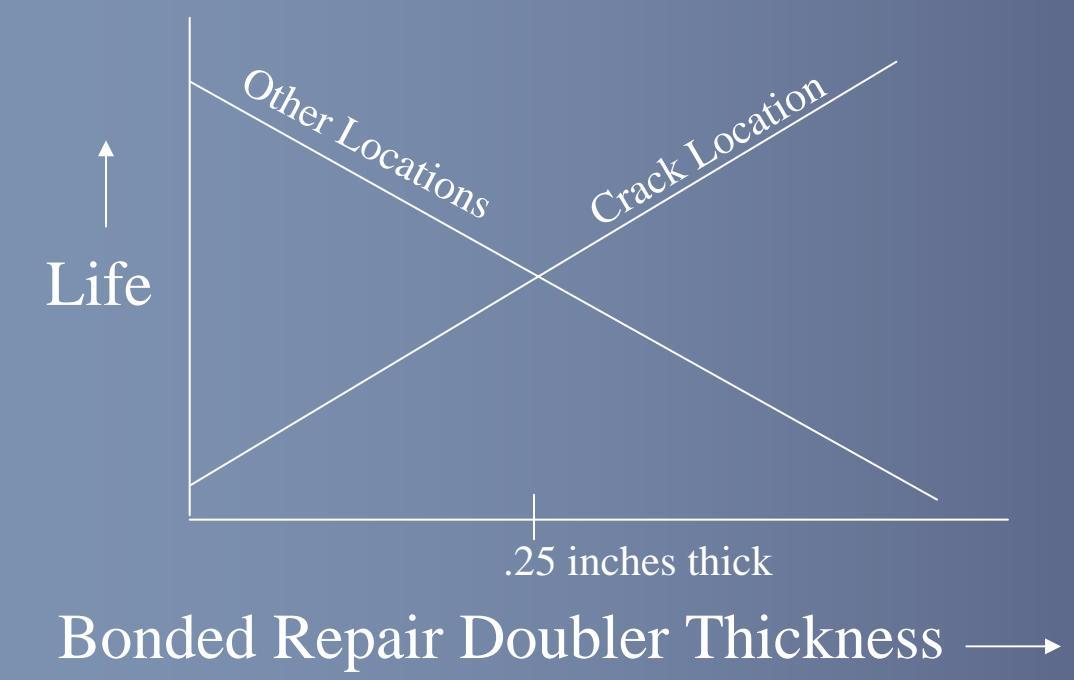
- Delicate balancing act to <u>not</u> chase cracking elsewhere
 - Originally thought only isolated area needed to be fixed
 - Analysis determined that there are many more "hot spots" on longeron
 - Developing repair more complicated than anticipated

Thicker repair doubler reduces stress and increases life locally but attracts more load to longeron decreasing life elsewhere

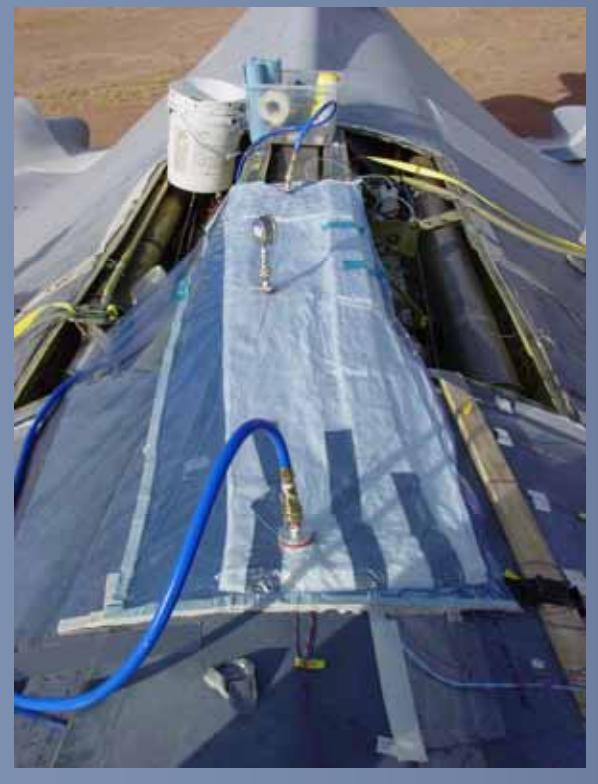
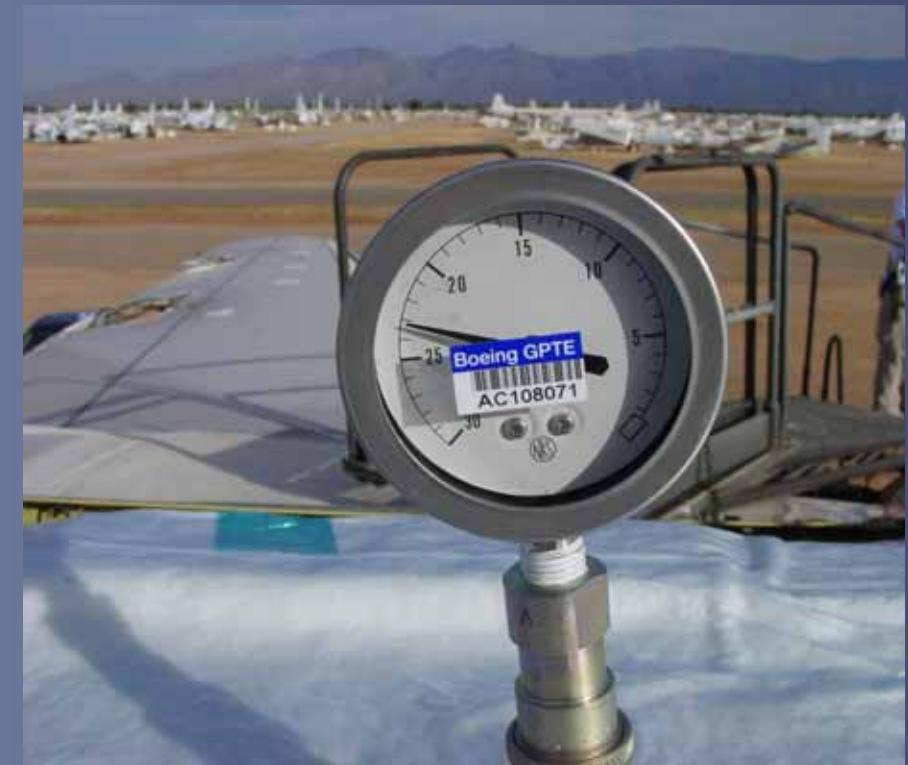
Thermal Survey at AMARC

- Vacuum Bag, Heater Blankets, multi channel Controller
- Required temperature 250 F achieved in steel, no hot spots in aluminum
- Minimal leakage, structure well sealed at fastener holes
