Residual Strength of Bonded Repairs After 10 Years of Service

Aircraft Structural Integrity Program Conference

A USAF-sponsored program to assess the residual strength of bonded repairs that experienced over a decade of operational service

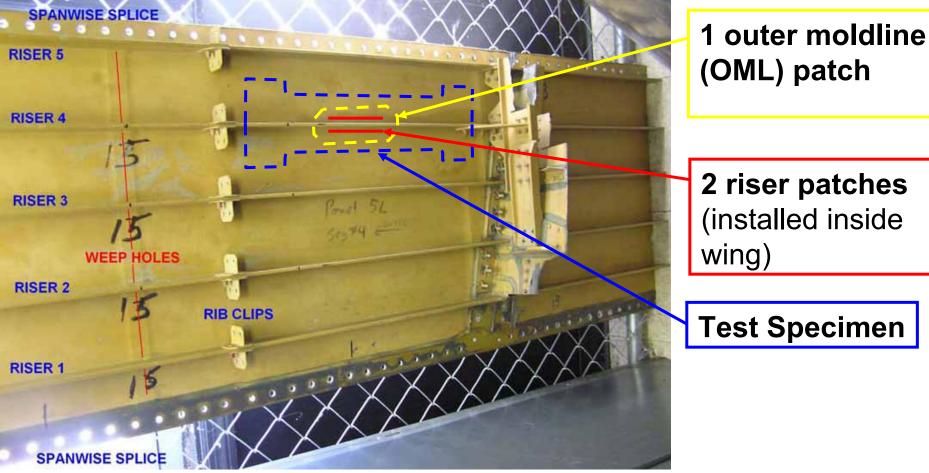
- C-141 Wing Plank
 - View from the inside looking out
 - ~ 20 feet long and ~ 4.5 feet wide

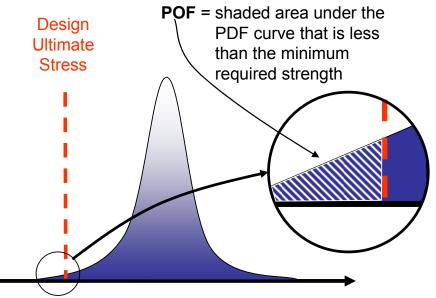
Probability Density Function (PDF) of the Residual Strength of Repaired Specimens

Probability (strength < DUS) ["POF"] must be < 10⁻⁷

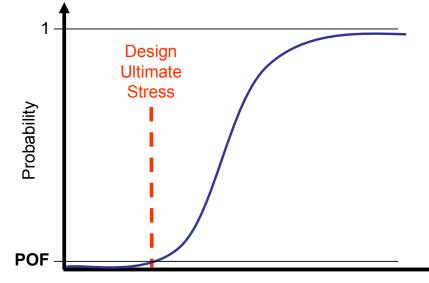
Cumulative Density Function (CDF) of the Residual Strength of Repaired Specimens

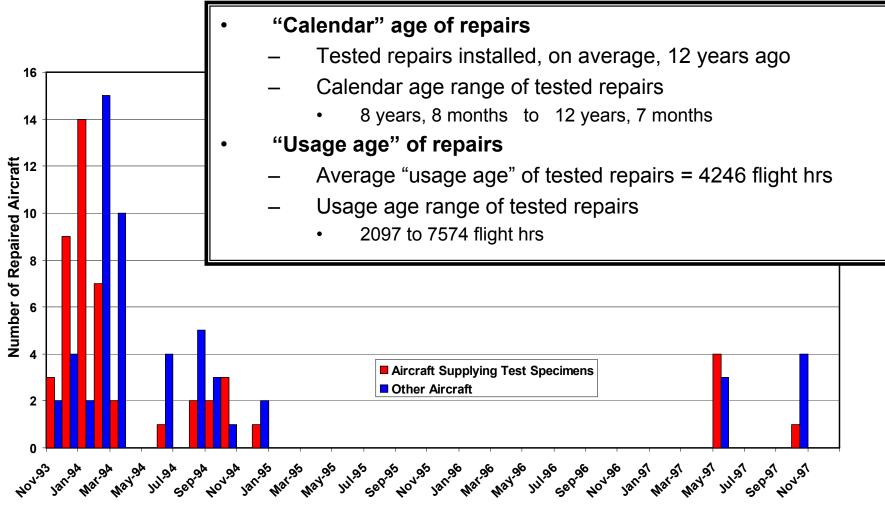
Repair Installation Date

Tested repair population ~ Total repair population

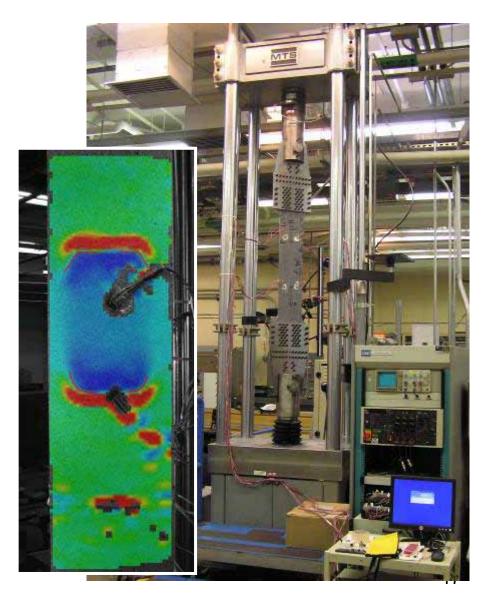
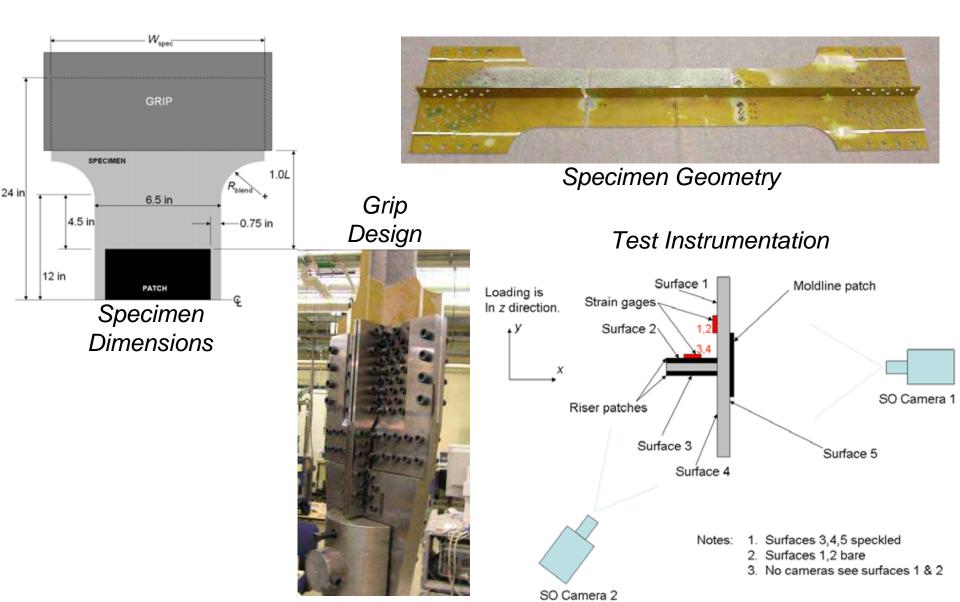
- Servohydraulic test frame
- Computer-controlled data acquisition
- Full-field stereo-optical (SO) speckle pattern strain measurement
 - Video strain mapping

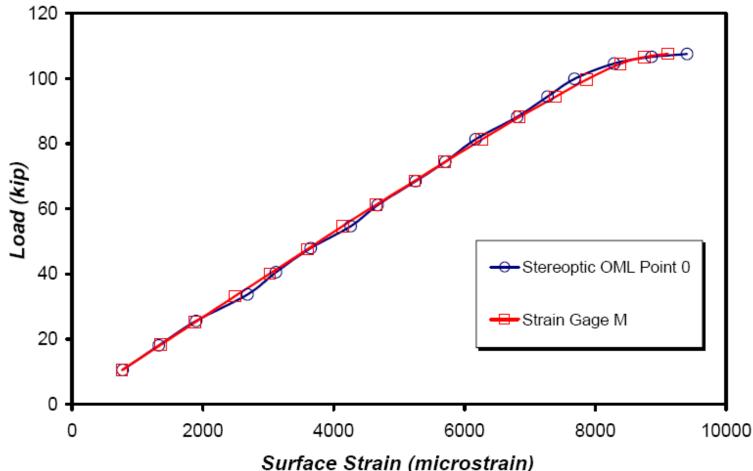
Strain Measurement Correlation

Very good correlation between strain gages & SO system

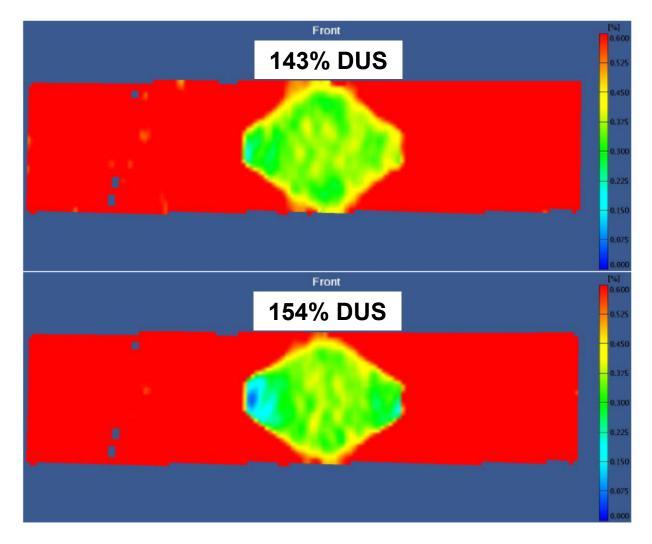
Typical Stereo-Optical Strain Measurements

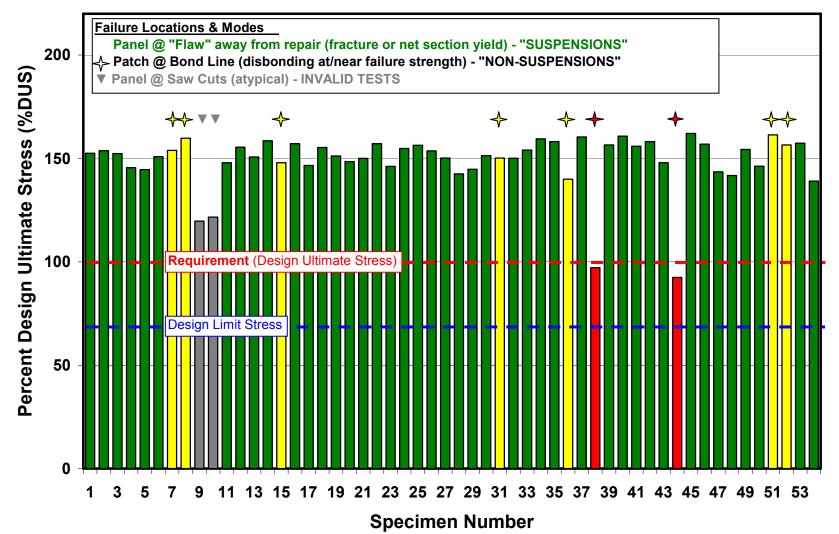
C-141 Bonded Repair Residual Strength

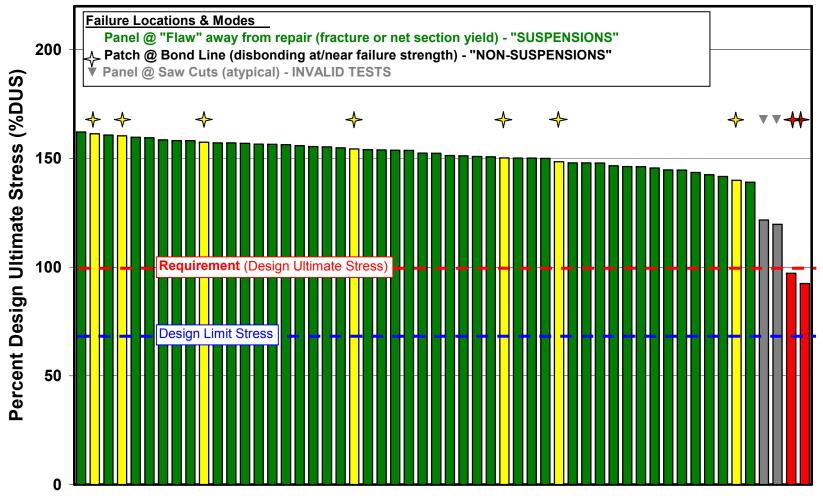
C-141 Bonded Repair Residual Strength

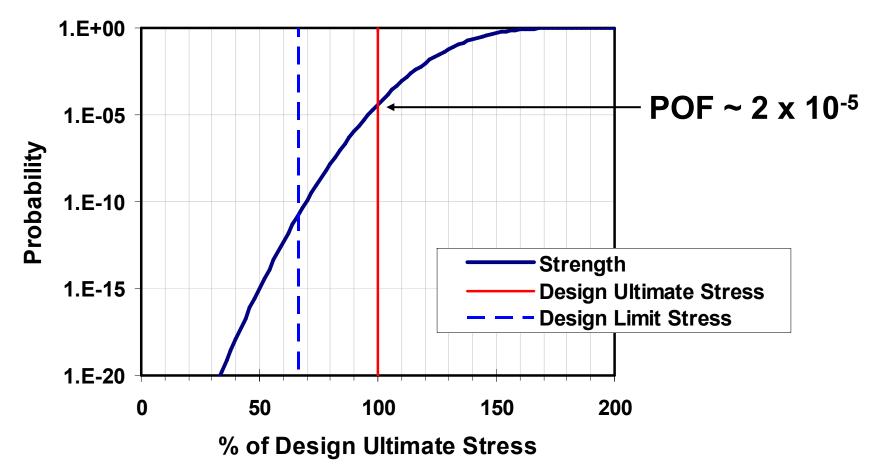
CDF of Repair Failure Strength

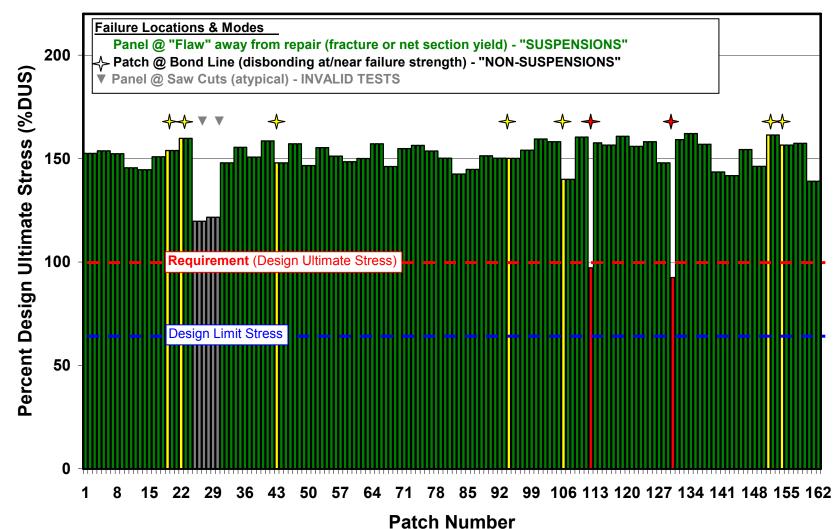
C-141 Bonded Repair Residual Strength

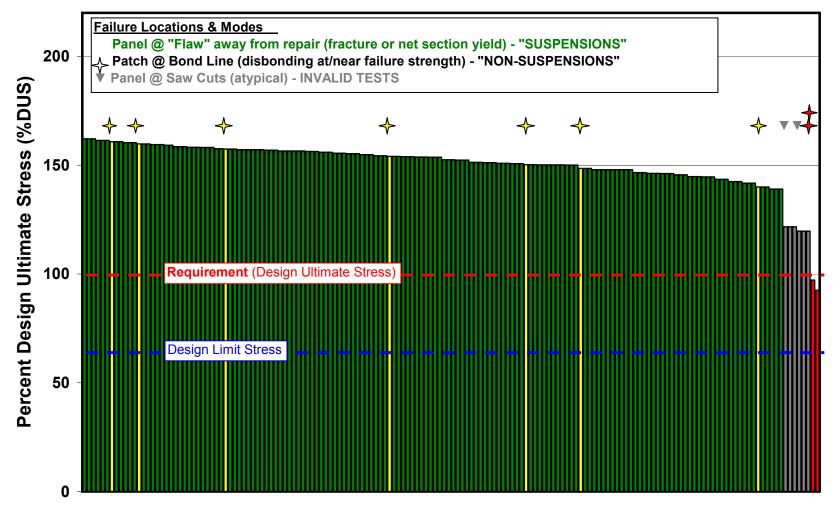
C-141 Bonded Repair Residual Strength

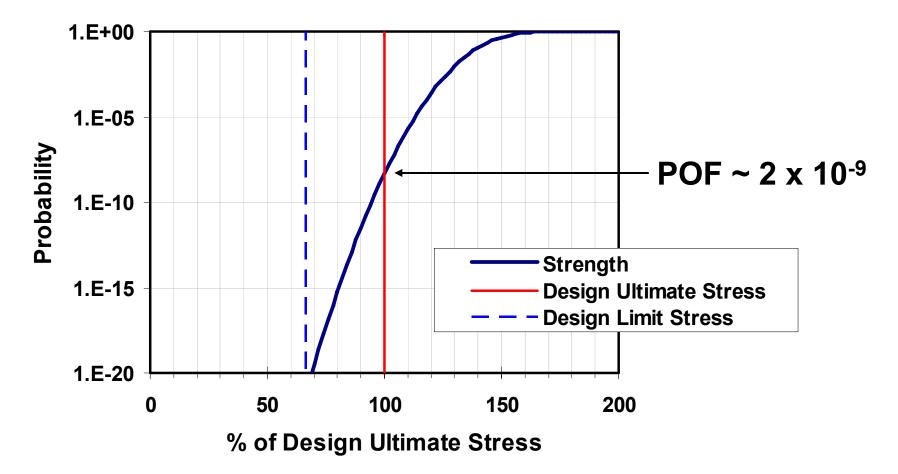
CDF of Patch Failure Strength

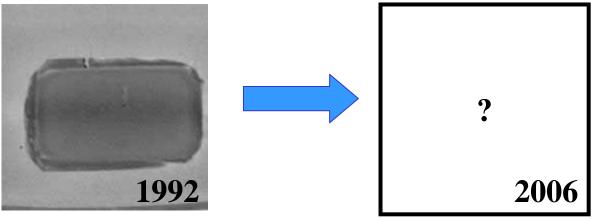
- Pre-test thermal imaging NDI ("thermography")
 - Compare with original images, circa 1990
 - Check for crack growth or disbonds
