# Analysis of Two Structural Failures of F-15 Speed Brakes

Mercer Engineering Research Center

*2006 USAF Aircraft Structural Integrity Program Conference*

# Background

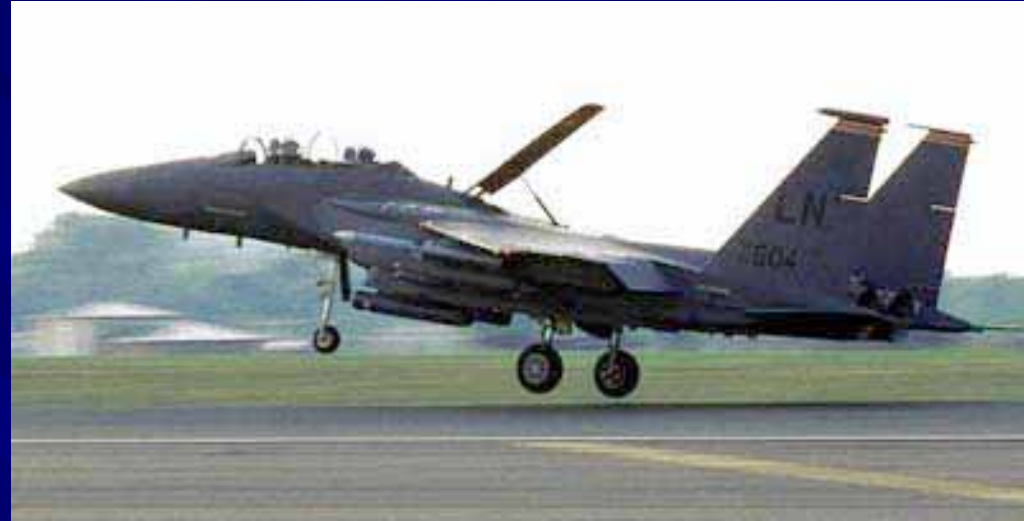
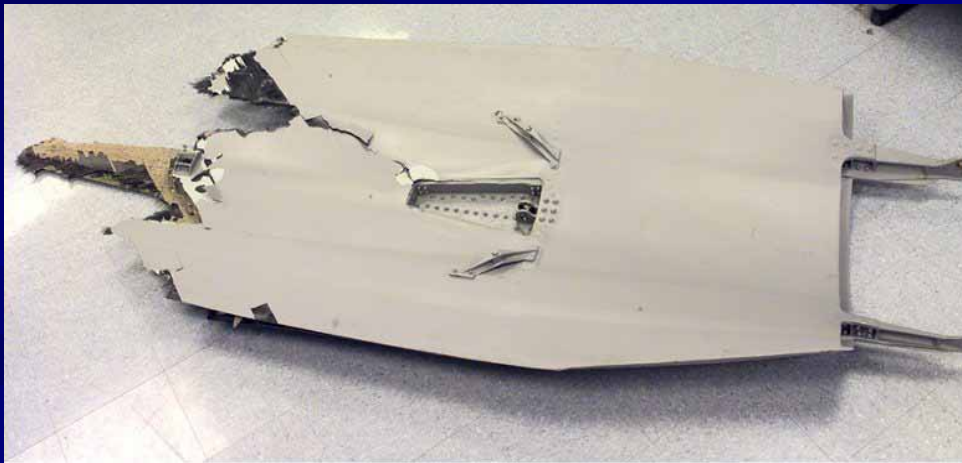
Two speed brakes failed during functional check flights following depot maintenance

- 1<sup>st</sup> failed speed brake
- Aft portion separated in flight - it was not recovered

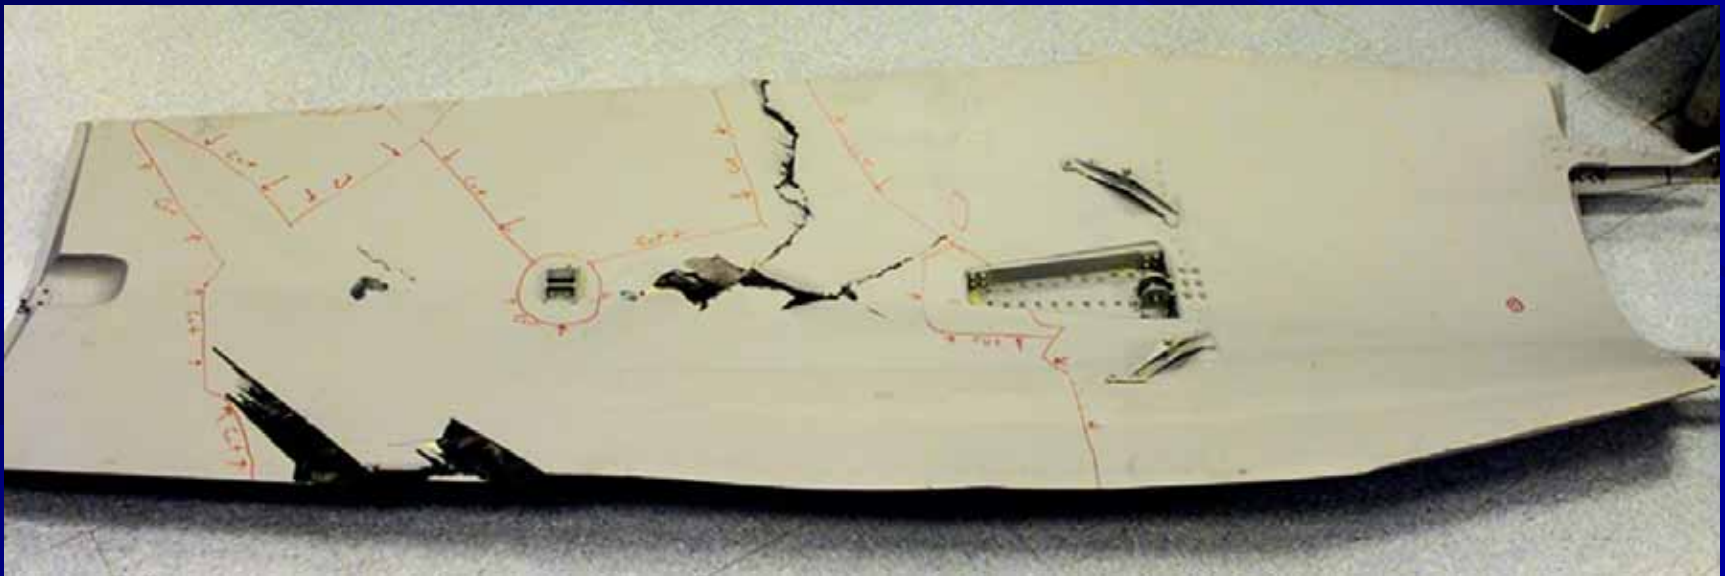
# 2<sup>nd</sup> Failed Speed Brake

- Second speed brake failed six weeks after 1<sup>st</sup>
- Note lateral and longitudinal crack orientations
- Red ink outlines regions of disbonding
  - Extent of disbonding prior to failure is unknown

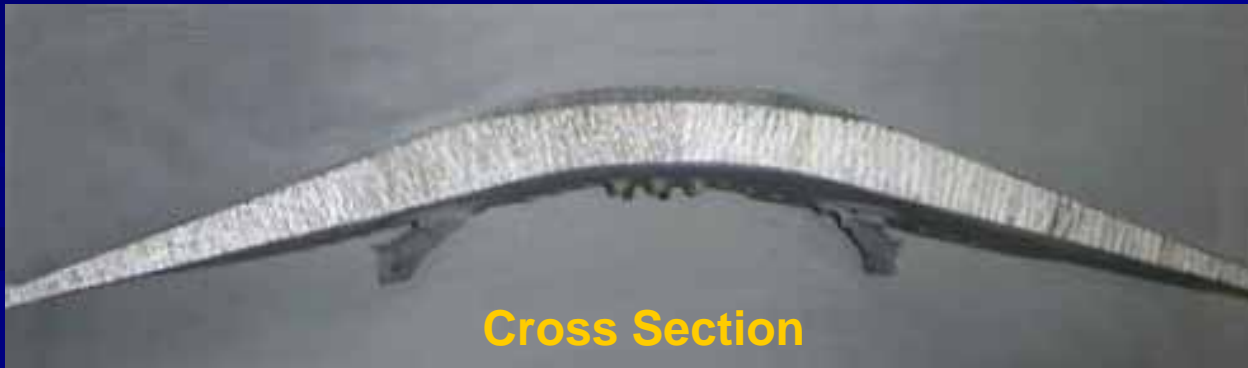
# Speed Brake Details

- Approximately 10 ft (length) x 3 ft (width)
- Reduces air speed by increasing aerodynamic drag
  - Can be deployed at any speed, including supersonic
- Graphite epoxy skin with aluminum honeycomb core

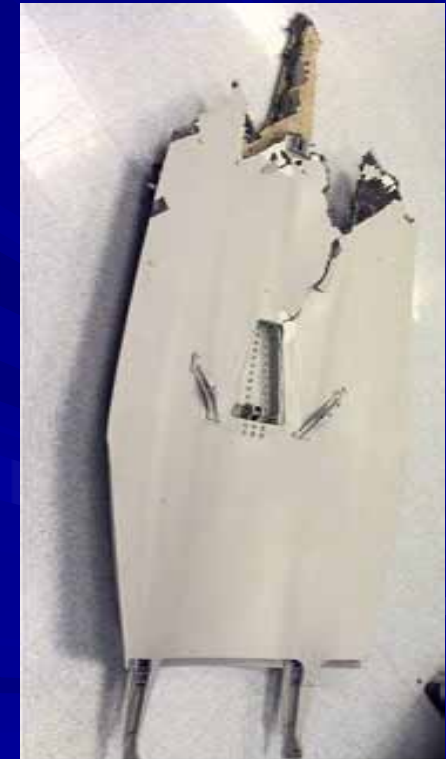
- Disbonds
- Weakened areas from repairs
- Corrosion from moisture entry
- General strength degradation of aging speed brakes

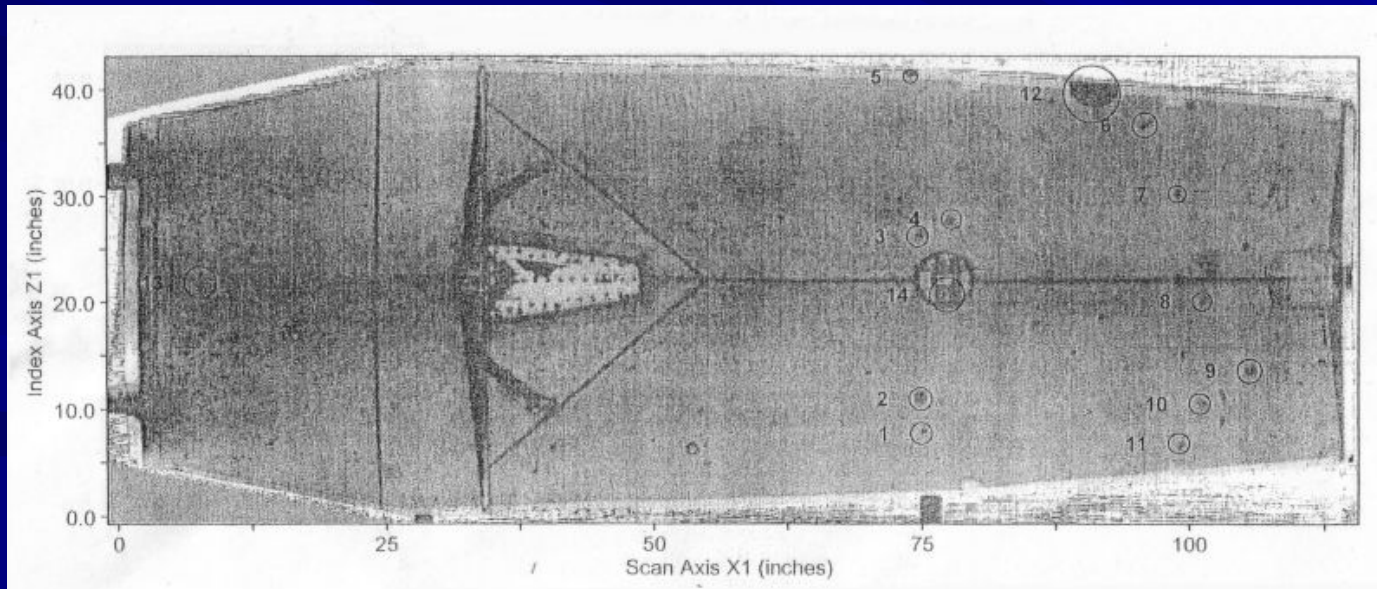
- **Ultrasonic and Radiographic**
  - Can detect voids, disbonds, core damage, etc
  - Cannot detect low bond integrity
  - Cannot assess overall load capacity

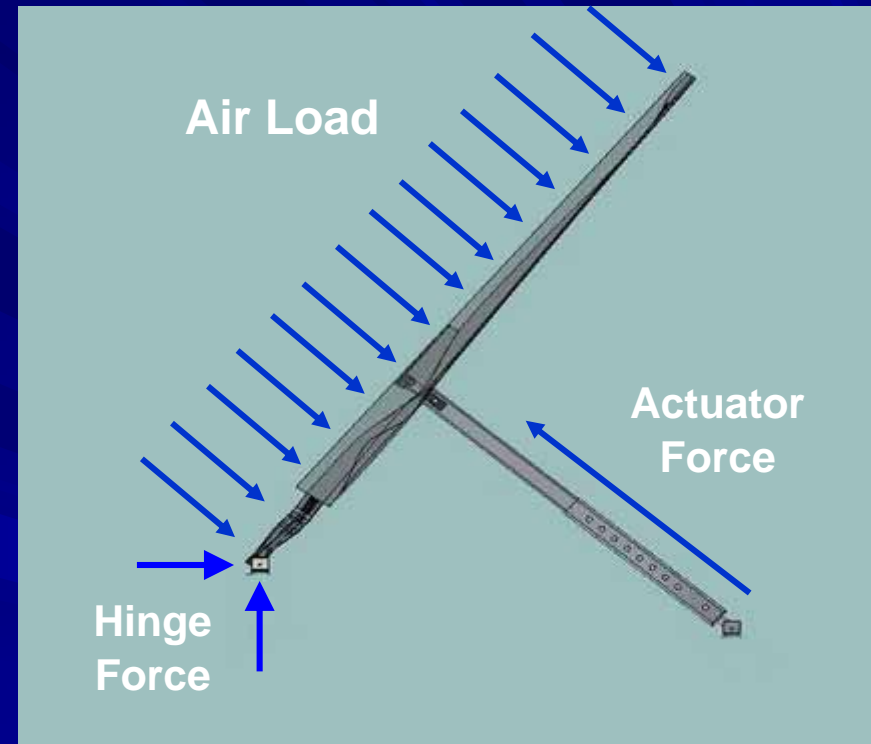
- Loads on speed brake consist of
  - Distributed aerodynamic load (*potentially nonuniform*)
  - Concentrated actuator force
  - Inertial loads due to maneuvers
- All loads vary with speed

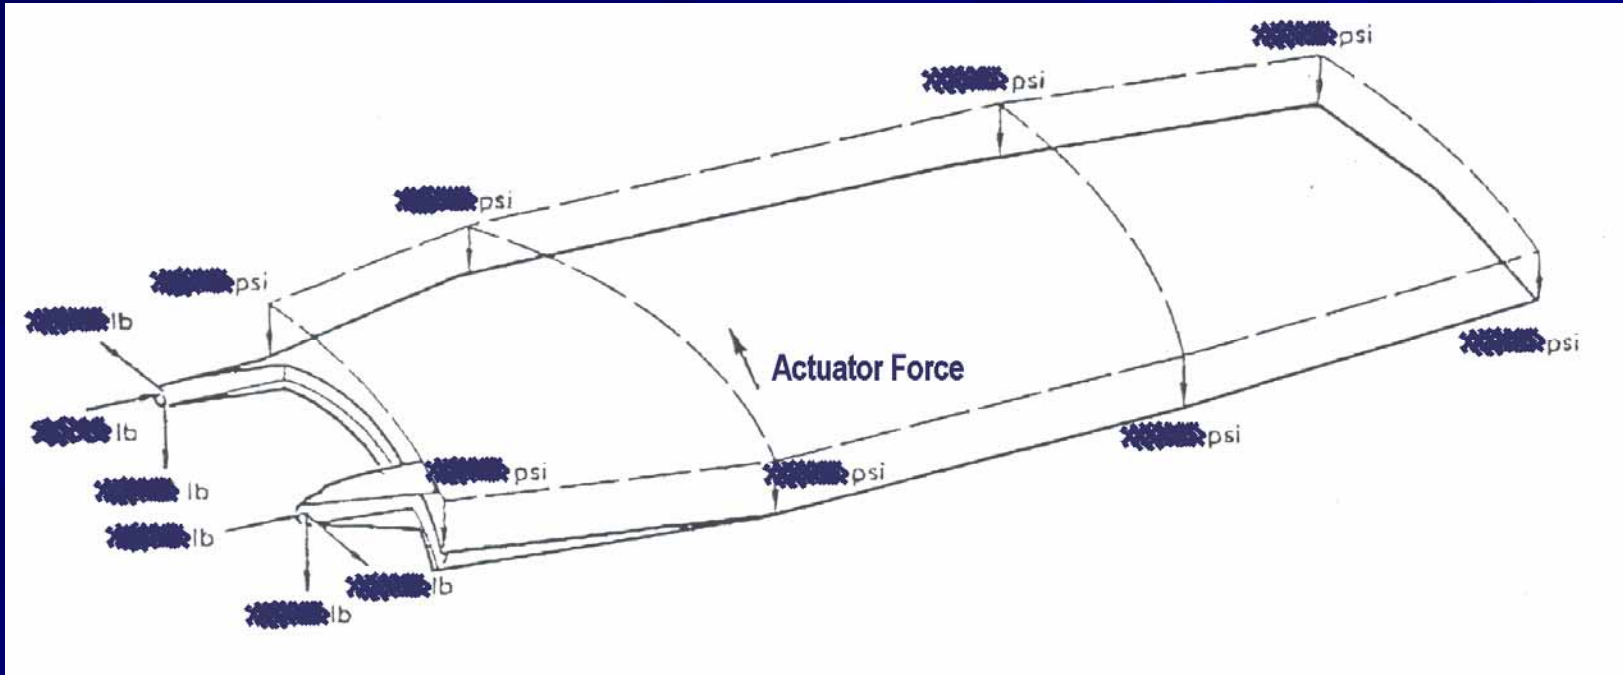
- Design (aero) load conditions obtained from McDonnell Aircraft Company

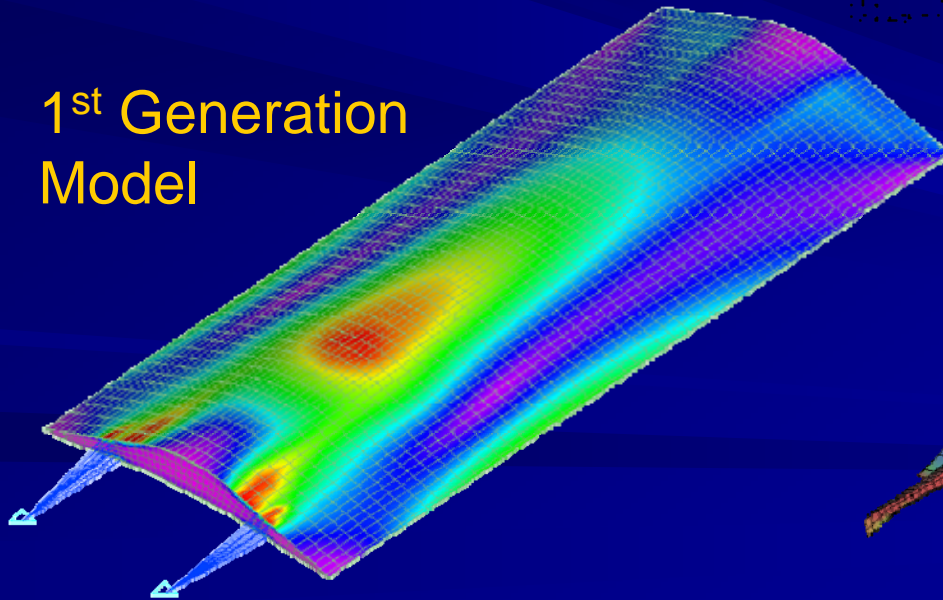
1<sup>st</sup> Generation  
Model

- Because of time constraints, two FE models were developed
  - **1<sup>st</sup> Gen Model** (simplified geometry and isotropic materials) was developed within hours to provide general mechanical insight while awaiting final model
  - **Final Model** required 2-3 weeks to develop because of complex tapered composite thicknesses, orthotropic material properties, and nonlinear analysis

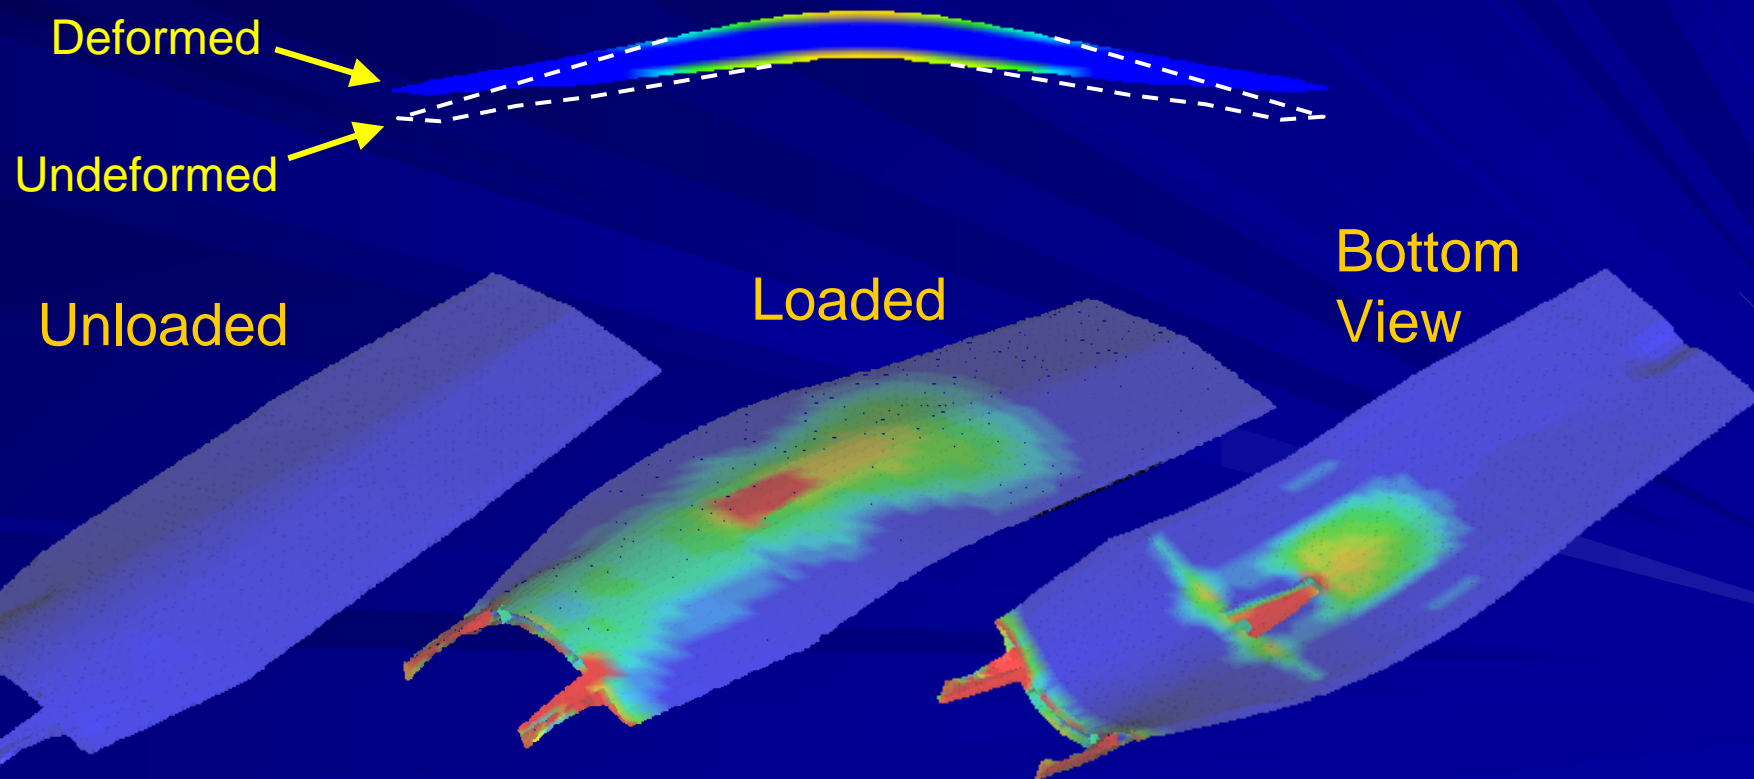
- High tensile stresses aft of actuator on upper and lower surfaces
- Nonlinear "flare-out" mechanism of cross section at high loads places lower surface in tension and reduces moment of inertia

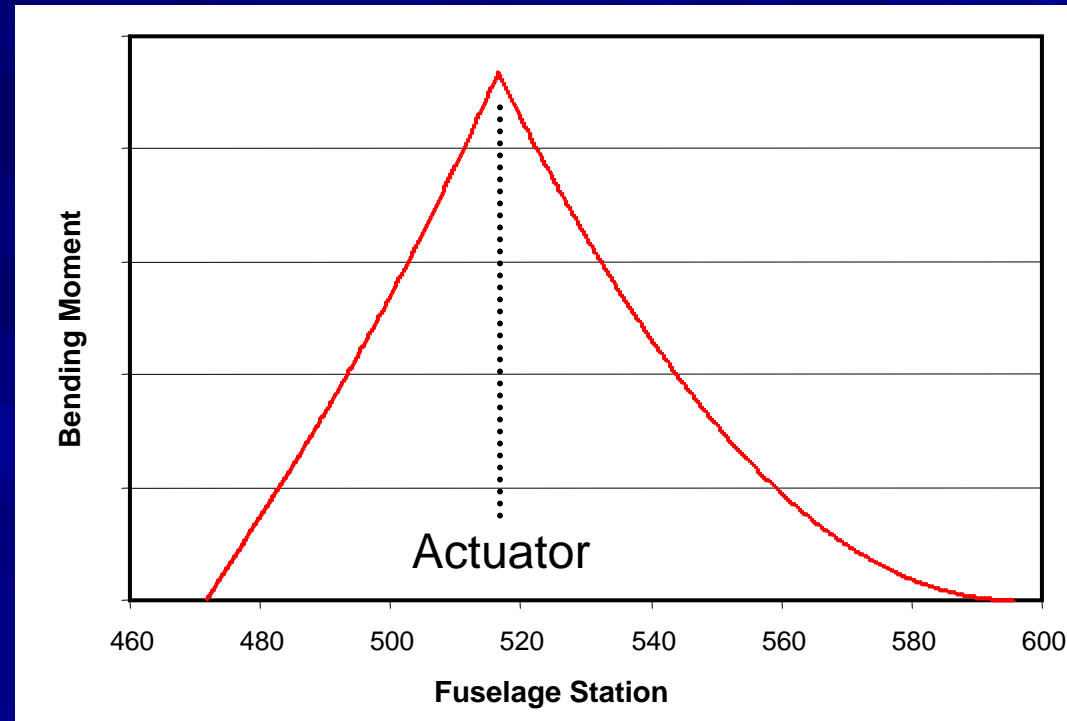
- Bending moment due to distributed aerodynamic loading reaches a maximum at actuator mount

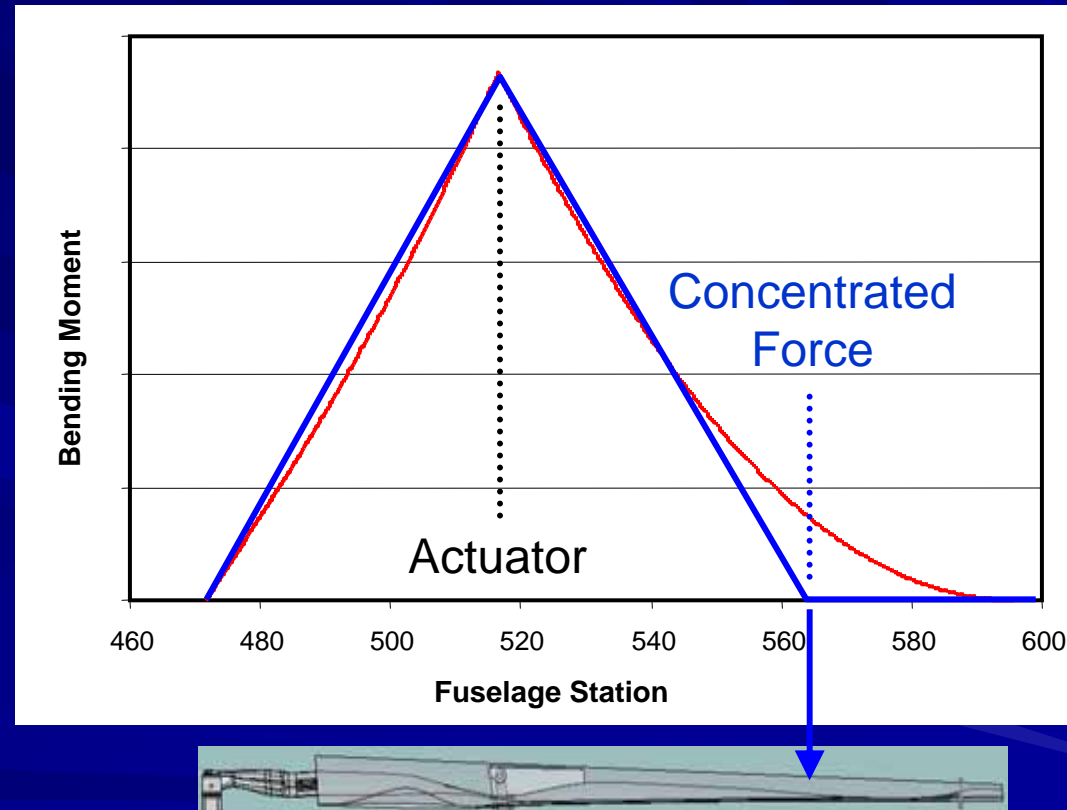
- A single force of proper magnitude and location gives a similar bending moment distribution in speed brake

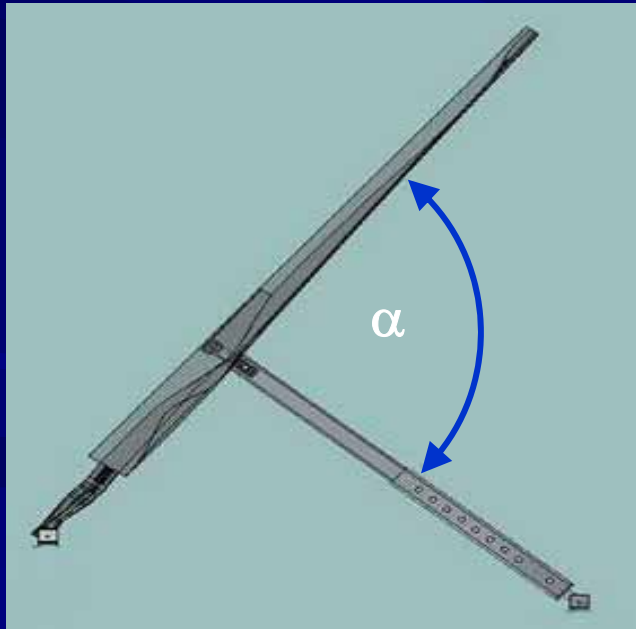
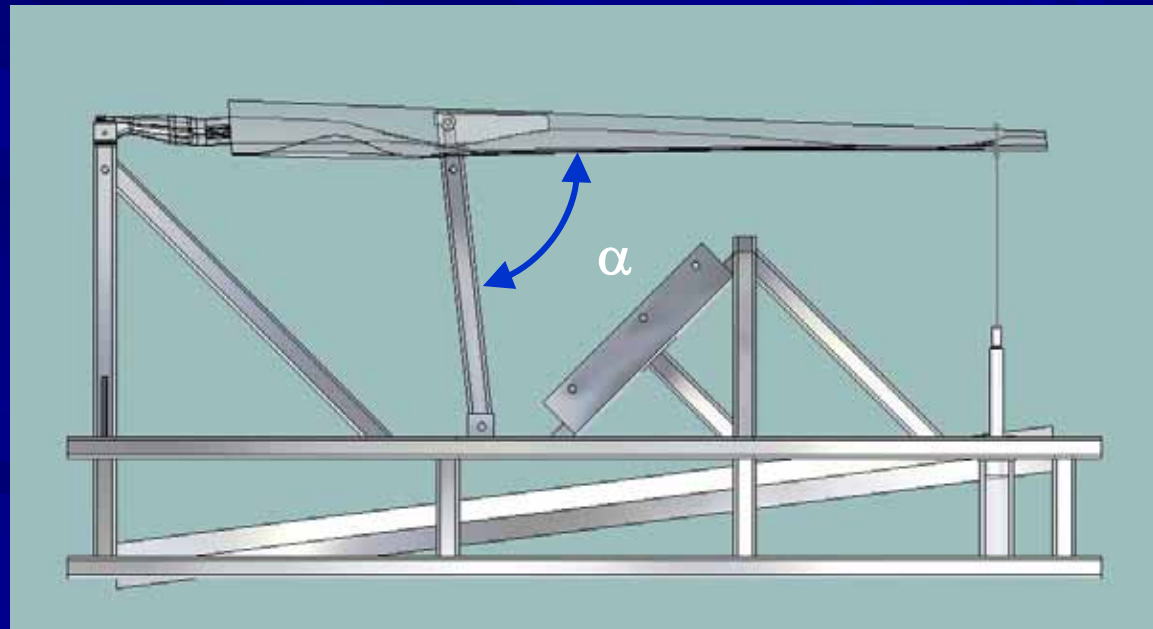
# Test Fixture Development

- Preliminary design features
  - Multiple actuator angles,  $\alpha$
  - Concentrated force(s) applied near aft tip of speed brake
  - Push, pull, and torsional loading possible

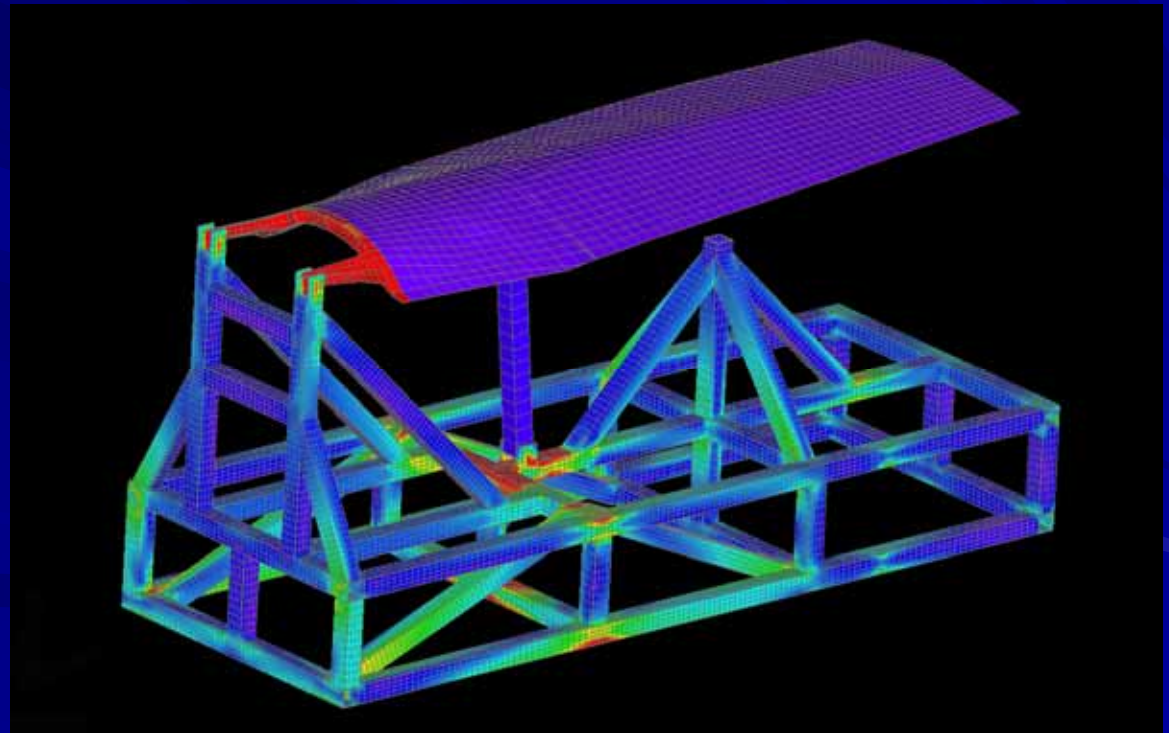
# Structural Analysis

- Initial strength analyses performed by hand
- Follow-up FE analysis performed to...
  - Check for stress concentrations
  - Ensure minimal deflections of free-standing structure

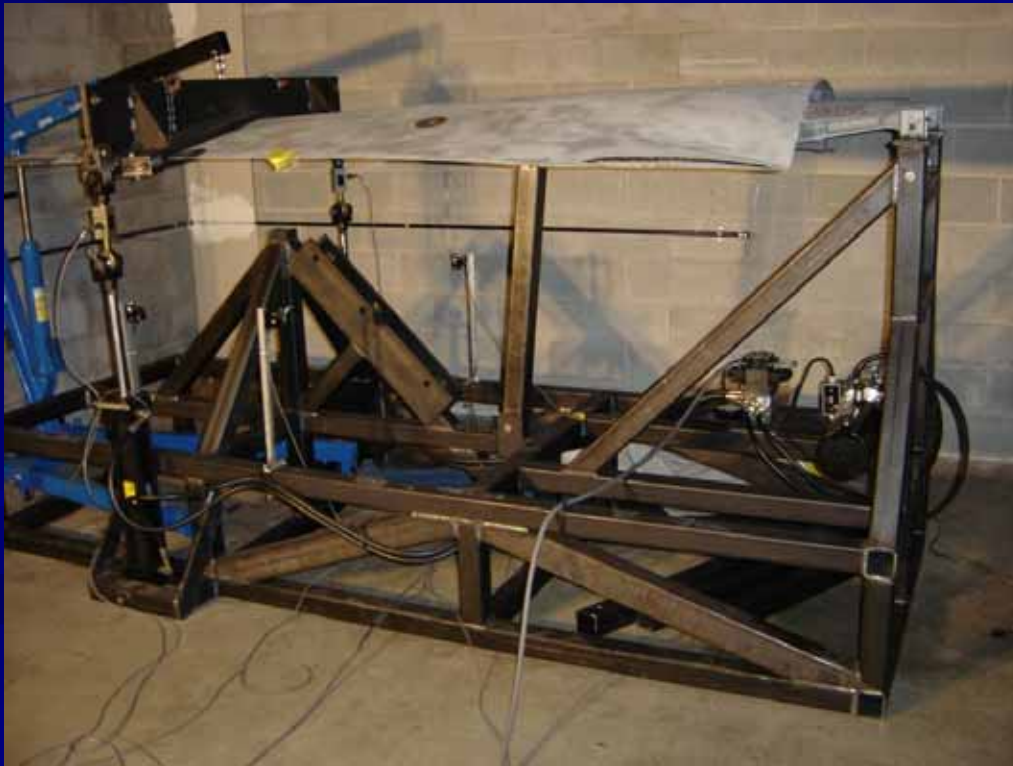
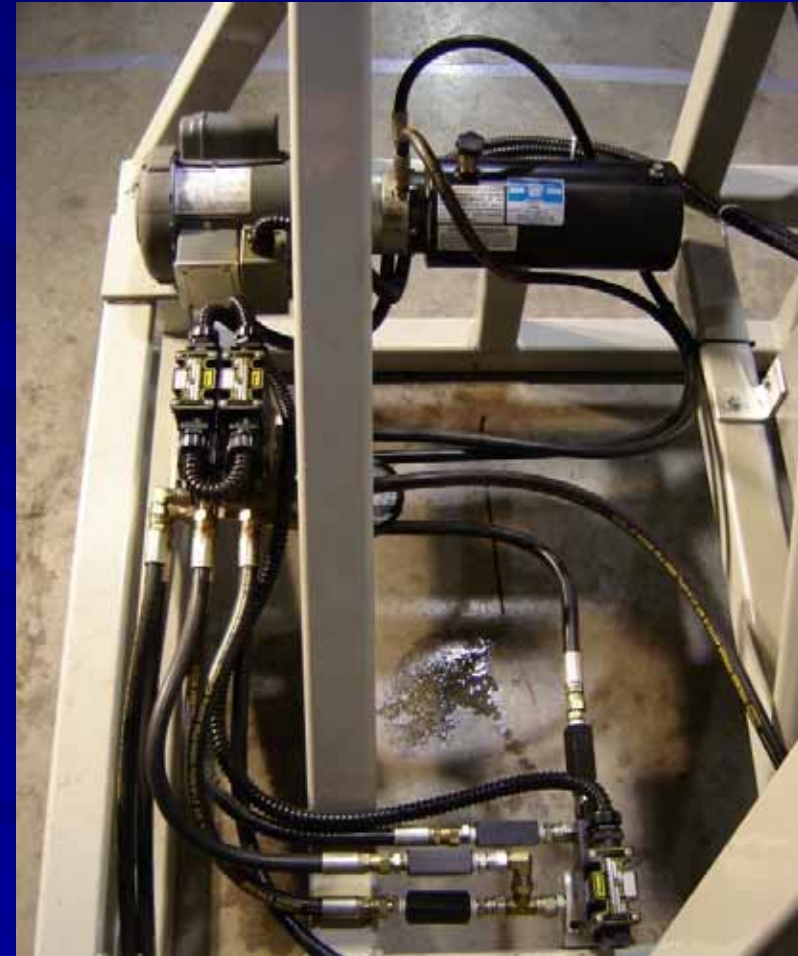
# Test Fixture Fabrication

- System built at MERC

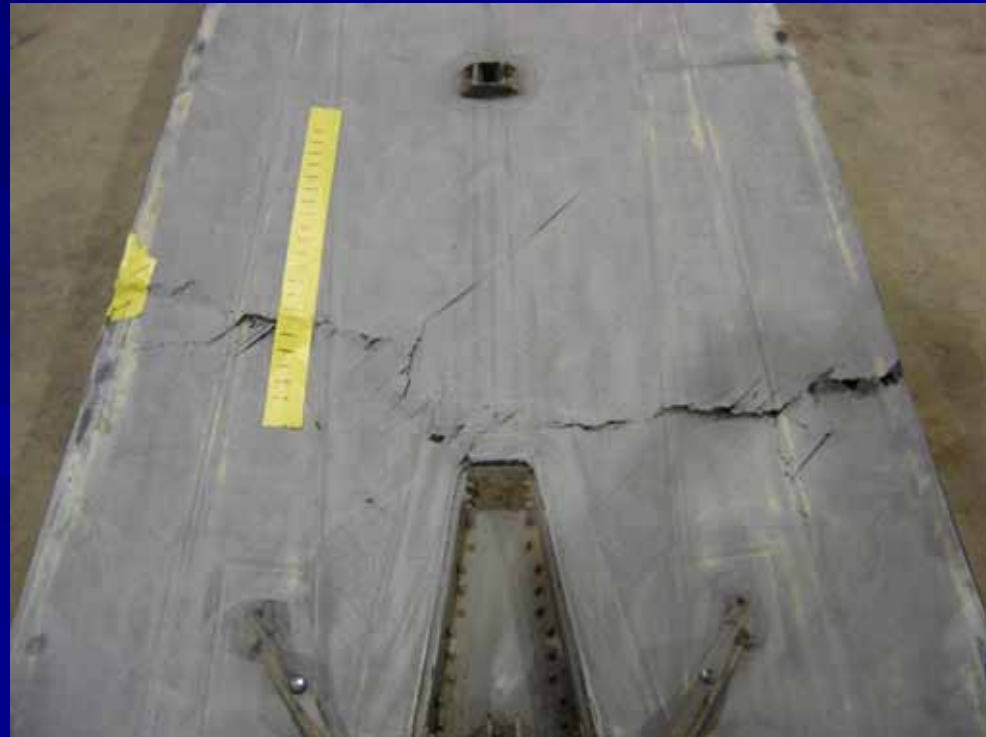
# Test Results

- Speed brake tested to failure in fixture
- Failure mode same as in-flight failures
  - Lateral and longitudinal cracks aft of actuator well
- Pass/fail criteria defined, test process established

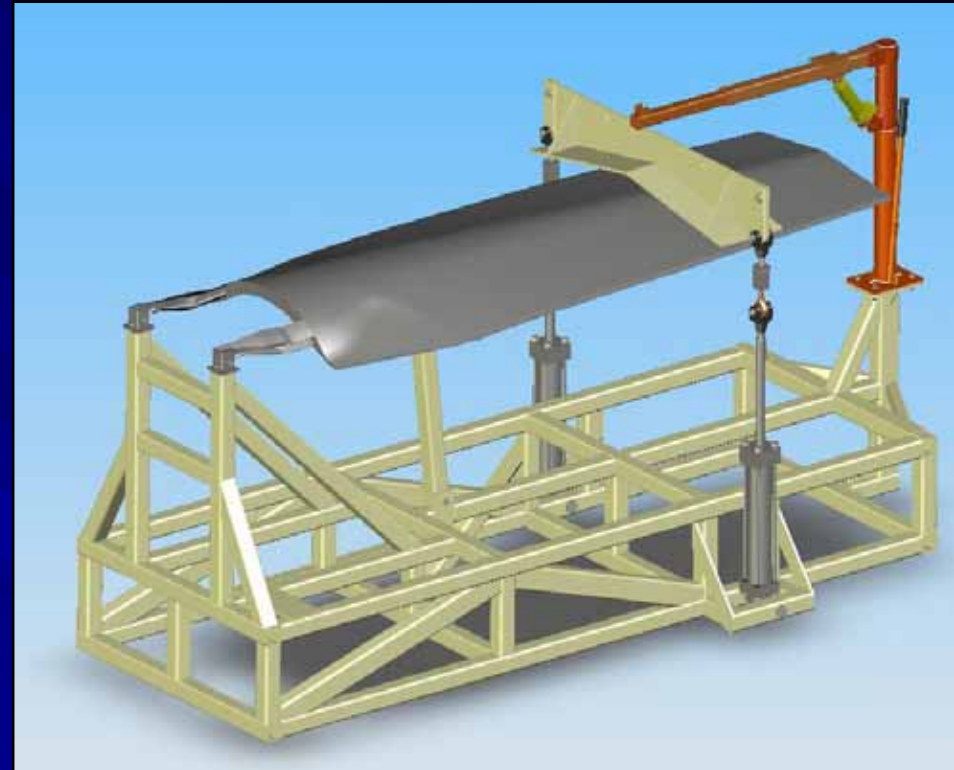
# Final Test Fixture Design

- Integrated hydraulic loading system
- Load cradle contoured to fit speed brake upper surface

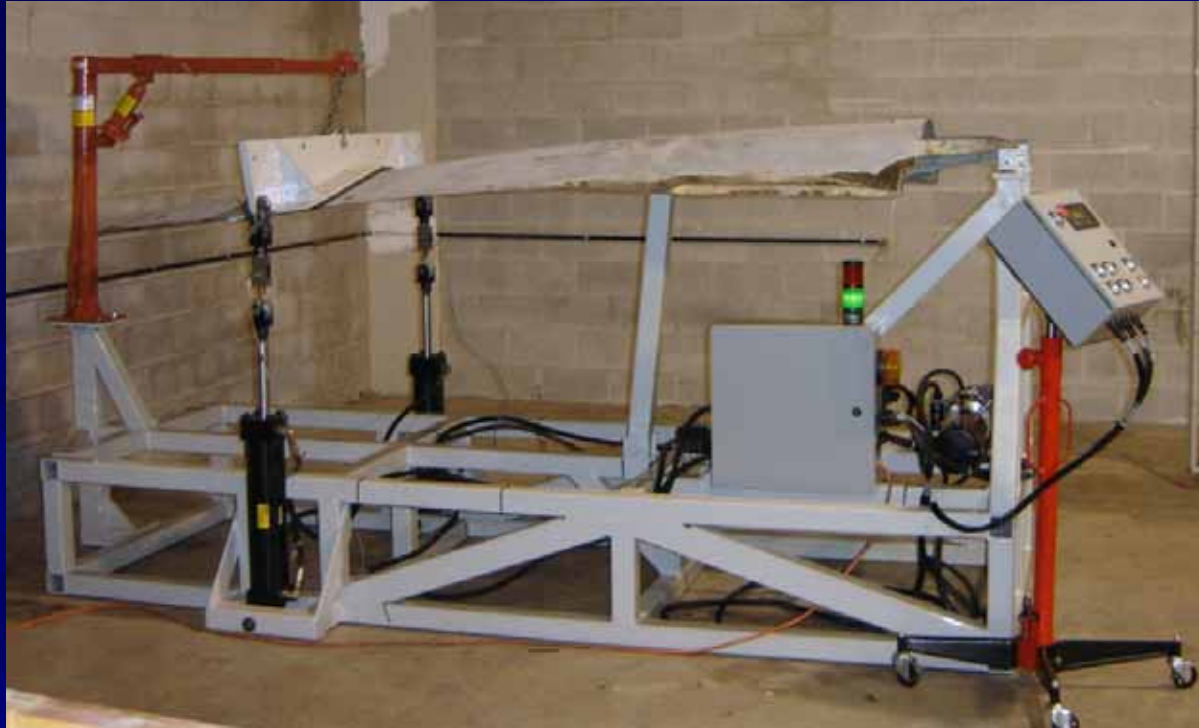
# Complete Test System

- Final test fixture design with fully automatic hydraulic controls
- One button operation for complete test

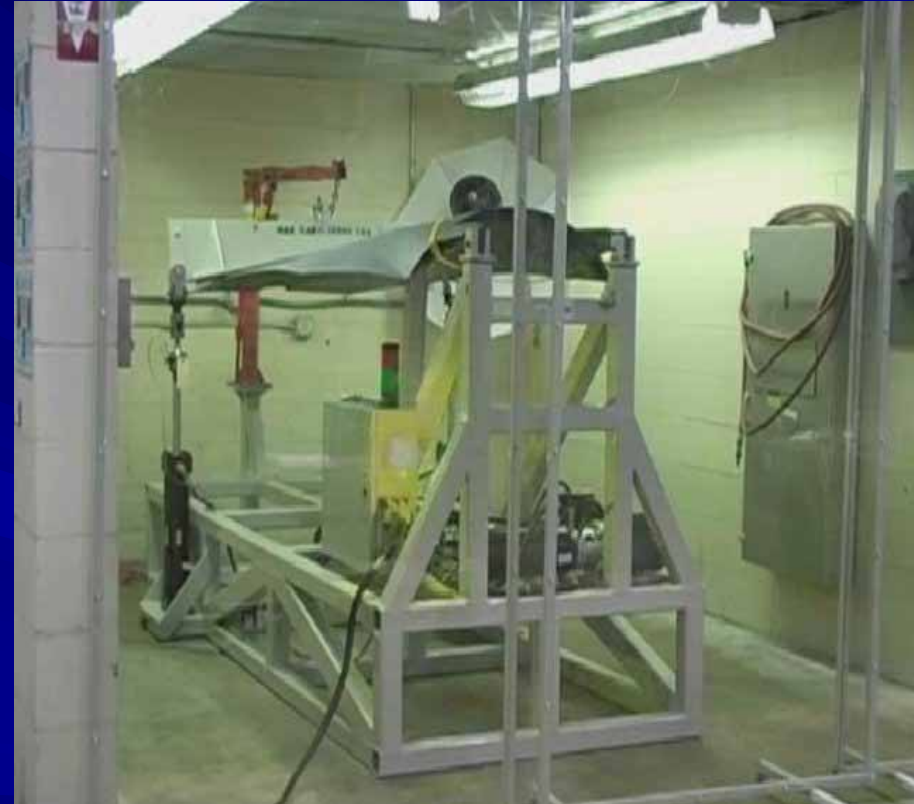
# Test System Implementation

- System currently in use at WR-ALC
- Preliminary testing identified several sub-standard speed brakes
- Tests allowed AF to relax strict NDI standards
