F-22 Full Scale Durability Test & Evaluation

*Pete Caruso, Tom Brussat, and Wendy Hynes
Lockheed Martin Aeronautics Company*

*2006 USAF ASIP Conference
San Antonio, Texas
28-30 November 2006*

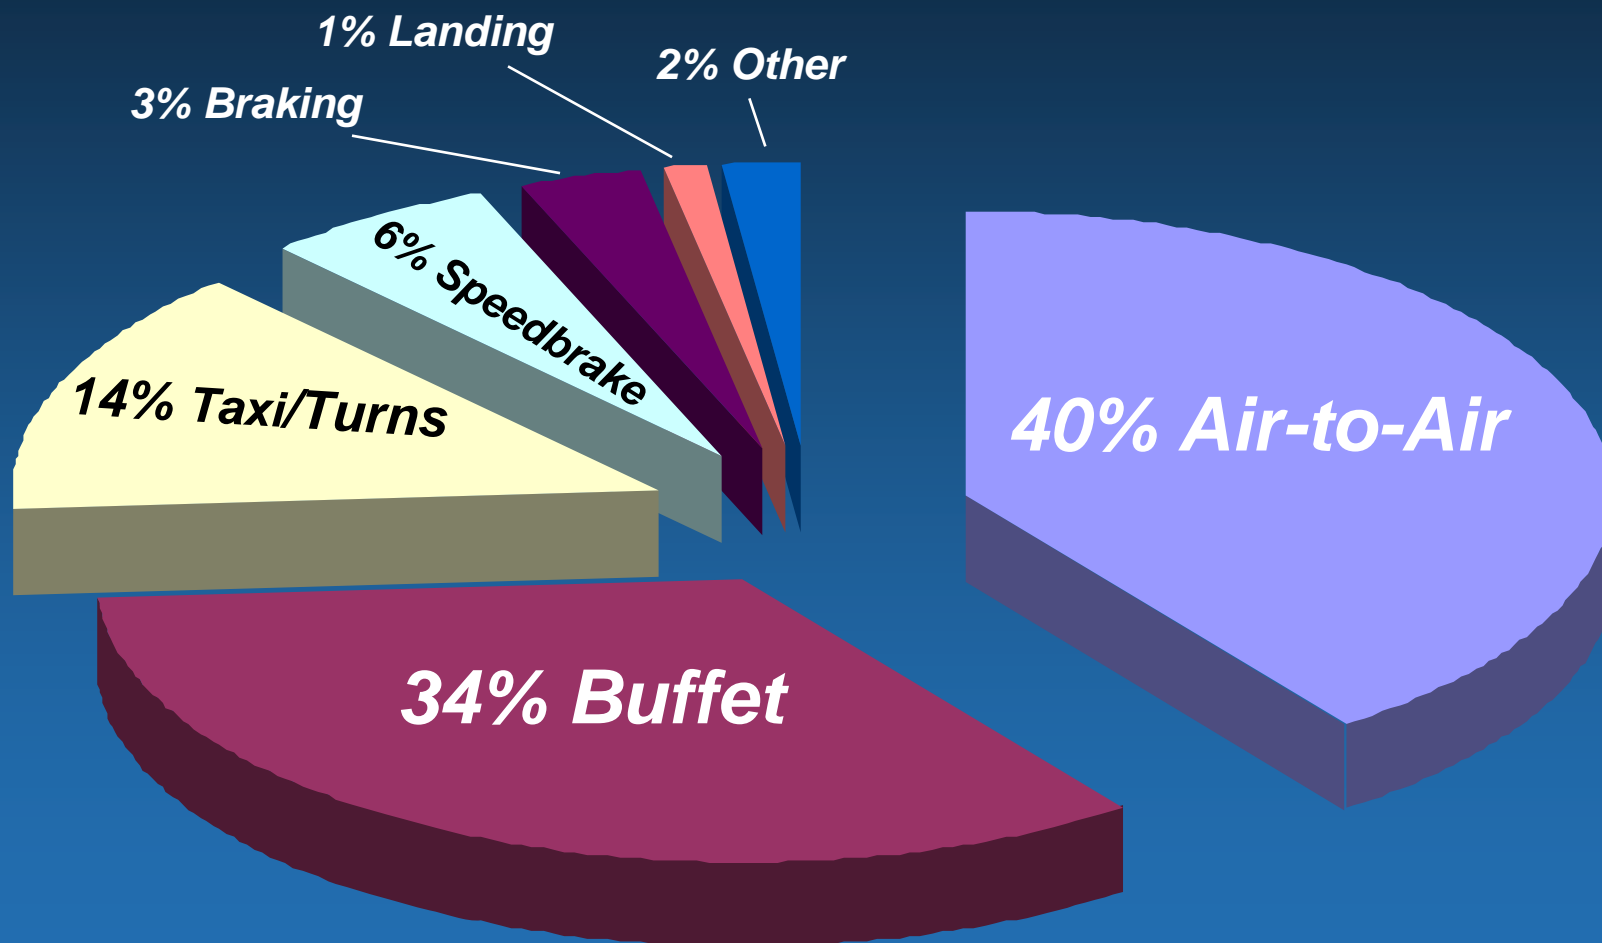
➤ 2.67 Lifetimes of 2.78M Cycles

Flight Maneuvers and Buffet Loads Dominate the Test Spectrum

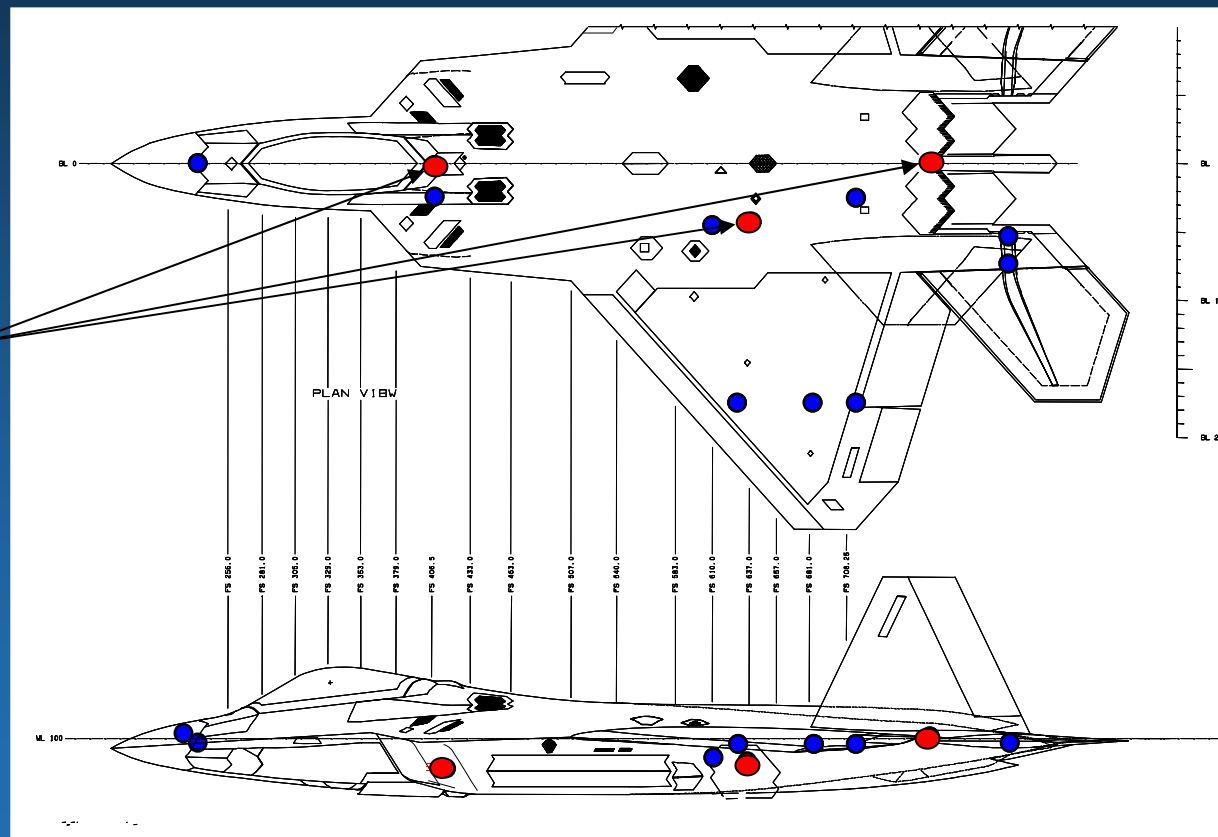
- 196 RAMS Balanced at 7 Reaction Points
- Imbalance Loads Detected
 - *Wear or Friction*
 - *RAM Load Errors*

- *Reaction Point*
- *Balance Point*

New Method Required for Load Error Evaluation

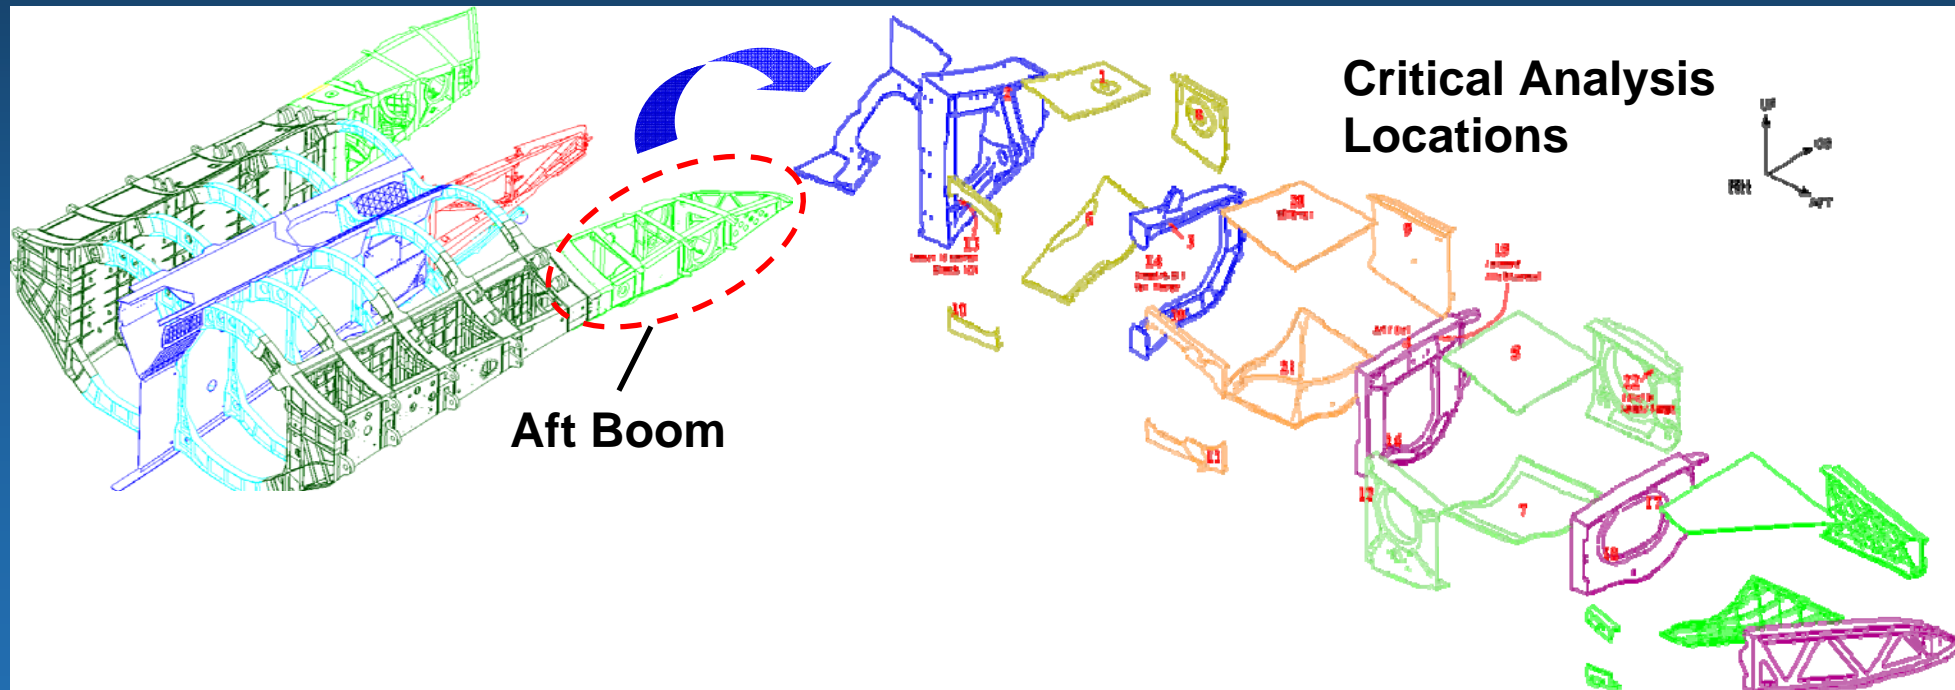
- Pre-test Start Spectrum Adjustments
- Post-Start Spectrum Update
 - *Pre-Production AFT Boom Experienced Early Cracking*

New Method Required for Spectrum Updates

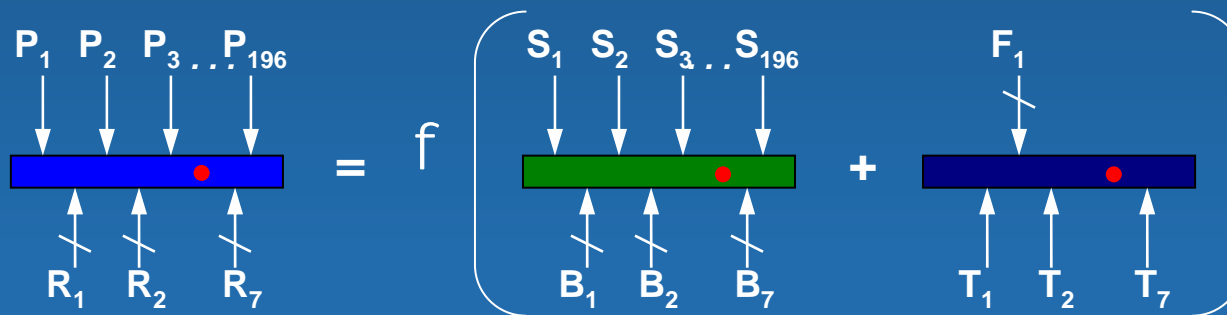
➤ Unit Load Cases Applied to Test Article FEM

➤ 1050 Unit Cases for 11 A/V Configurations, Pressures, and Reaction Loads

➤ Internal Loads Spectra With Actual Test Loads

$$\text{Reaction Error, } \Delta R_n = (R_n - B_{th,n})$$

$$\text{Internal Load} = \sigma_{th} + \sigma_{n,T} * \Delta R_n / T_n = \sigma_{th} + \sigma_{n,T} * (R_n - B_{th,n}) / T_n$$

Stress Spectra Includes Sources of Error Loads

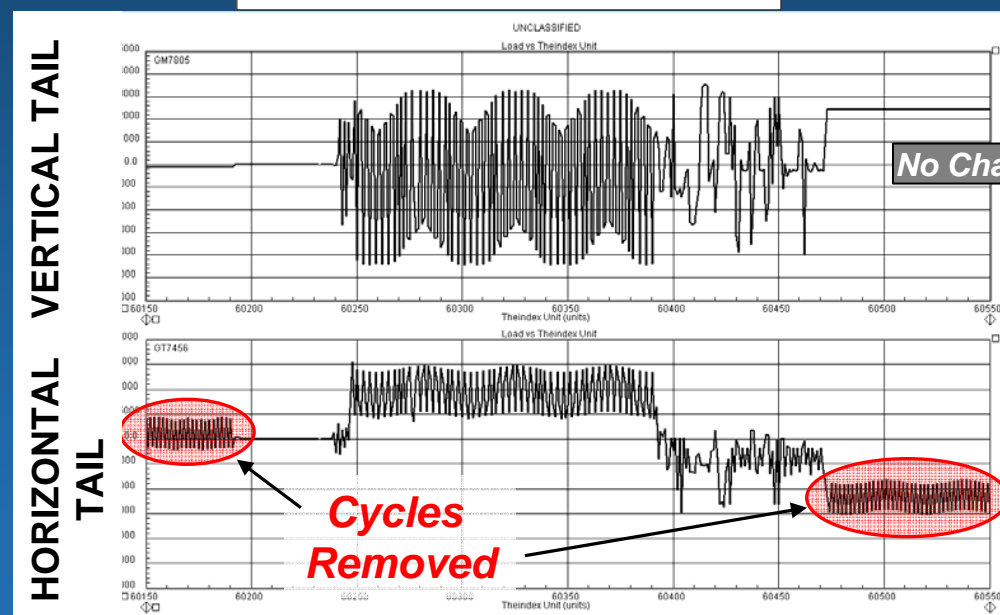
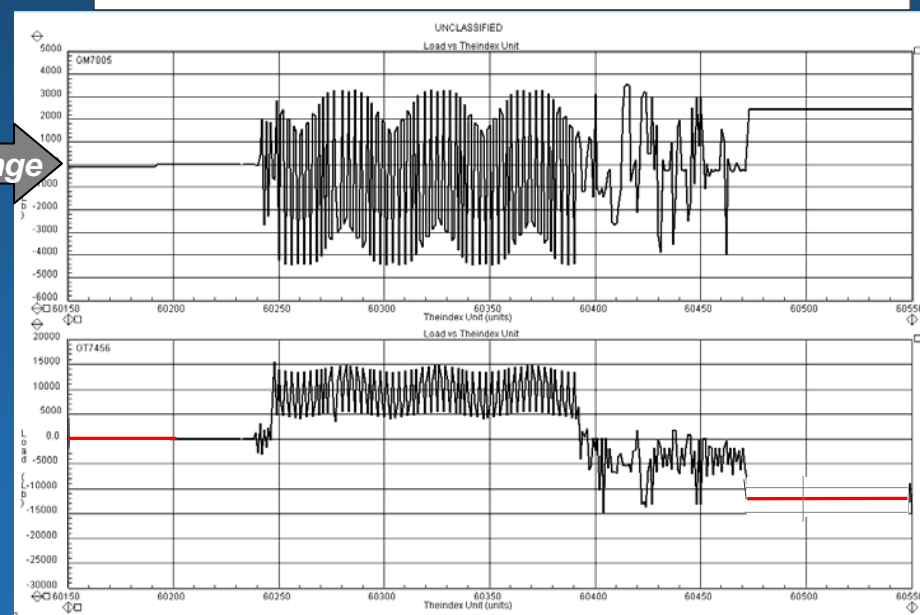
- 2nd and 3^d Lifetime Test Spectrum Updated
 - Horizontal Tail Buffet Cycles Removed (25% of End-Points)
 - Events Containing Both Vertical and Horizontal Buffet is Unchanged

1st Lifetime Spectrum

2nd and 3^d Lifetime – After Update

No Change

Test Life of Pre-Production AFT Boom Improved 7%-291%

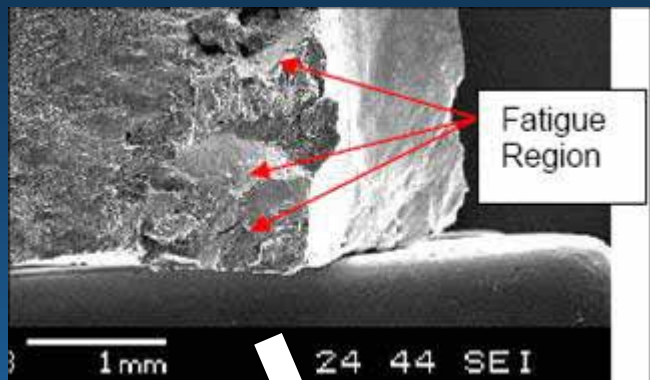
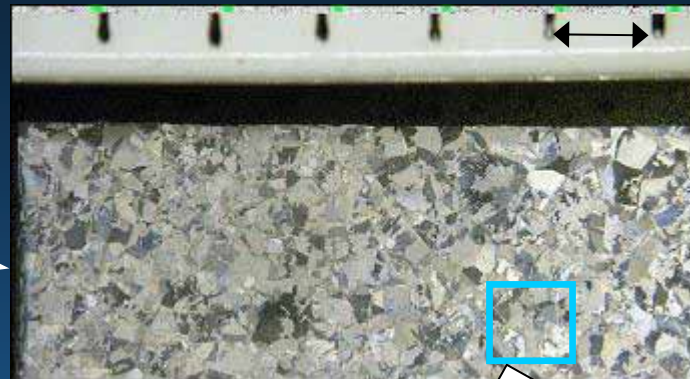
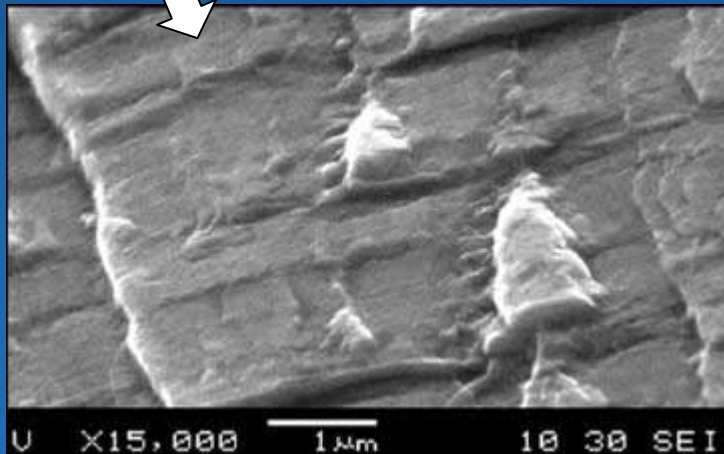
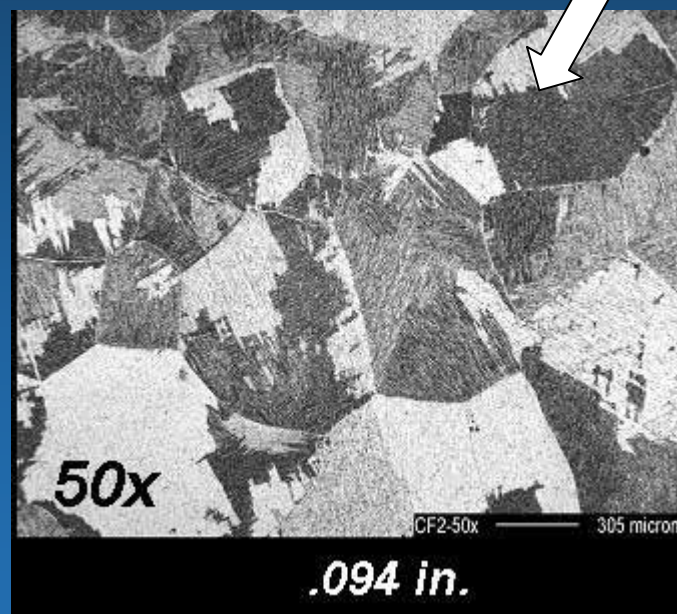
3.175 mm
(.125 in)

➤ Ti 6Al-4V BA

➤ Poor fracture surface marking

Limited Observations of Crack Growth Rate

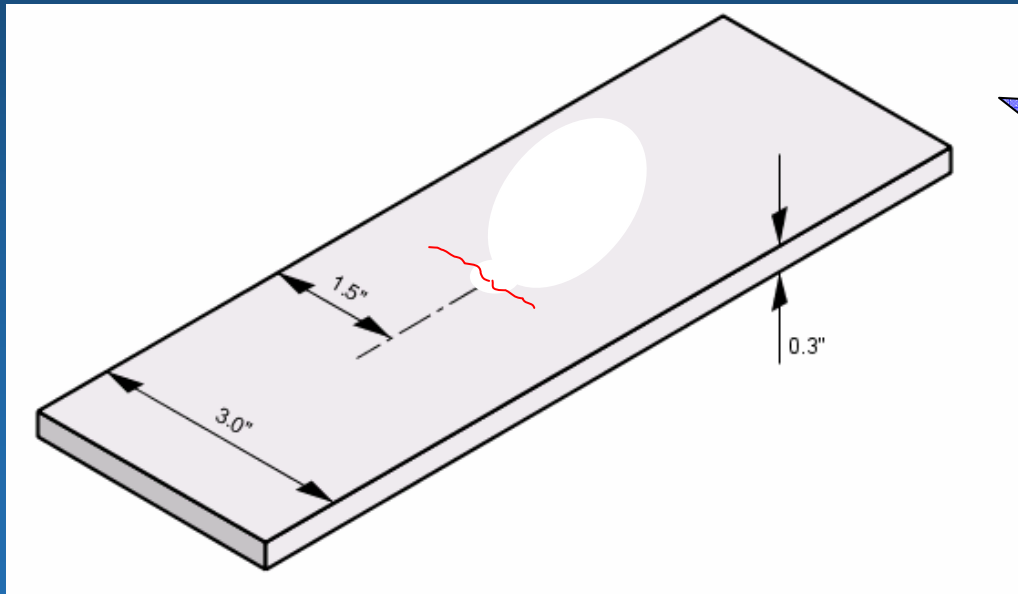
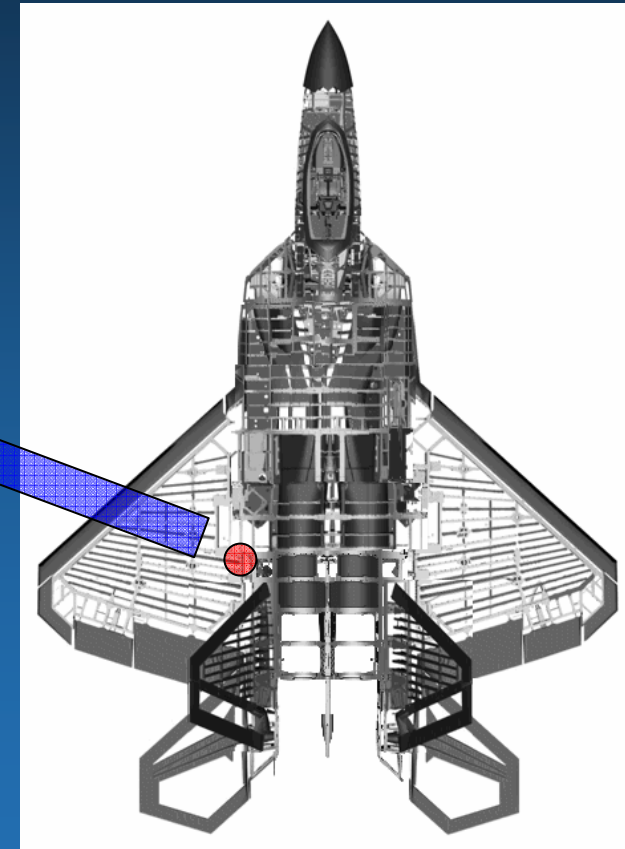
- Additional Strain Gages During Cycling
- Quantitative Fractography (as feasible)
 - 75 Crack Indications Examined
- Spectrum Crack Growth Tests

Center Crack Specimen

Crack Models have Improved

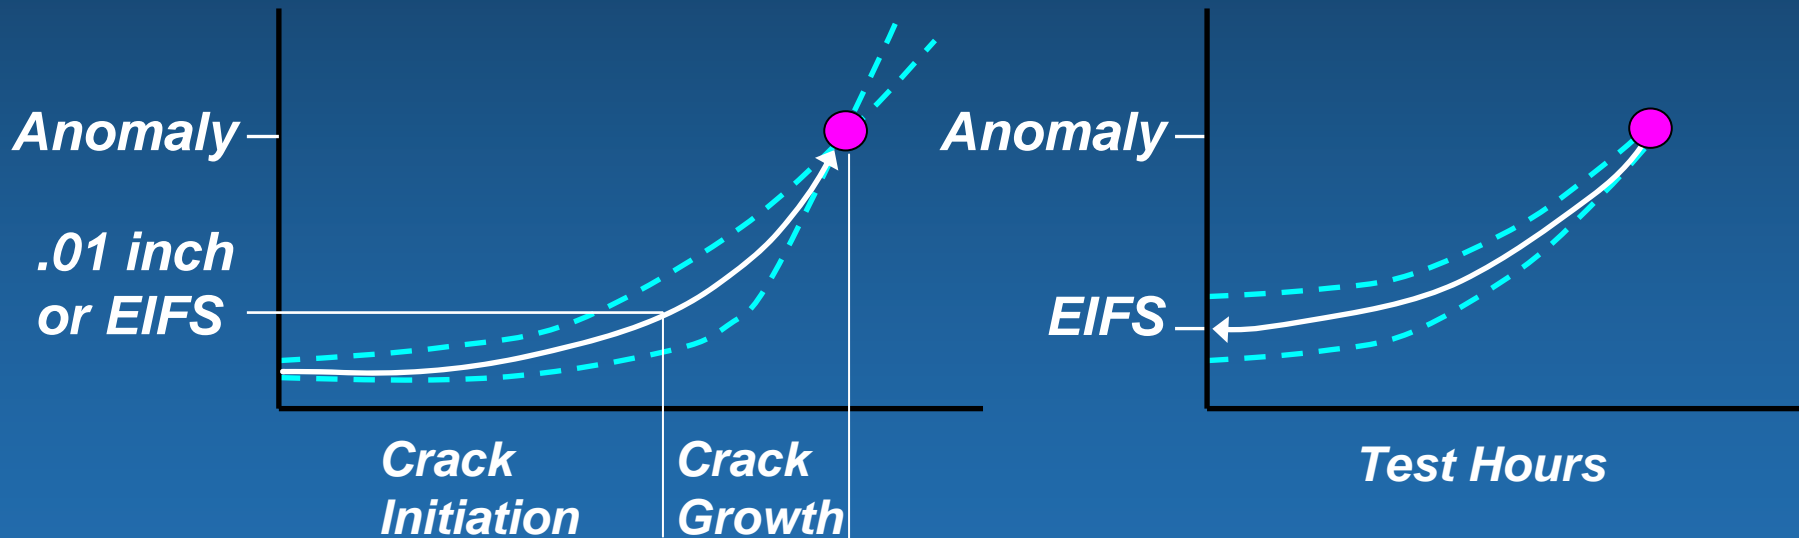
- Crack Correlation Procedure
 - Crack Initiation + Crack Growth
 - EIFS Developed

Single point data requires conservative correlation analysis

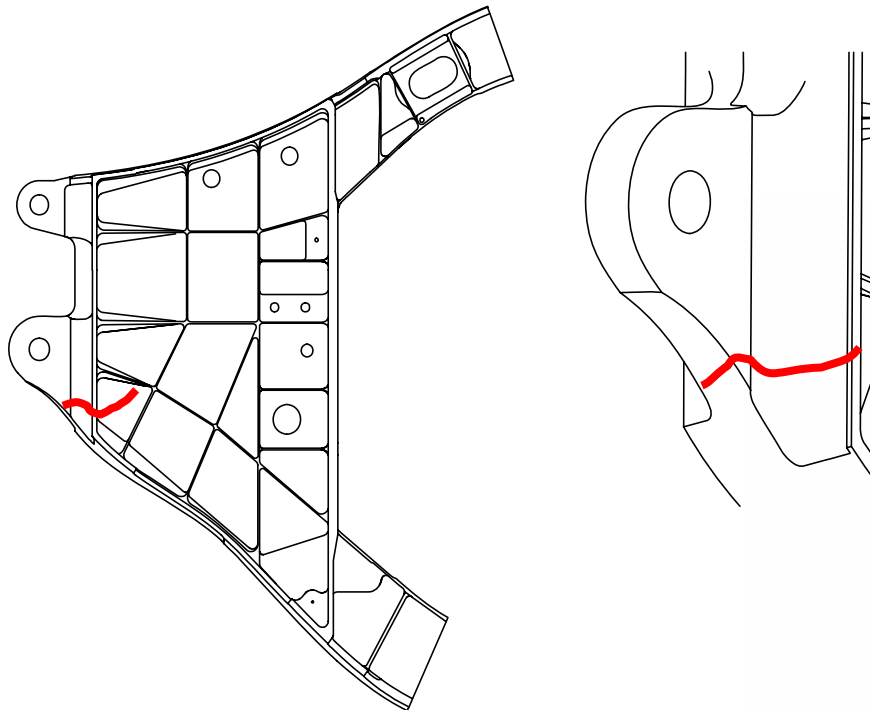
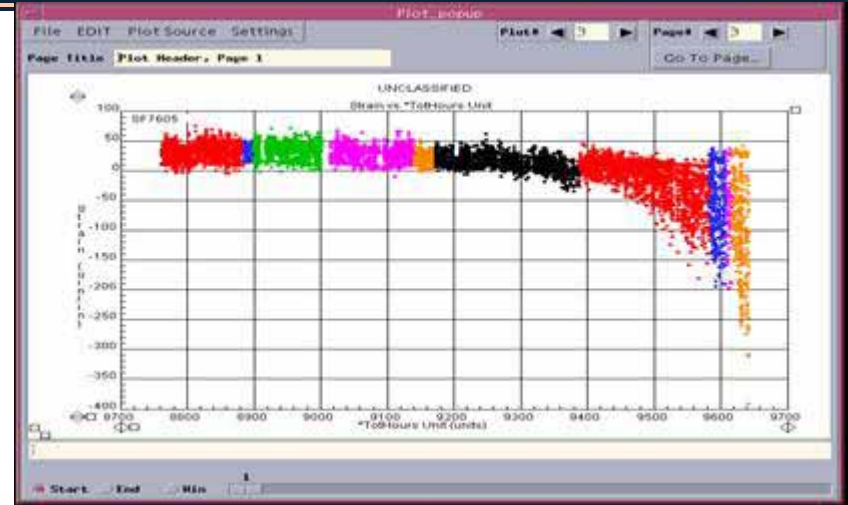
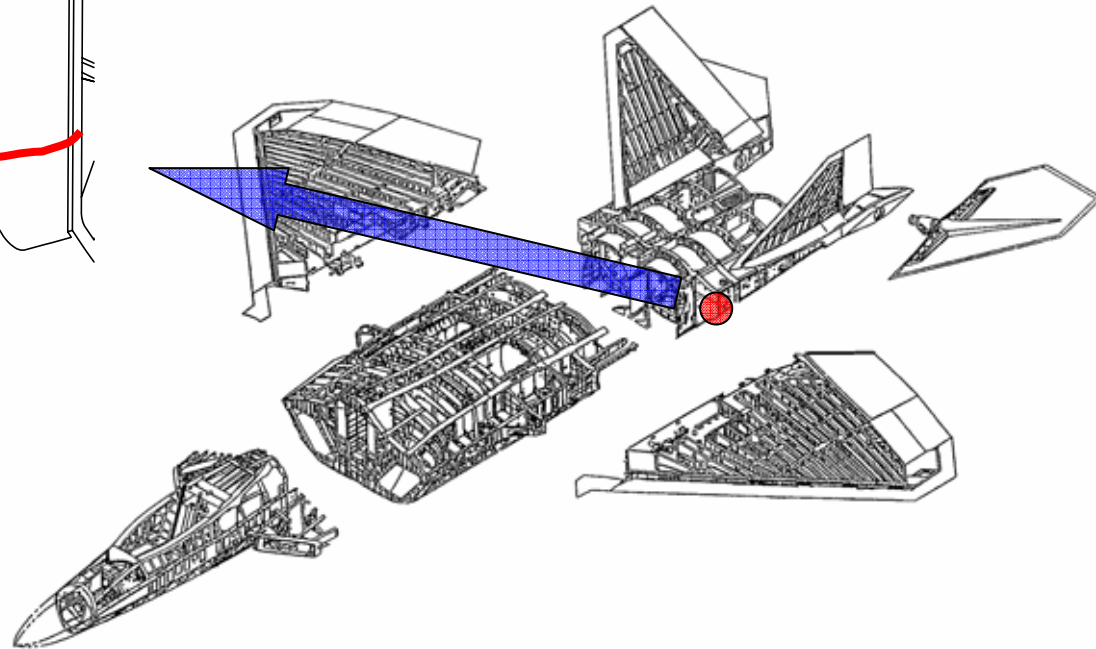
- **Strain Departure Detected**
- **Crack Located**
