# USAF F-16 ASIP Data Collection

## ASIP 2007

### December 6, 2007

Kimberli Jones, Ph.D., SAIC  
Bryce Harris, USAF, Ogden ALC

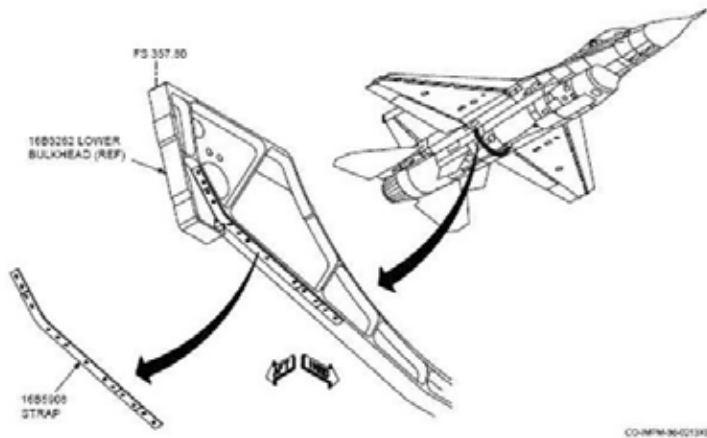
## FS 357 bulkhead -- strap area

Inspection	Visual Inspection of FS 357.8 Lower Bulkhead Strap Fitting Attachment Area	Control Number	07-000000-00074	Date	09/19/20
Aircraft S/N		Flight Hours	4321.00	Base Depot	
Inspector	Kimberli Jones	Phone

### Inspection Results

Crack Found?	<input checked="" type="radio"/> Yes <input type="radio"/> No
Crack Length	<input type="text" value="0.5"/>
Crack Location	<input type="text"/>
Comments	<input type="text" value="Crack found during IAT inspection."/>

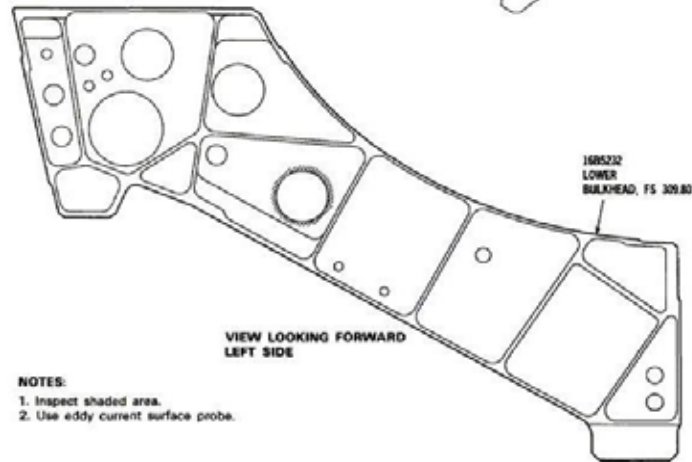
## Control point inspection

Control Point B5232AC: FS 309 BLKHD LH PANEL F

Defect Found	<input type="radio"/> Yes <input checked="" type="radio"/> No
Crack Length (inches)	<input type="text"/>
Origination	<input type="text"/>
Orientation	<input type="text"/>
Repaired	<input type="radio"/> Yes <input checked="" type="radio"/> No
Repair Method	-- Select a Repair Method --

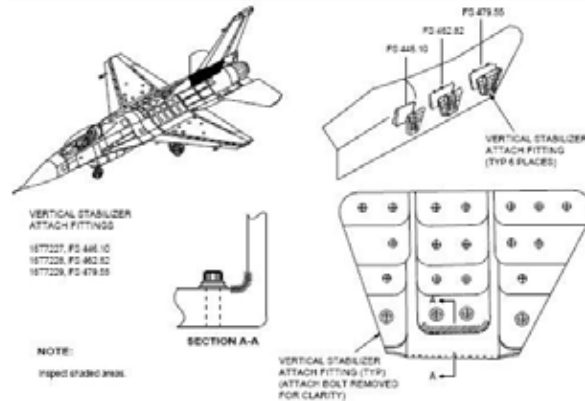
## Control point inspection

Control Point T7228BA: VERTICAL TAIL CENTER ATTACH FITTING (INCLUDE ALL 3 ATTACH PADS)

Defect Found	<input checked="" type="radio"/> Yes <input type="radio"/> No
Crack Length (inches)	-- Select a Repair Method -- No Action Taken Replaced Part
Origination	Submitted 107 Request
Orientation	Stop Drilled Crack Rout/Ream Hole Installed Doubler Machined Fitting
Repaired	Other (enter comments)
Repair Method	-- Select a Repair Method --
Comments	<input type="text"/>
