# ***330th Aircraft Sustainment Group***

**C-130 Center Wing Fatigue Cracking  
Lessons Learned: Application to  
ASIP Force Management Execution**

**Peter Christiansen  
USAF C-130 ASIP Manager**

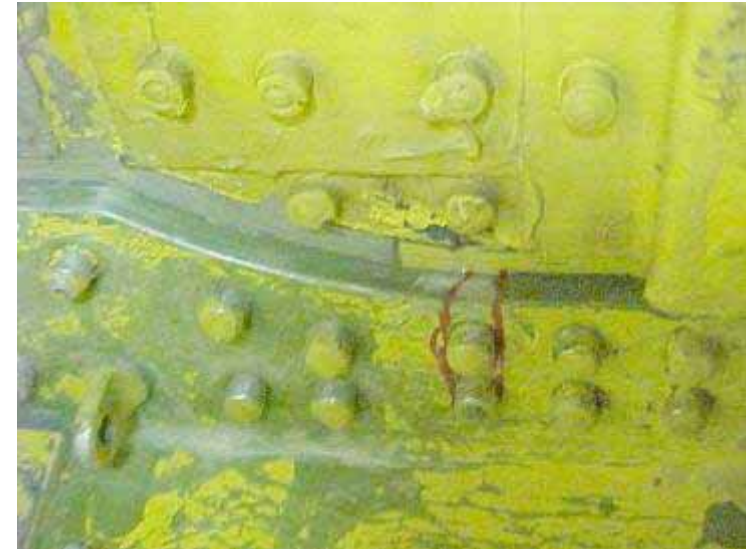
# Discovery – April 2003

- Aircraft found with 1.2” crack in center wing spar cap in April 2003
  - Crack longer than expected (based upon safety limit and previous inspection history)
  - Lockheed tasked to update DTA
    - Revised DTA included updated methodology and WDT results
    - Safety limit decreased from 73K to 19K EBH
- Urgent Action TCTO issued
  - $A_{NDI} > 2.0$ ”
  - 8 additional aircraft found with cracks
  - ✓ Flight hour based inspection program instituted leading to more findings

- Lockheed tasked to provide interim DTA updates for all Center Wing and Outer Wing fatigue critical locations
- ✓ Critical areas prioritized based upon risk and probability of cracking

- TCTOs issued to inspect portions of Special Operations fleet and critical areas on high time aircraft

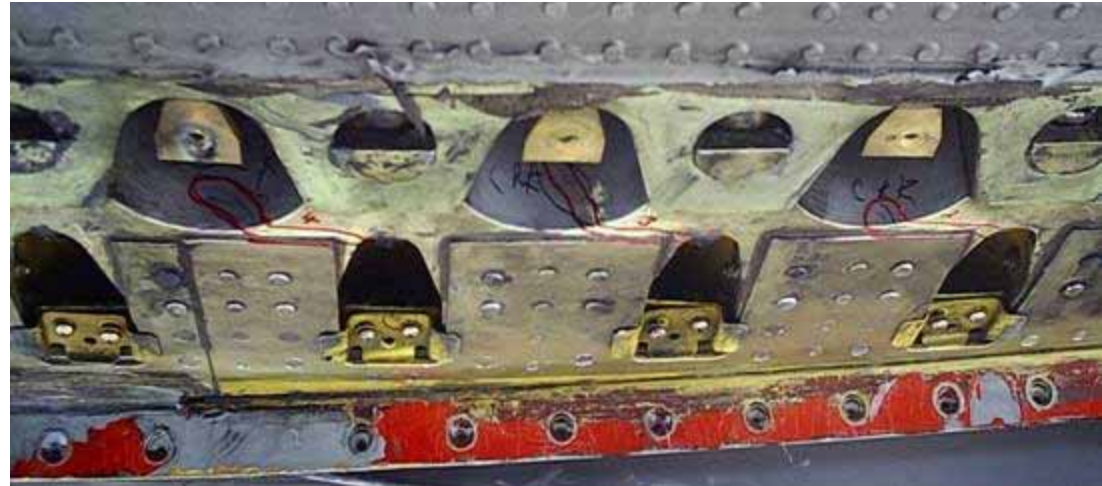
# *Discovery – March 2004*

- **TCTO 1875 issued to inspect Special Ops (SOF) aircraft that had not entered PDM cycle**
  - **15 year initial PDM interval based upon standard C-130H usage**
  - **More severe usage of SOF led some locations to be beyond safety limit without inspection**
  - **SOF aircraft found with 3 consecutive nodes cracked on Rainbow fitting**

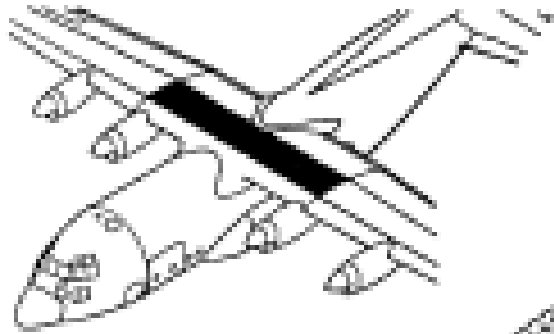
# Finalized Inspection Requirement

Surface Eddy Current

Magneto-Optical Imaging(MOI)

Bolt-hole Eddy Current

Two independent inspections required at critical locations

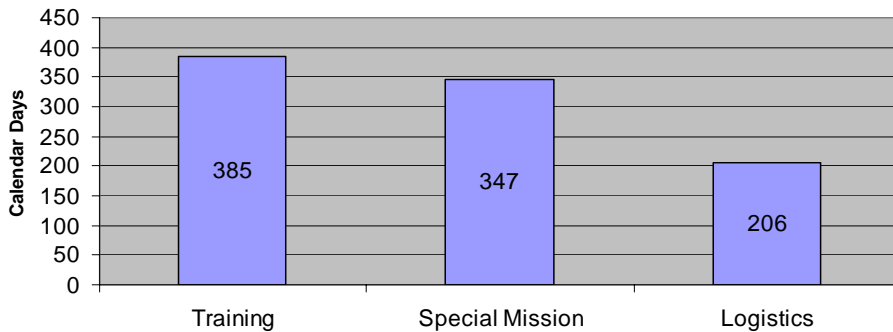
Average TCTO 1908 Duration by Mission Type

- 39 aircraft have been completed, 17 aircraft in-work
  - All aircraft found with fatigue cracking
- 37 of the 39 were repairable
  - 2 aircraft with damage beyond economical repair

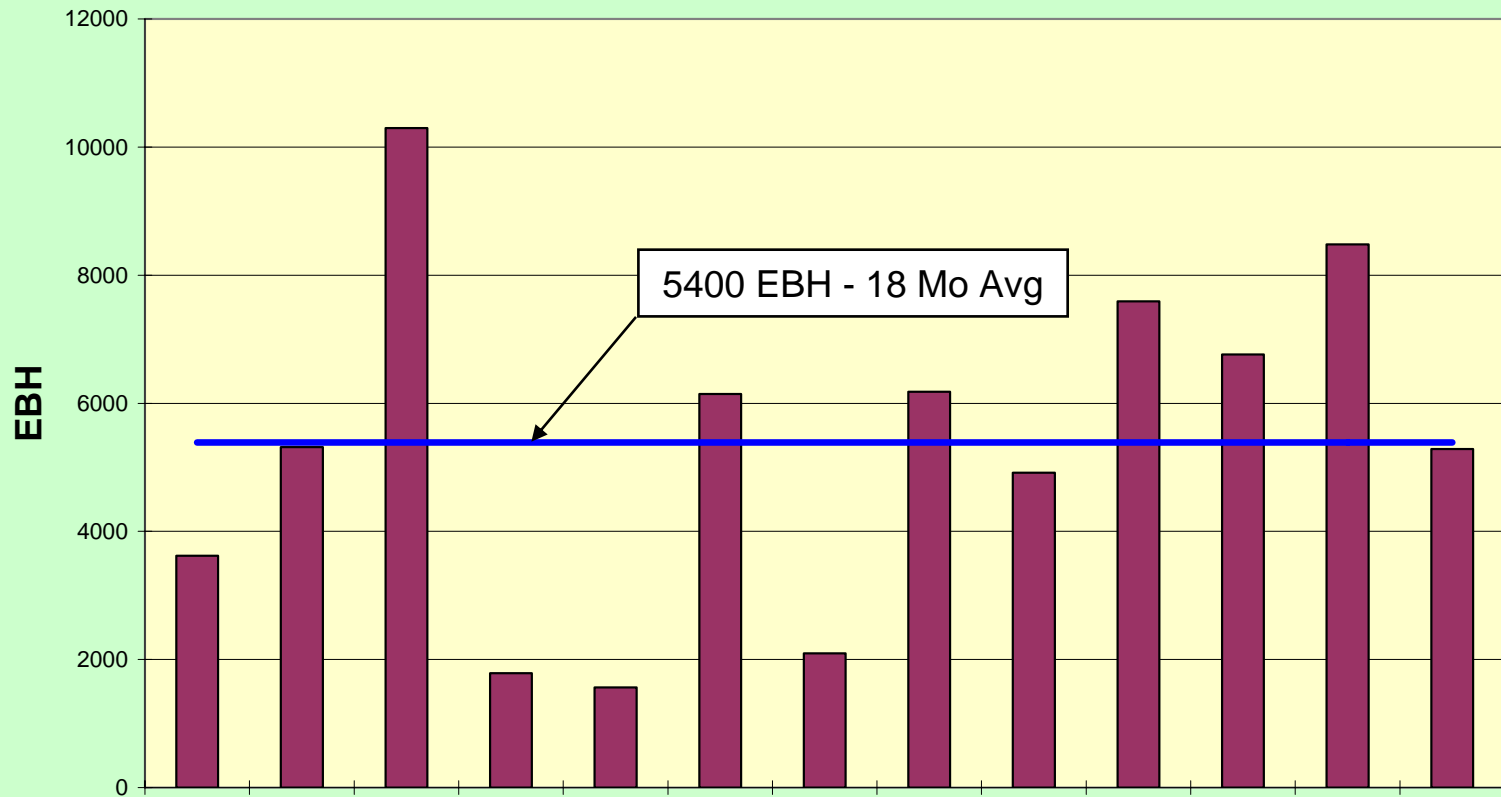
### EBH Usage Variation (Last 18 Months)

- **Center wing cracking has decreased aircraft available to perform missions**
  - **Force realignment**
    - **Aircraft reassigned from ARC to active duty**
    - **Squadron sizes reduced to minimum requirement**
    - **Aircraft transferred between bases**
  - **Projections for future groundings and restrictions published on a weekly basis**
    - **Assumes uniform distribution of flight hours and severity across a squadron**
  - **Unrestricted aircraft performing multiple deployments to meet operational requirements**
    - **EBH consumption rates beyond projected levels**
      - **Deployed usage up to 4x home station usage**
