Improving Structural Durability and Aircraft Availability through Innovative Tracking, Analysis and Repair Technology

2007 ASIP Conference

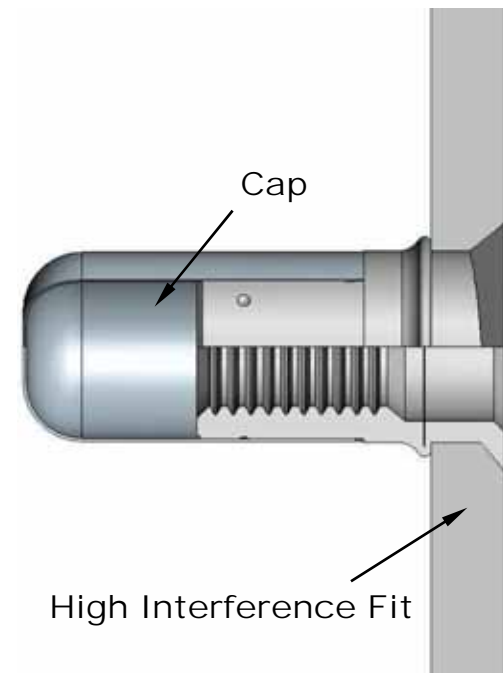
TukLoc™ Benefits Sealing

- Prevents leaking from all potential leak paths
 - High interference fit reduces / eliminates primary leak path
 - Cap eliminates a second leak path (threads)
- Accepts multiple bolt installations without leaking
- No sealant required

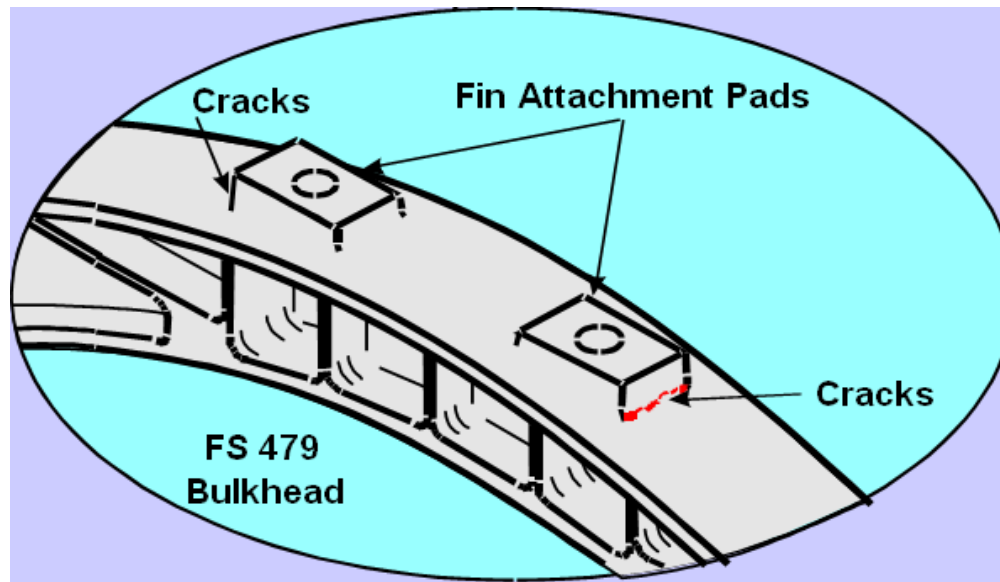
479 Bonded Doubler Modification

- The upper 479 bulkhead cracks at the base of the attach pad
- Sudden change in beam stiffness
- Small radius

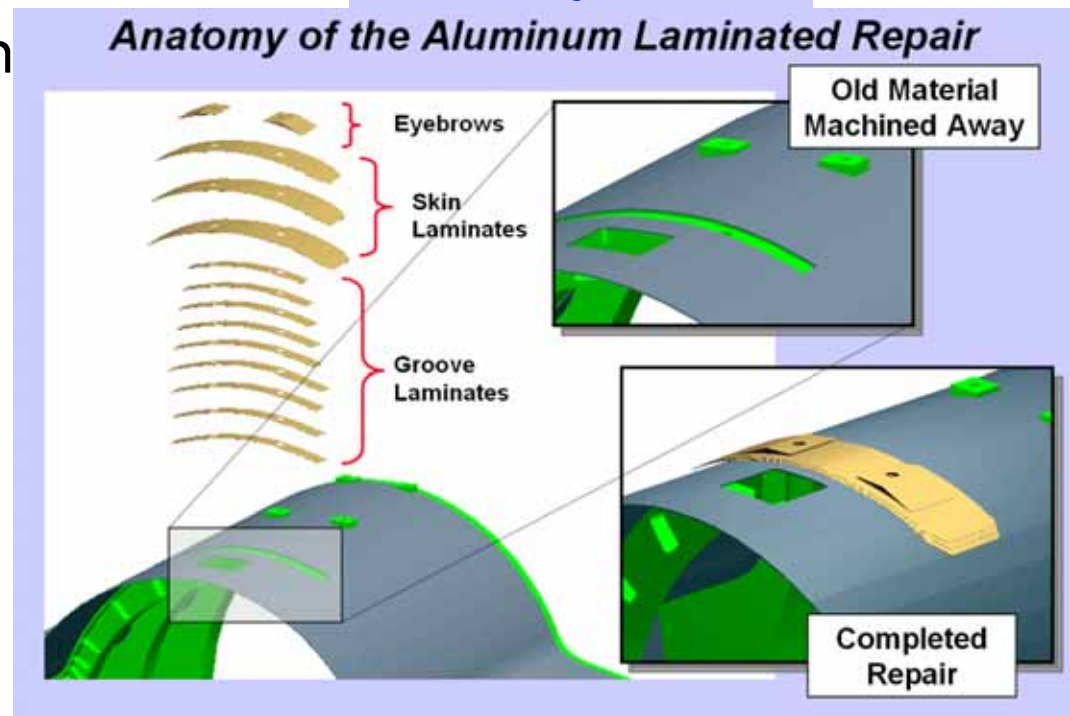
479 Bonded Doubler Modification

- Consists of layers of aluminum bonded together with a high strength adhesive
- Provides a smooth stiffness transition
- Eliminates stress concentration

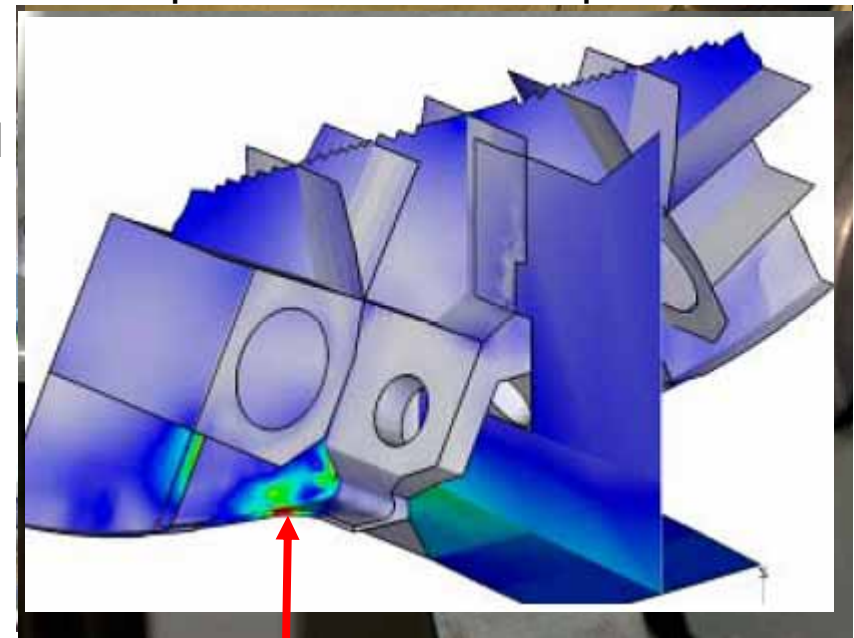
Finite element model shows stress concentration at FS 341 Bulkhead Keel Beam Radius

- Background: OO-ALC in conjunction with AFRL and Southwest Research Institute (SWRI) have developed a Bonded Repair for the FS 341 Bulkhead
- Problem: Cracking on lower 341 Blkhd
- Cracking caused by:
 - Stress Concentration
 - Maintenance Induced Damage
 - Rework exceeding limitations
- Cracks extending to vertical web require bulkhead replacement

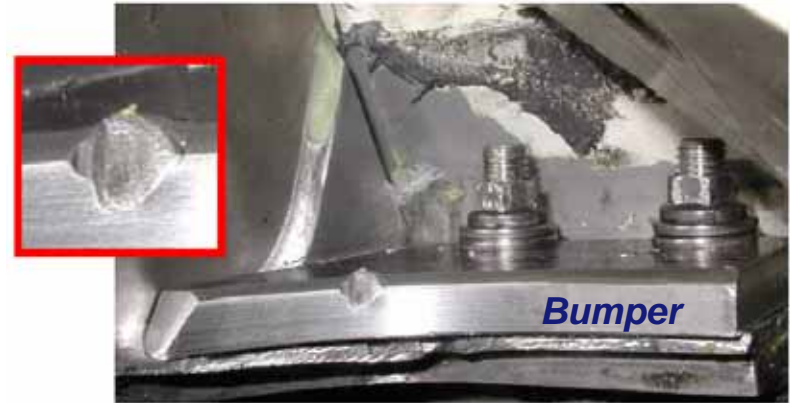
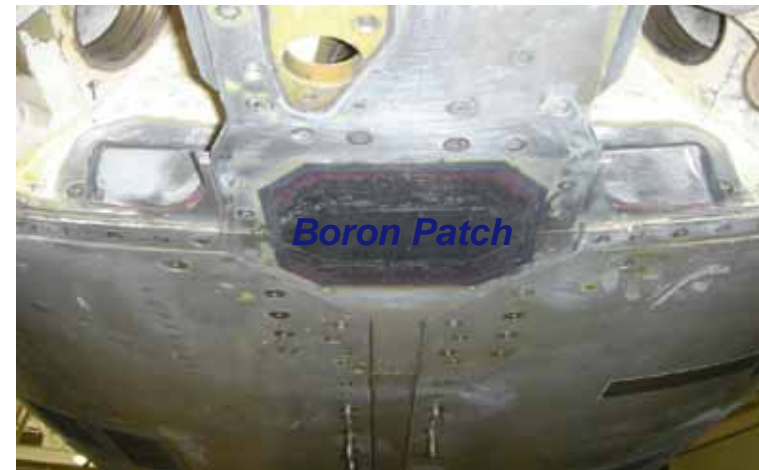
FS 341 Bulkhead Bonded Repair

- 6 day repair time vs. 90 day replacement time
- Work accomplished on site
- Repair cost is \$45K
- Replacement costs \$200K+
- Doublers reduce local stress over 60%
- Bumpers prevent future maintenance damage
- Repaired bulkhead coupons survived 6X as long as un-repaired coupons

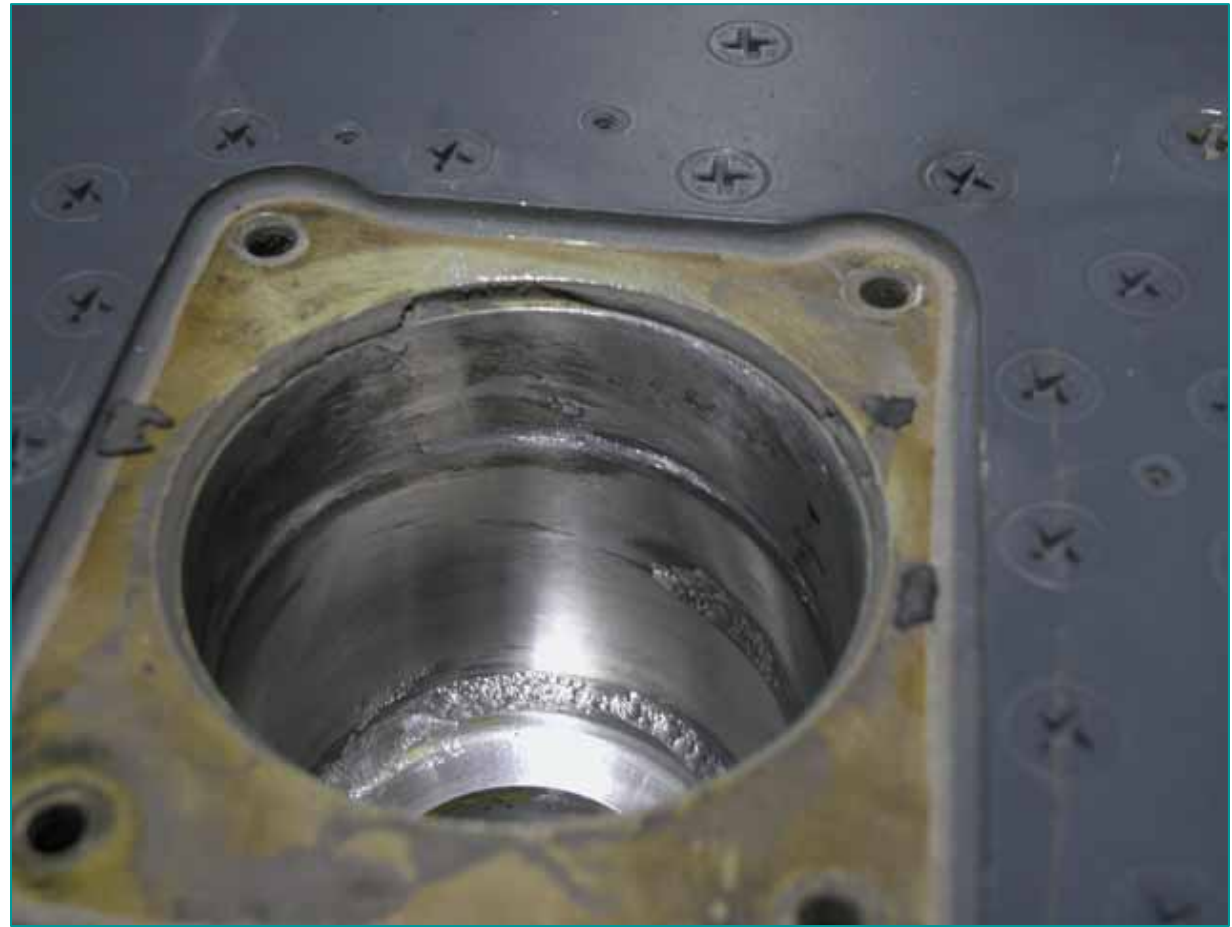
16W112 Wing Rib Pylon Attach

30+ reports in
one year of
corrosion
and/or gouging

- Has been problematic for several years
 - Pitting/galvanic corrosion
 - Upward facing “cup” retains water--doesn't evaporate
 - Bare metal requirements per engineering drawings
 - Impacting aircraft Fully Mission Capable rates
- Solutions (1st iteration long-term)
 - Slip fit Al sleeve-type repair (16RW148)
 - Corrosion re-occurring after sleeve repair
 - Sleeve migration observed
