2007 USAF Aircraft Structural Integrity Program Conference

C-130 Center Wing Rainbow Fitting, Spare Redesign

5 December 2007

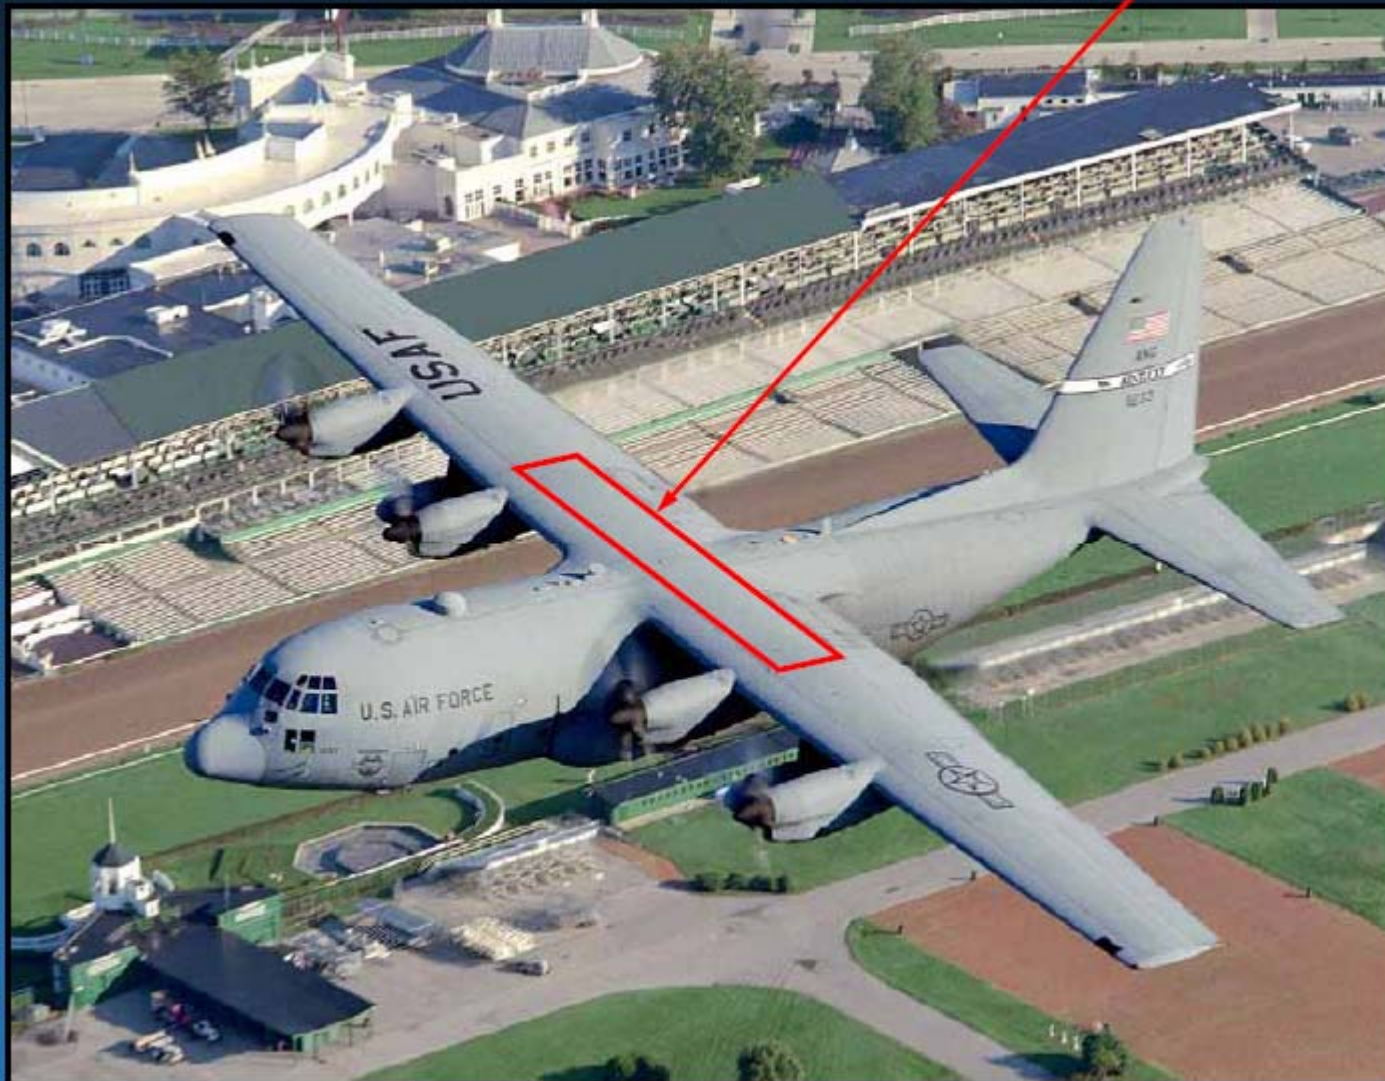
C-130 Center Wing Box

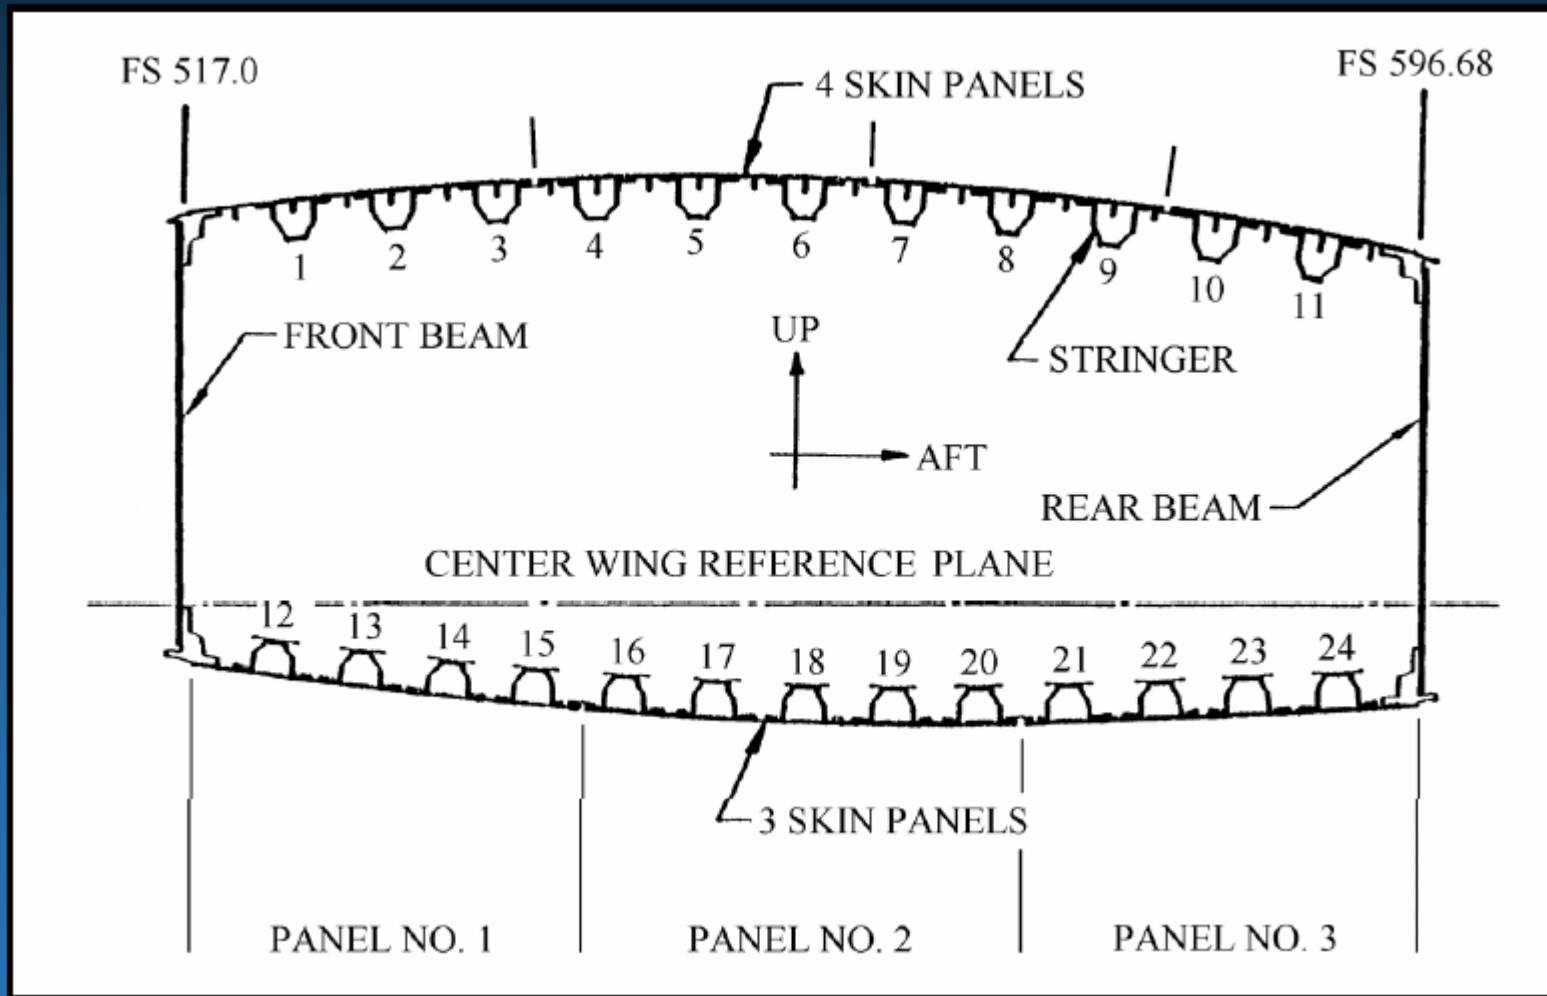
Center Wing Box, Section View

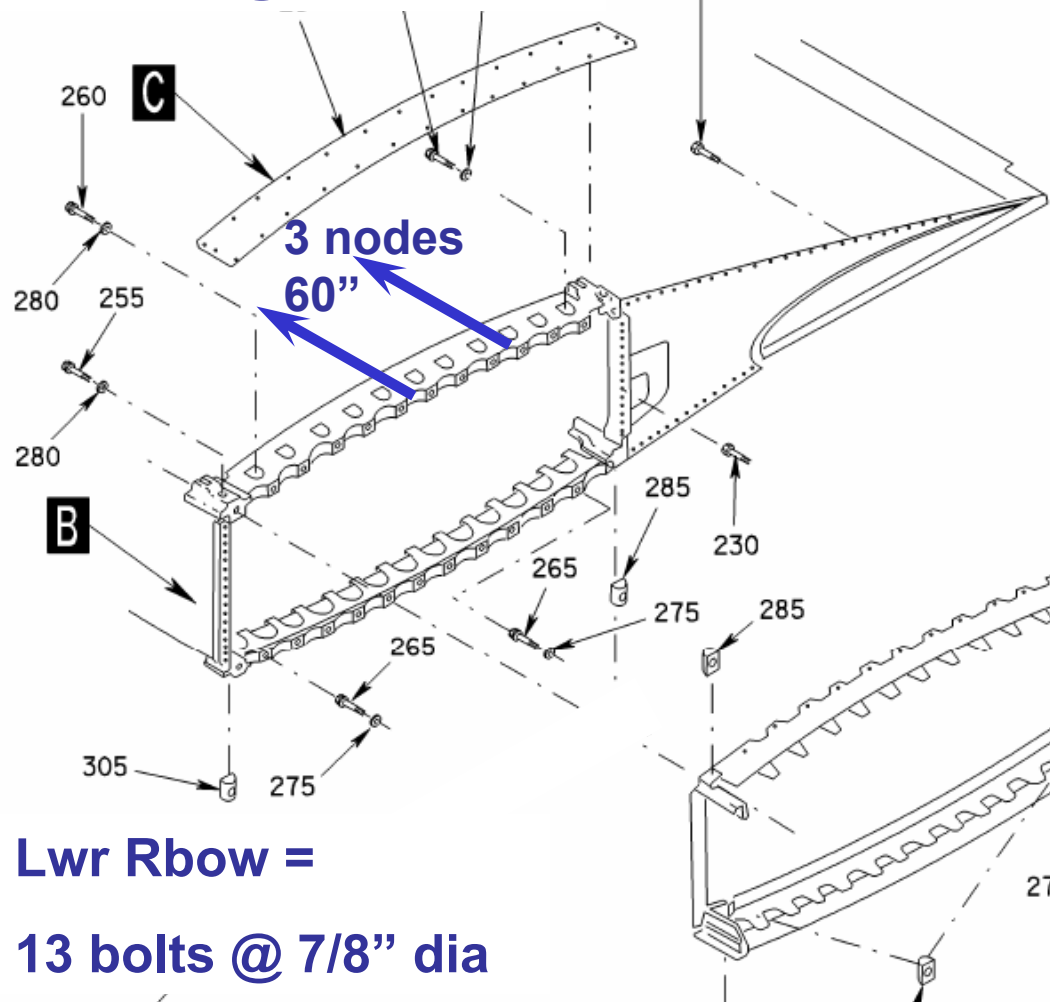
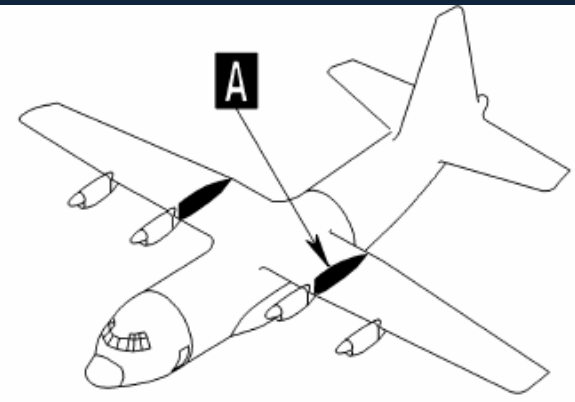
Upr Rbow =

11 bolts @ 3/4" dia

Lwr Rbow =

13 bolts @ 7/8" dia

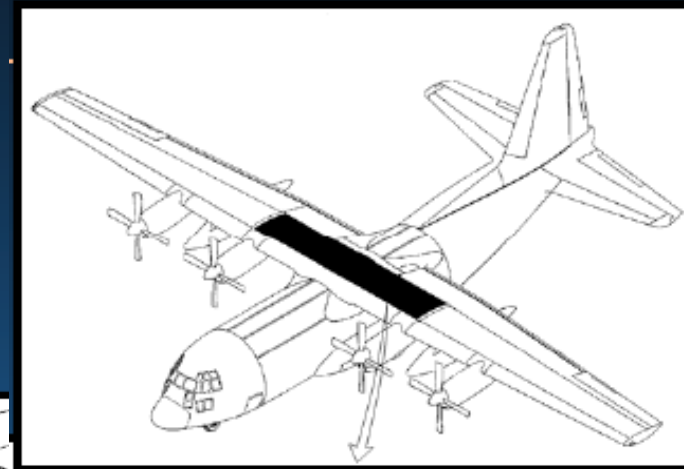
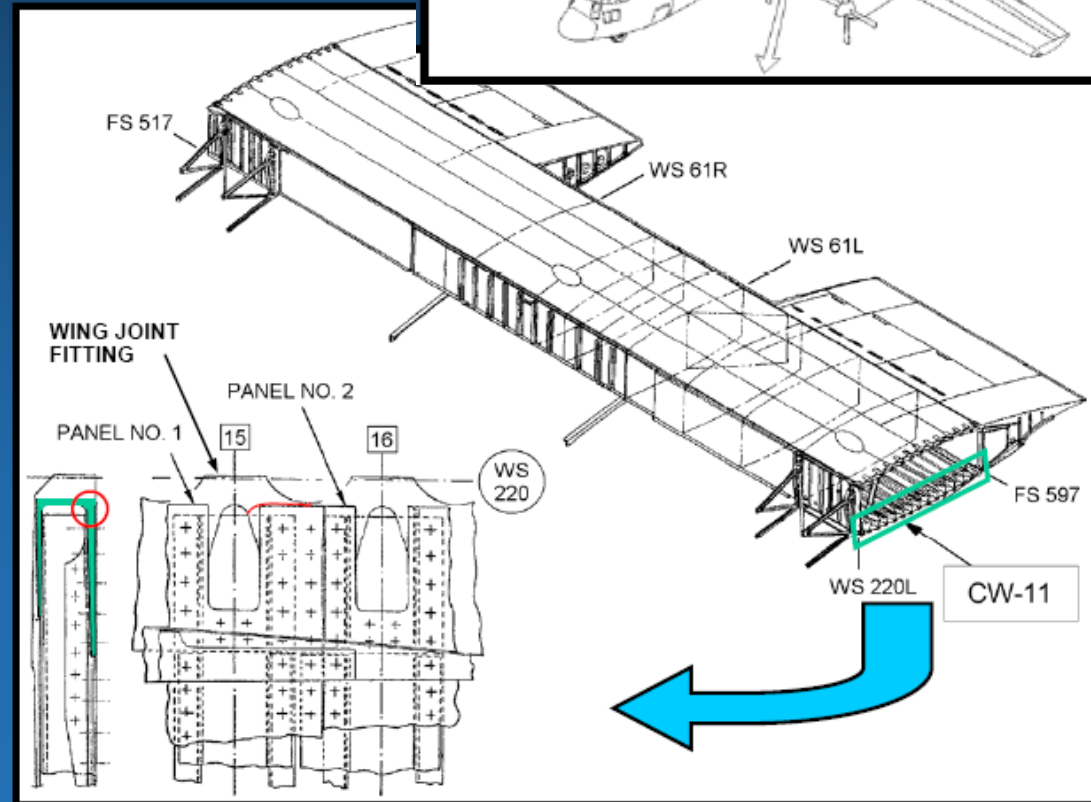
2006 Presented on Risk Assessment Methodology for Wing Joint Ftg

- Prone to MSD Cracking
- Short “critical” crack length (0.07 in.)
- 35 A/C documented with in-service MSD/MED cracking:
 - Multiple Node Cracks (adjacent/non-adjacent)
 - Adjacent Panel Cracks
- Three adjacent Node cracks reduce strength to below Design Limit

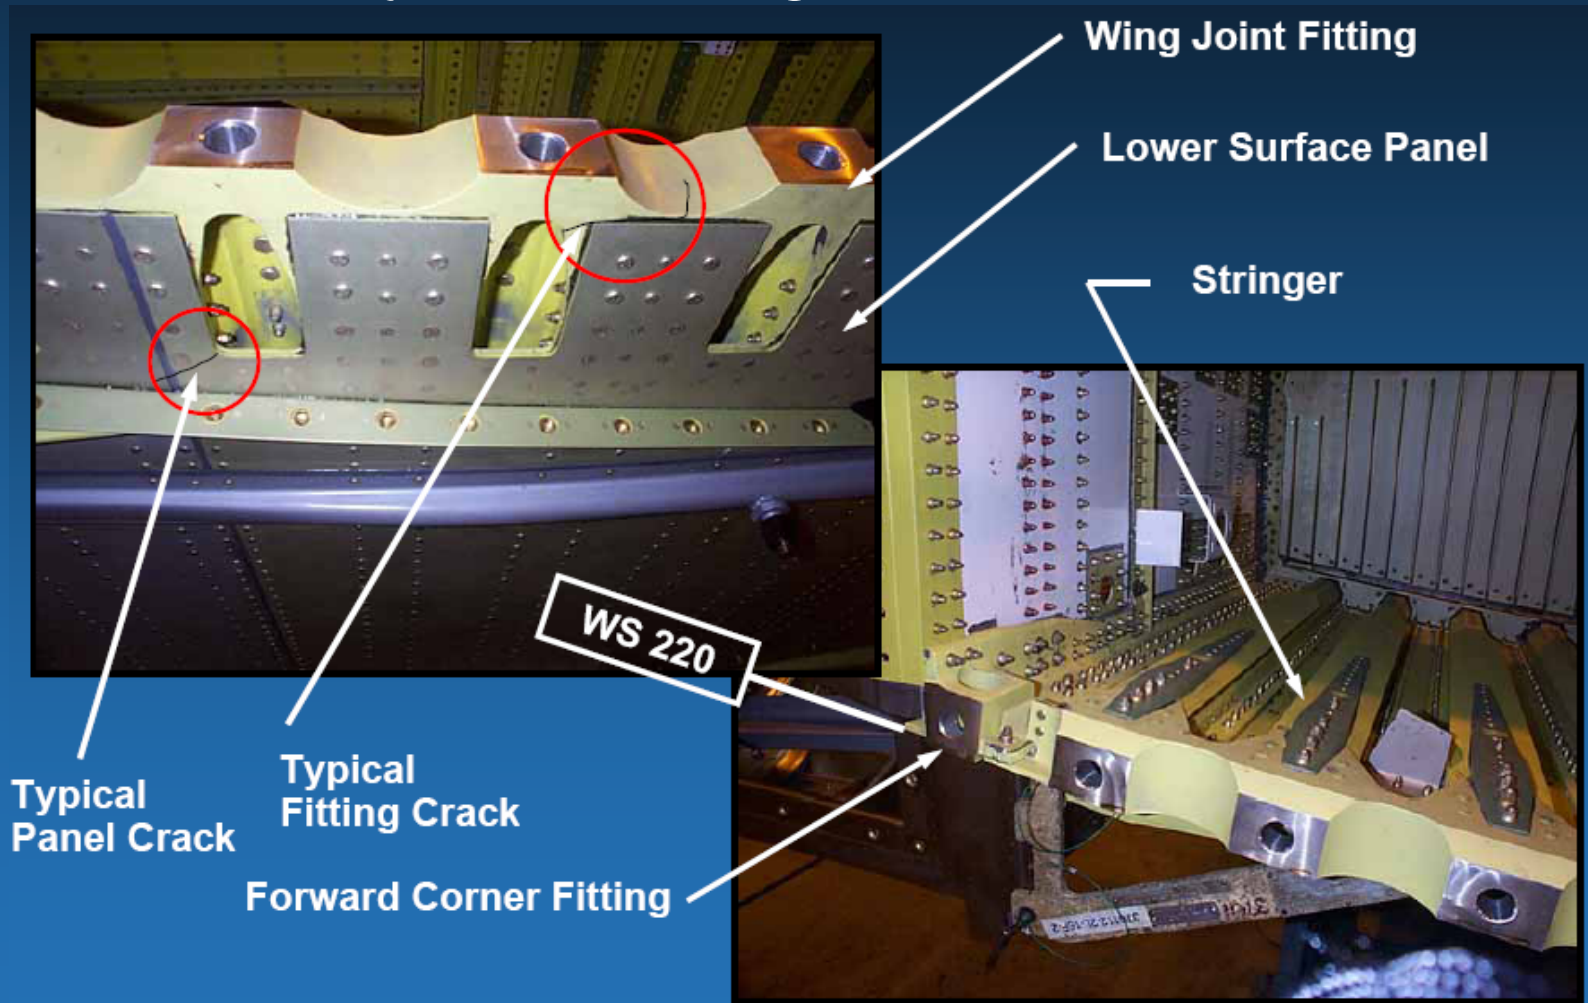
– MSD Risk Analysis of the Wing Joint

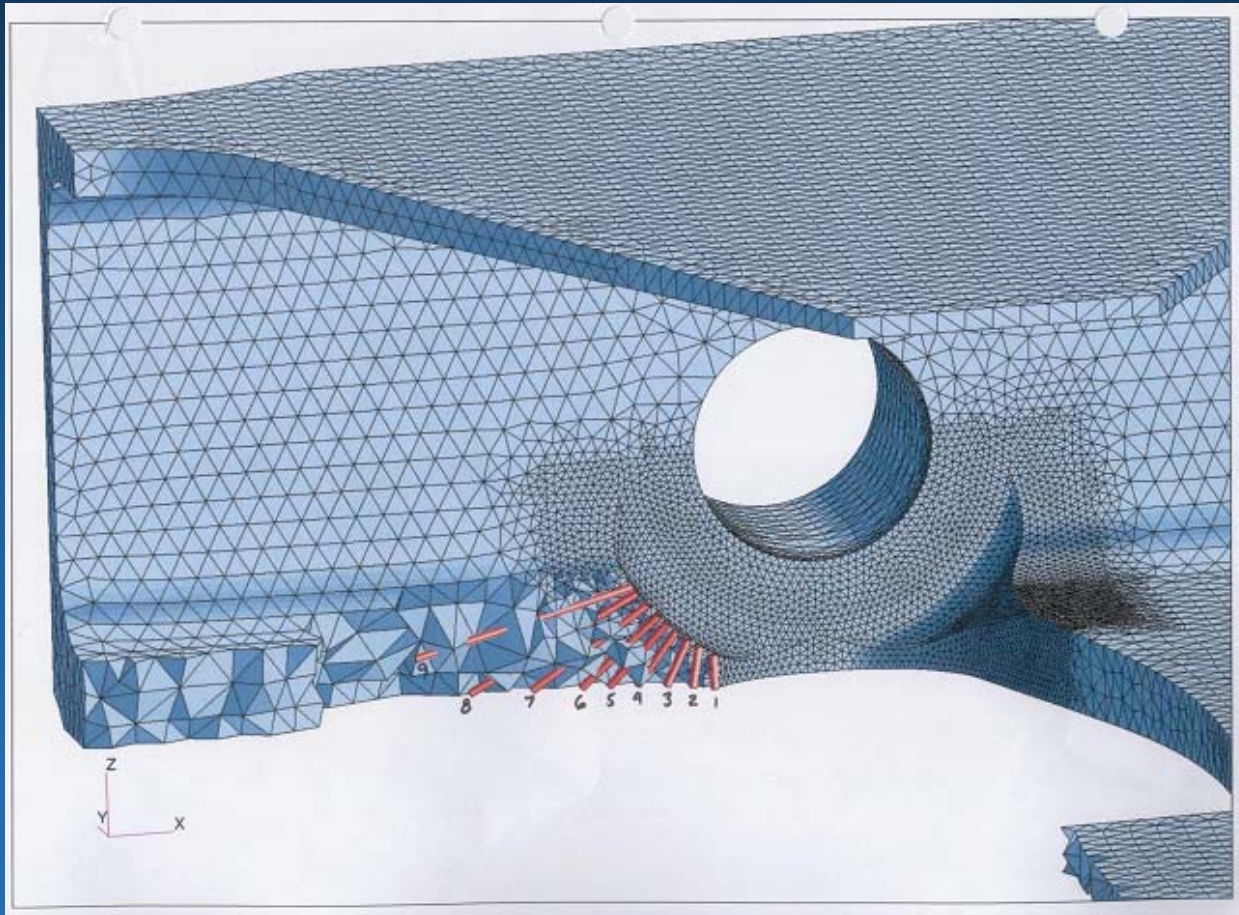
- **Distribution of stress normal to the projected critical plane along a series of paths (shown as tubes)**

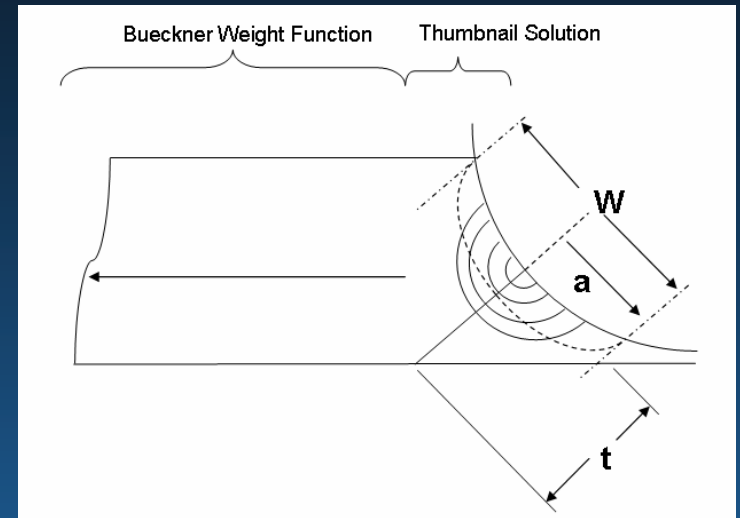
- Stress Intensity Factor using variable aspect ratio ellipses via Newman and Raju Thumbnail Flaw solution matched to stress distribution
- Weight function + Flange Bending + Internal Load Redistribution after transition to through-the-thickness
- Longer cracks solutions using stress distributions from global airframe level FEM
- JSSG2006 initial flaw criteria for Durability and for Damage Tolerance

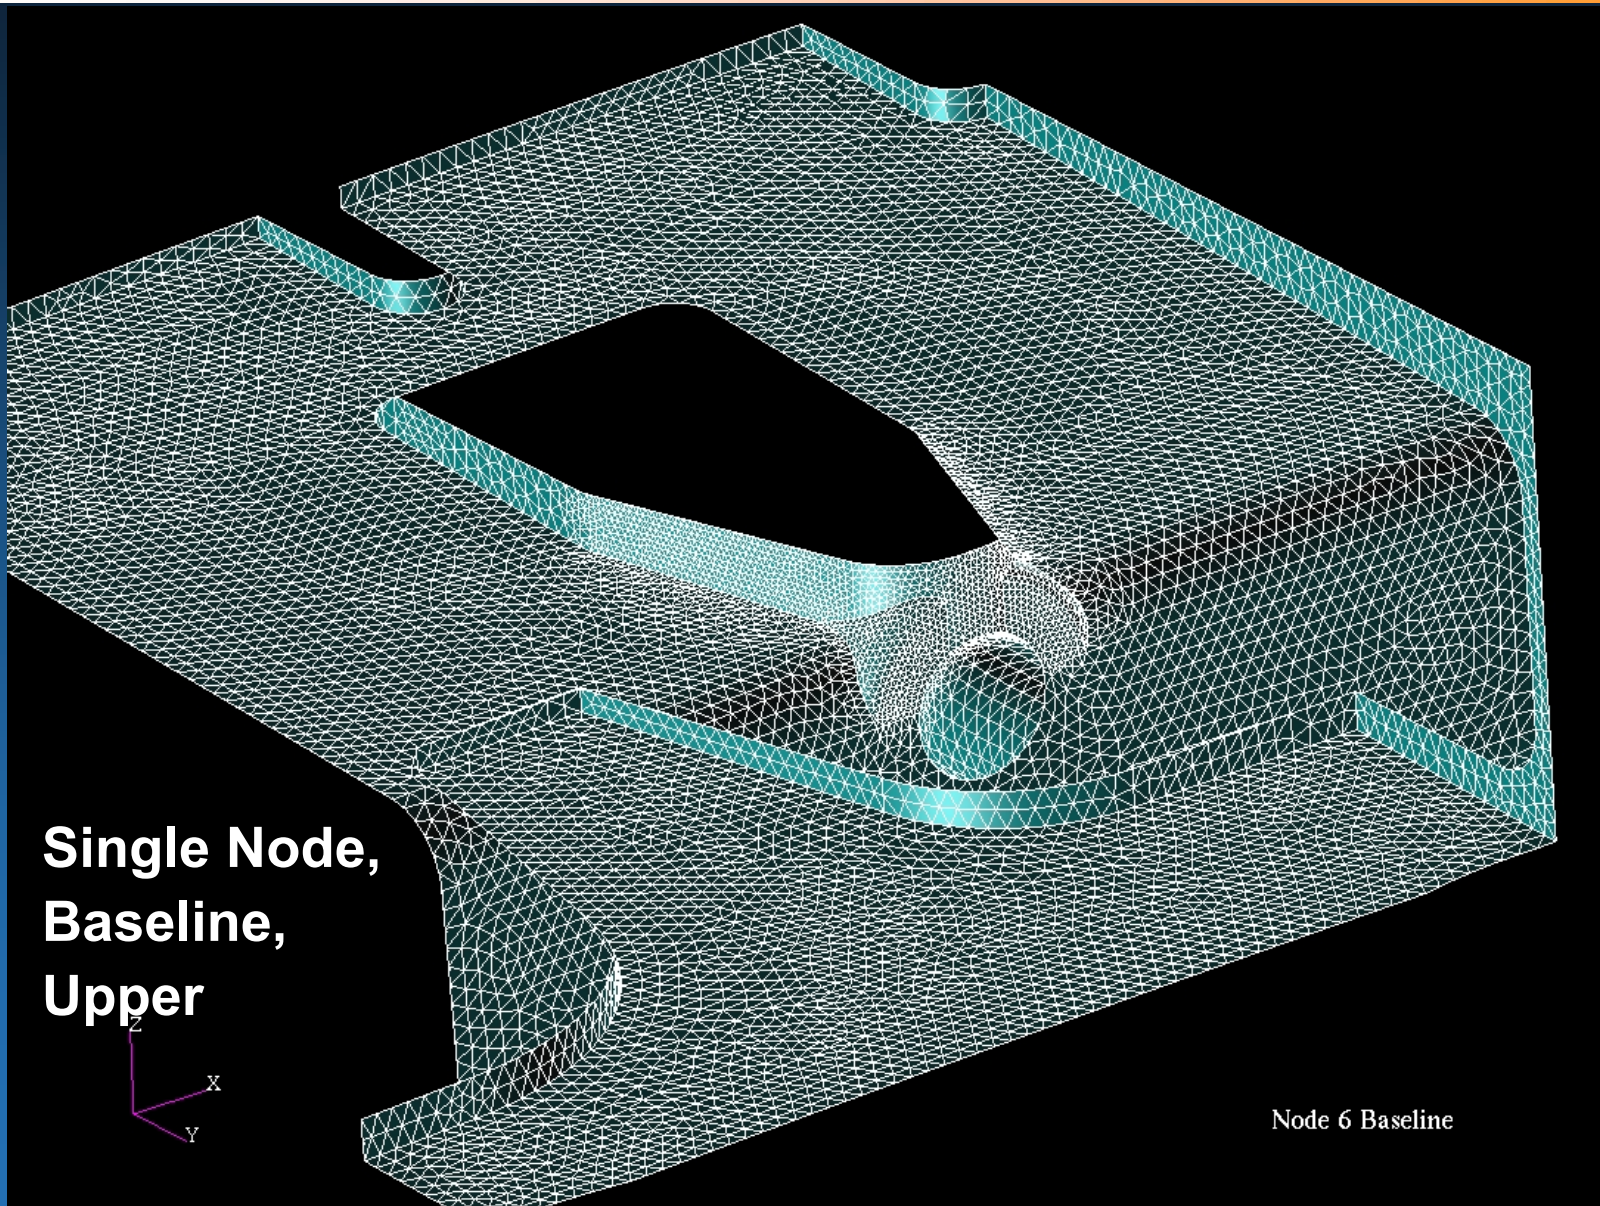
**Single Node,
Baseline,
Upper**

Node 6 Baseline

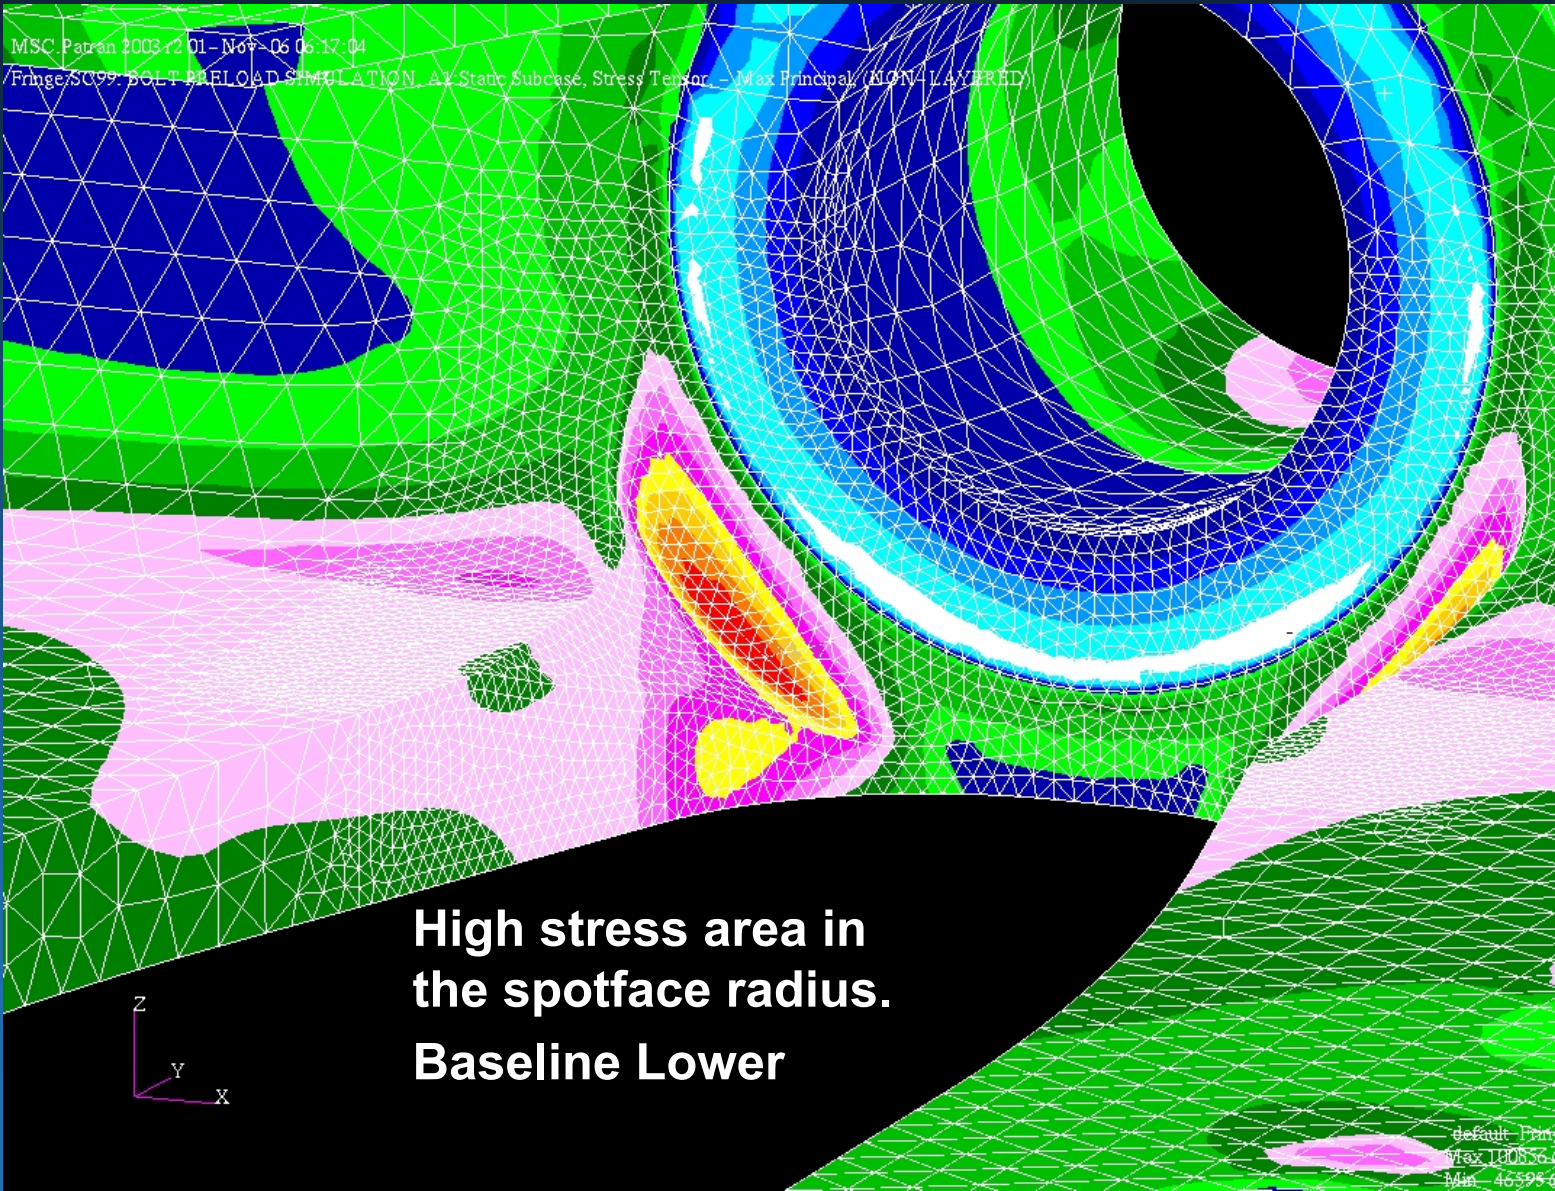
**High stress area in
the spotface radius.
Baseline Lower**

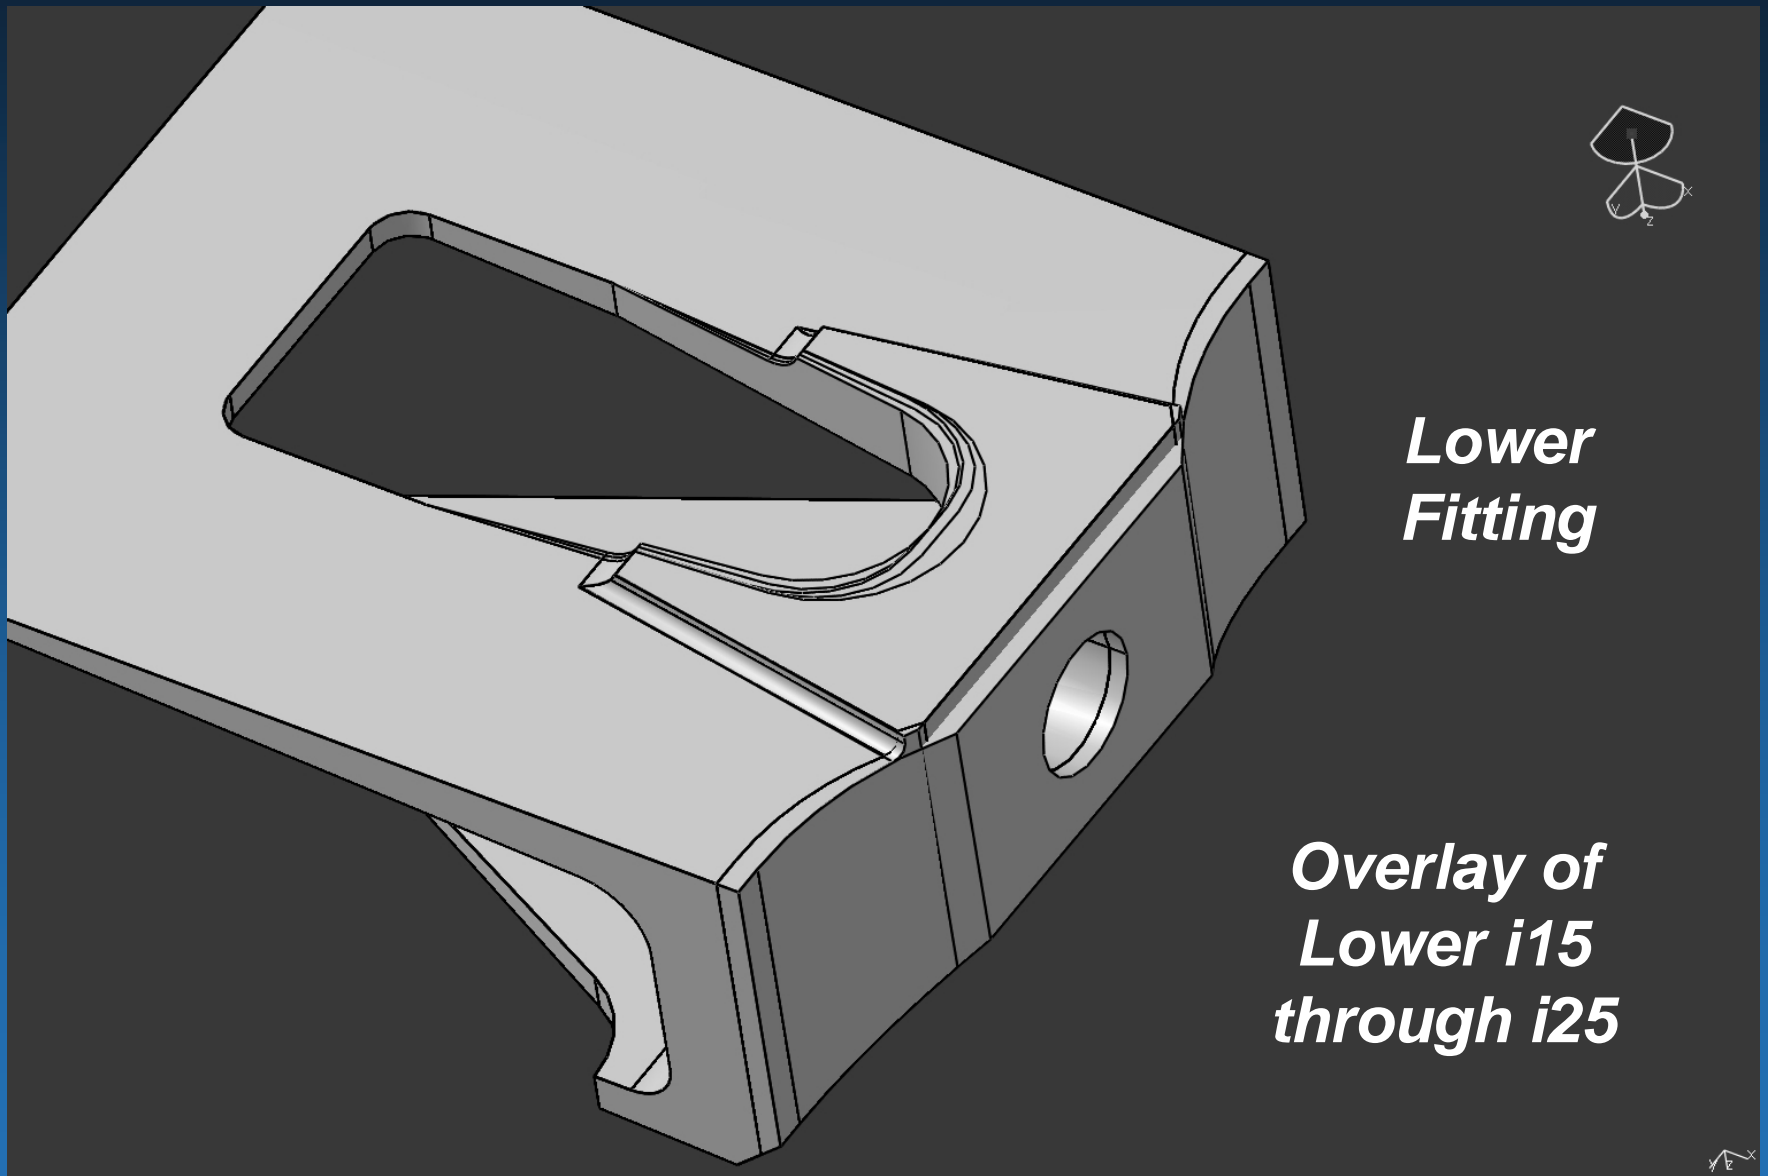
Lower Fitting

Overlay of Lower i15 through i25

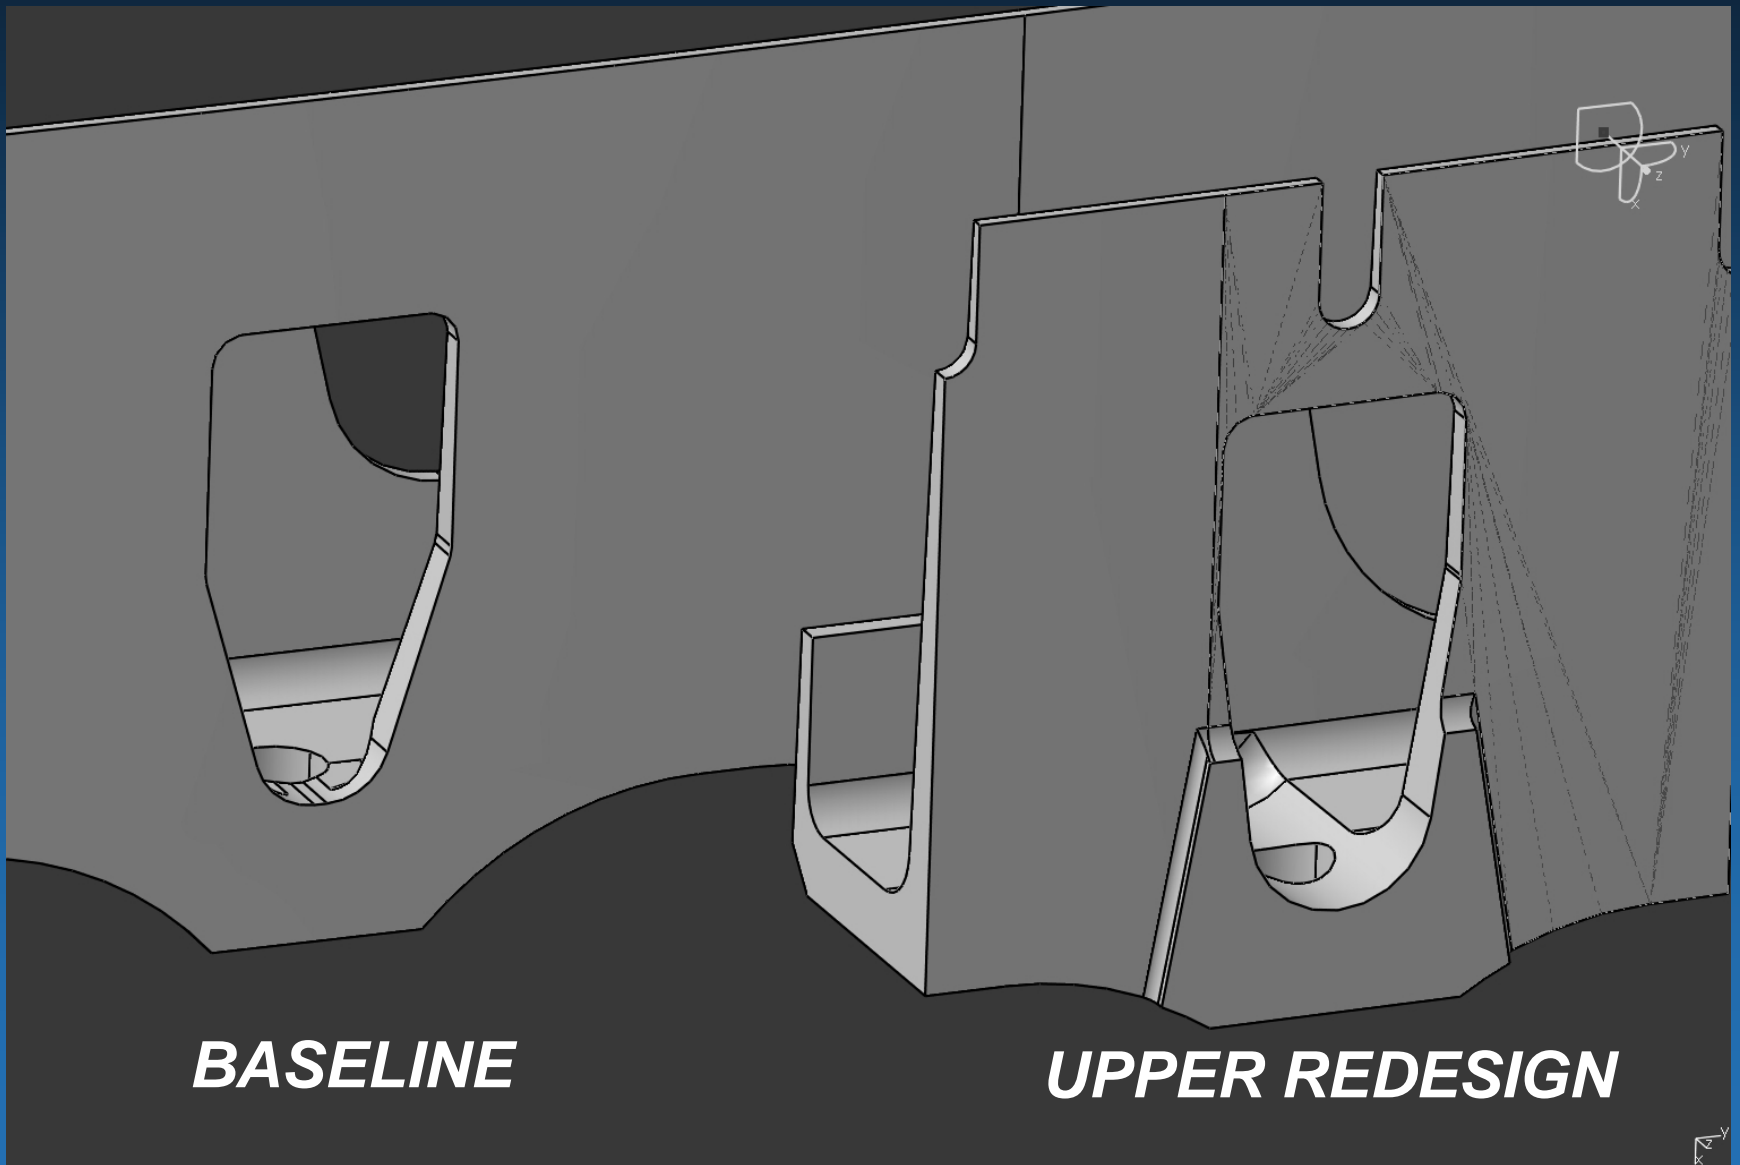
BASELINE

UPPER REDESIGN

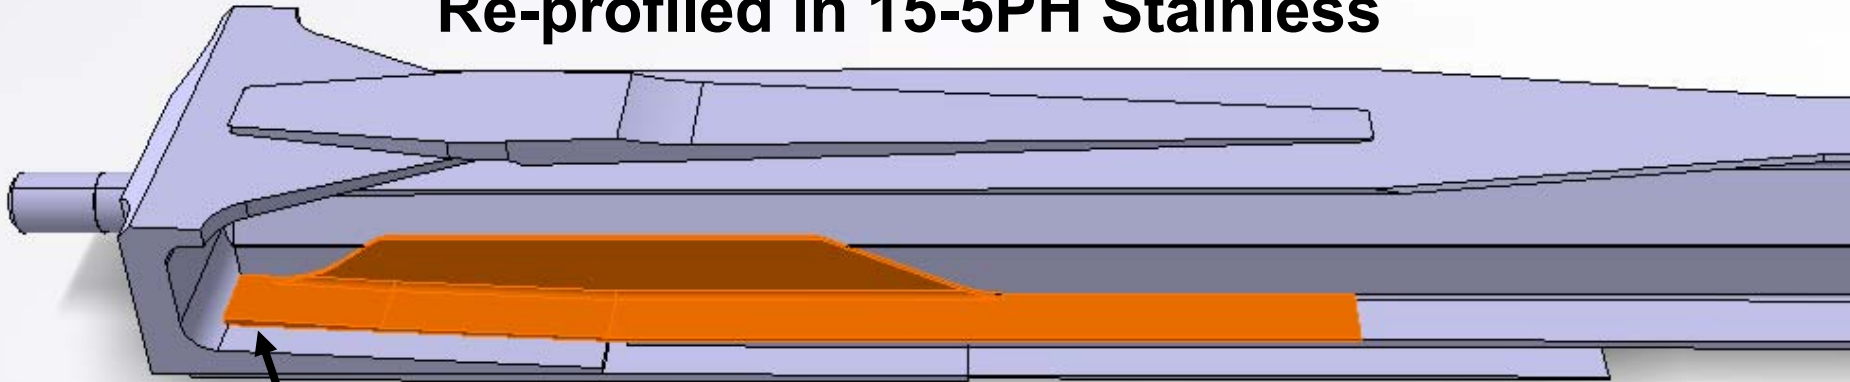
**Attach Angle, Stringer Sidewall to Rainbow
Re-profiled in 15-5PH Stainless**

Reverse Taper

- 0.08" to approx $\frac{1}{4}$ "
- 0.11" to 0.07"

- **Redesign for Barrel Washer**
- **Longer Bolts**
- **Local Integral Pad (0.150”) to External Tang**
- **7249-T76511 with New Extrusion Profile**
- **Straight-Shank Fasteners in Coldworked Holes**
- **Bushings in Bolt Holes**
- **Profile and Material of Lwr Attach Angles (15-5PH SS bar.....was 7075-T73 forging)**

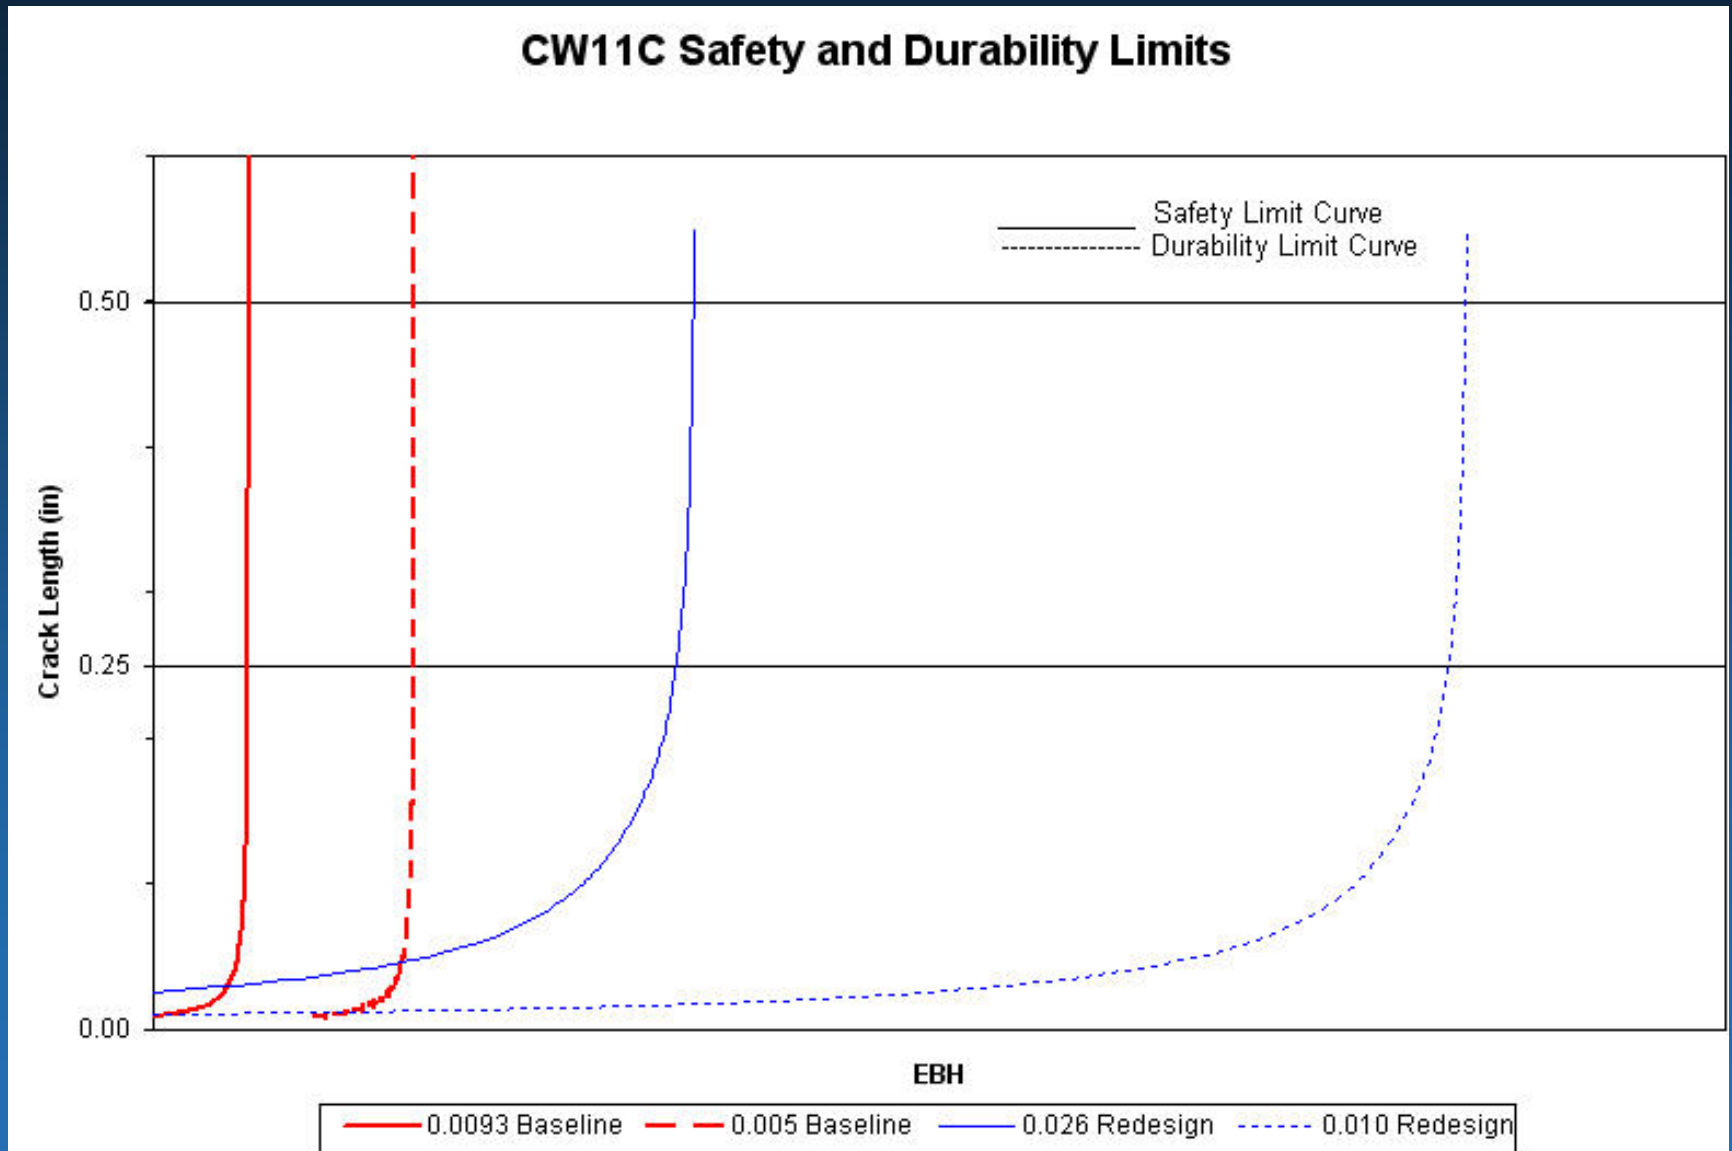
Redesign Service Life

- All design goals were met with exception that:
 - *the redesign requires a trim to wing panel cutouts*
 - *the redesign requires a change in bolt length*
- All DADTA locations meet the 38,000 EBH goal using a scatter factor of 2, as required by JSSG.
- With the exception of CW-11A, all meet the SL requirement using a scatter factor of 4 (LM Aero self-imposed stretch goal)
