Canadian Forces Generic Bolt Hole Eddy Current Probability of Detection Study

ASIP 2007

05 Dec 2007 Palm Springs, CA

DJ Butcher¹, Catalin Mandache², Muzibur Khan²

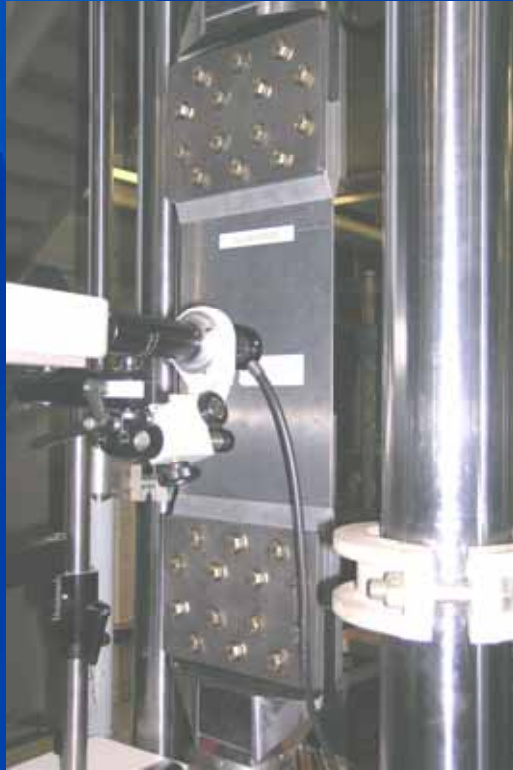
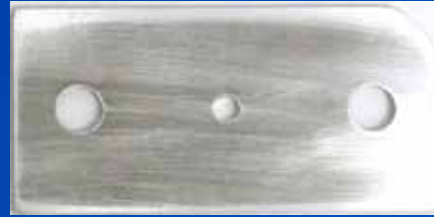
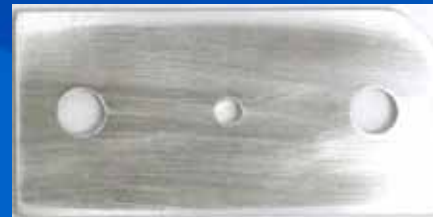
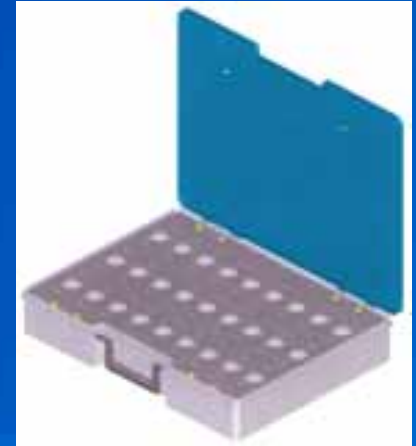
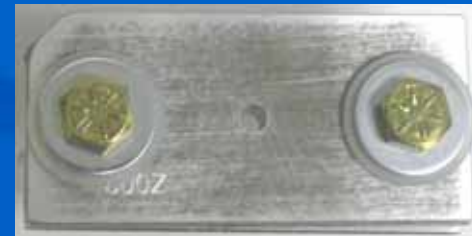
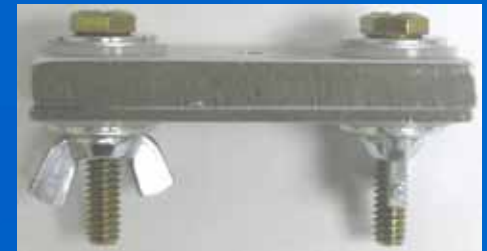
Inspector Test Result Data Sheet					
Date	Equipment				
Inspector ID:	Probe				
Organization	Frequency:		Threshold		
Box ID	Magnitude Scale		Noise Level		
Test Identification				Comments	
Box and Set Number	Crack Indication (Y/N)	Signal Magnitude	Phase Angle		
A01					
A02					
A03					
A04					
A05					
A06					
A23					
A24					
A25					
A26

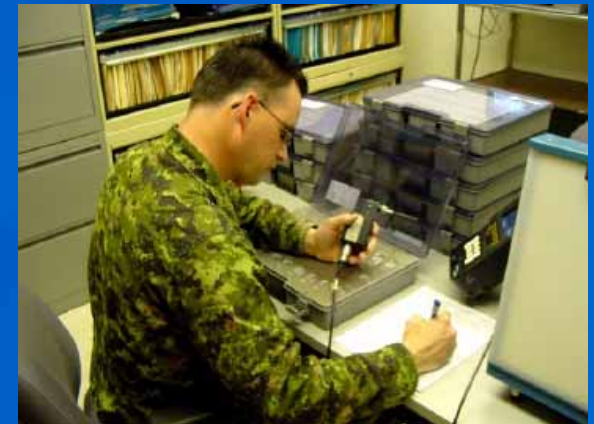
Empirical Study - Results

- Three different software codes were used to analyze the data
 - National Research Council of Canada (NRCC) code for hit-miss data
 - NRCC code for \hat{a} vs. a data
 - Draft MIL HDBK 1823 software
- There are many ways to estimate the PoD
 - depends on the type of data, the functional form, the thresholds and confidence bounds calculation
- Only the data analyzed with the draft MIL HDBK 1823 software will be presented
 - \hat{a} vs. a data, log-logistic functional form, and maximum likelihood ratio determination of confidence bounds
