# **Development of a Nondestructive Inspection (NDI) Approach based on Bolt Hole Ultrasonic Testing (BHUT) for complex, multi-layered Aircraft Structures**

**ASIP Conference - December 5<sup>th</sup> 2007**

# BHUT Inspection Development

AF Project F09650-03-D-001 5020 Task 2 (completed October 2007)

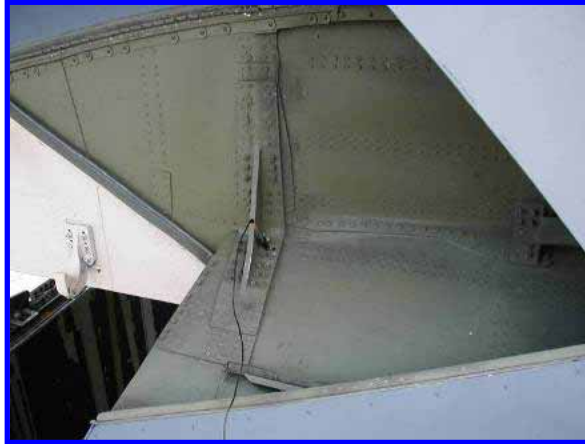
C-5 Contour Box Beam Fitting (CBBF) Structure

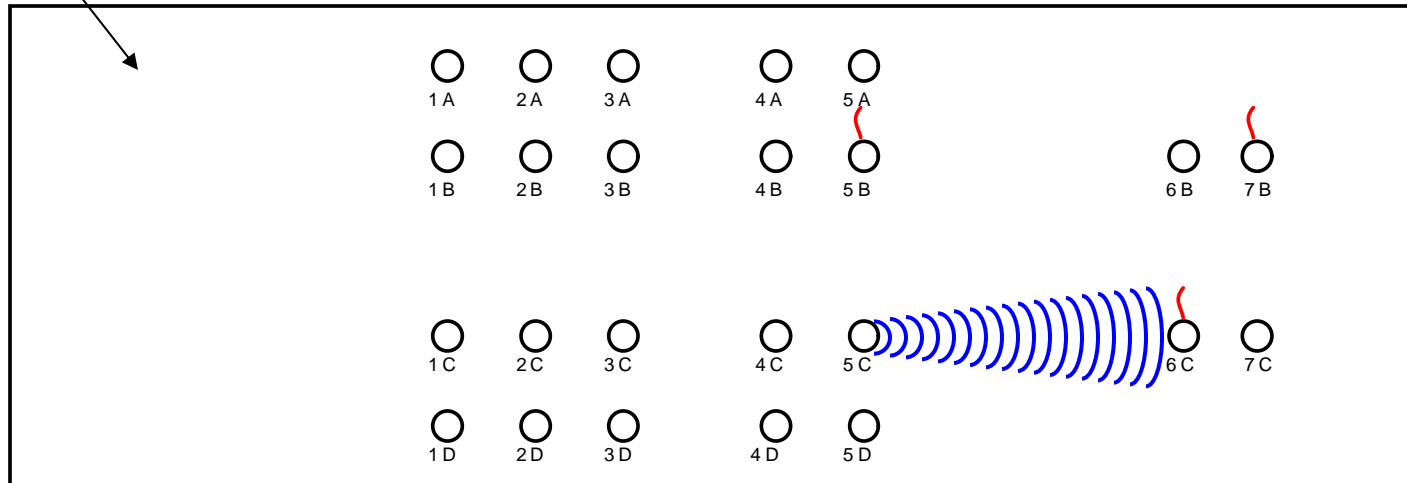
C-5 CBBF Mock-up Structure Schematic:

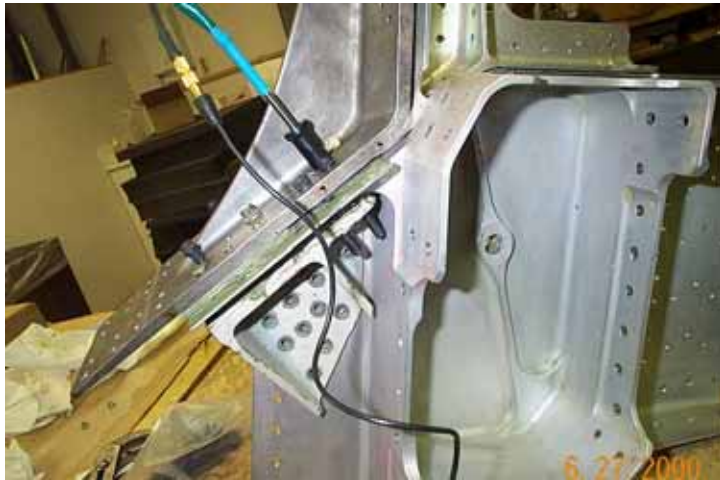
**C-5 CBBF structure removed from aircraft shown with ultrasonic probe**

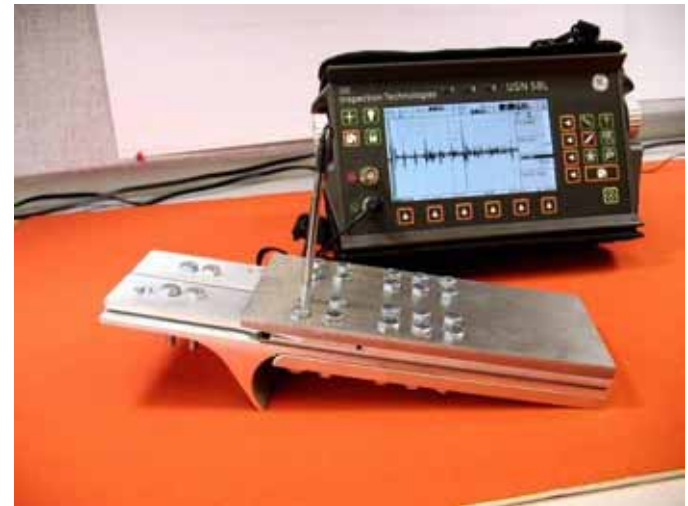
**SKT fabricated C-5 CBBF “mock-up” structure shown with bore probe and USN-58L**

- Test Article Mock-up Structure to simulate C-5 CBBF Structure, as on-aircraft verification of inspection results not an option
- Fatigue Cracks of critical length at critical locations were introduced in three layers of interest (Box Beam Fitting, Titanium Safety Strap and Y-Fitting)
- Mock-up Structure used for both Verification and Calibration

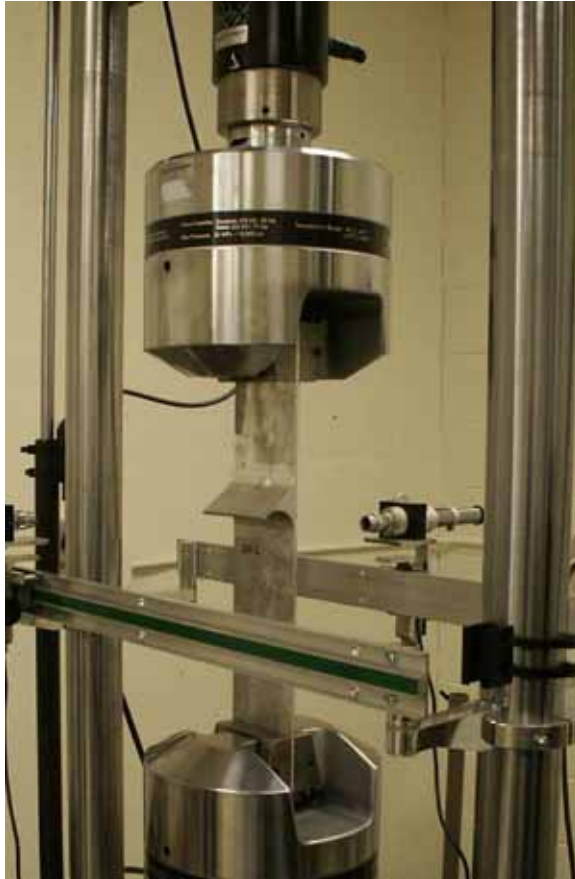
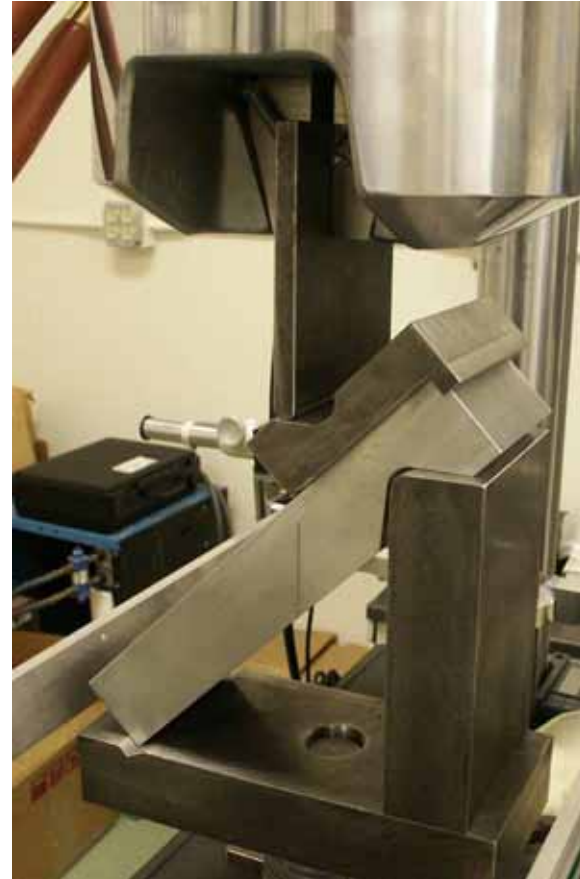
Bending  
Fatigue to  
introduce Crack  
in Radius

Fatigue Crack Introduction in Box Beam Fitting Specimens

Controlled crack propagation experiments required the generation of only  
one crack per specimen

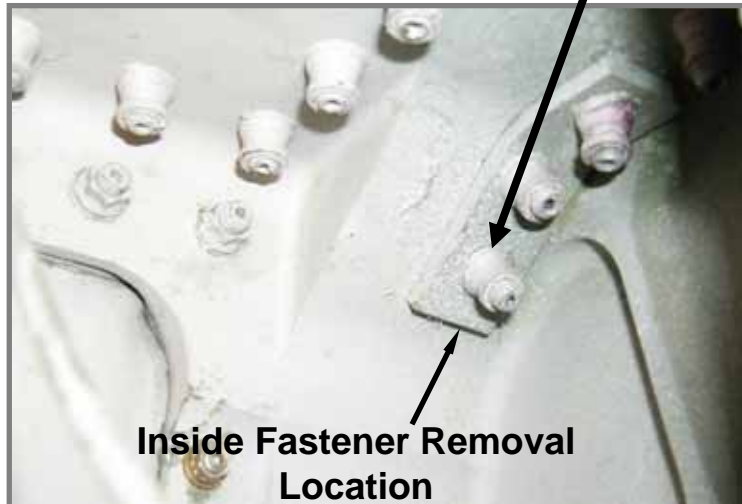
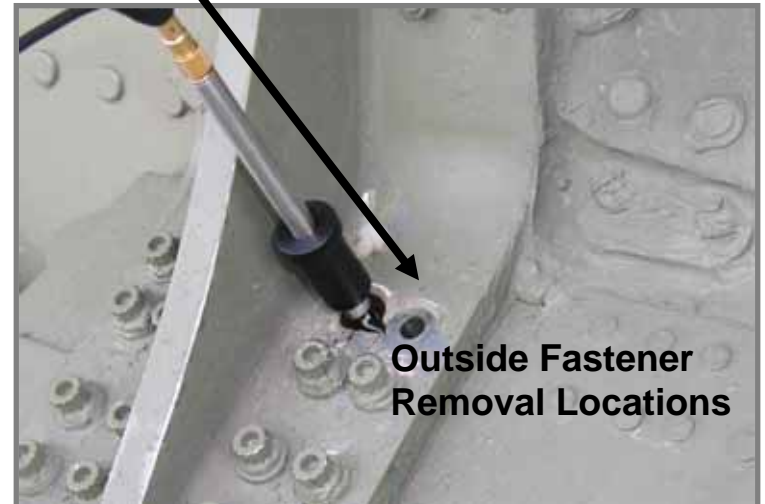
C-5 CBBF Mock-up  
Structure Assembly  
Inspection from Holes  
6B, 5C, 5D

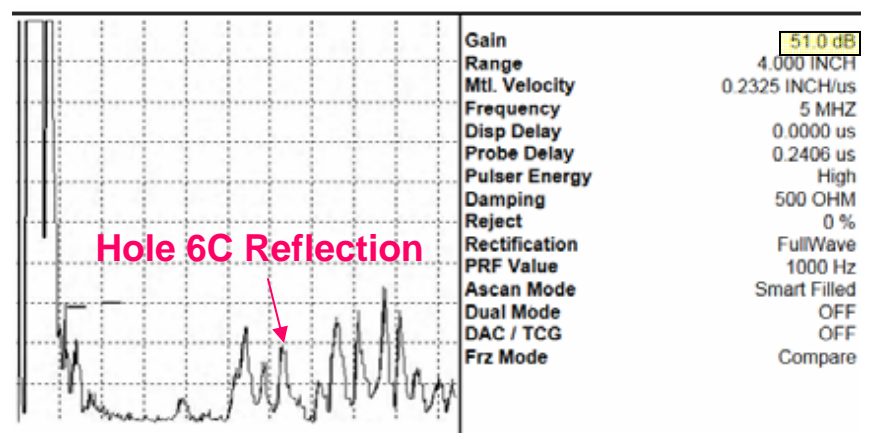
Inspection of 0.25" Crack at Pos5 from Hole 5C – Assembled with Sealant

- Verification test series using the inspection equipment (USN-58L and Bolt Hole Probes) in combination with the C-5 CBBF verification test articles
- Tests were designed to demonstrate the functionality of the ultrasonic inspection system
- Tests reveal influence of assembly/sealant on UT data by performing each inspection with layer disassembled, assembled, or assembled with sealant
  - Reflection signals are reduced or damped for the assembled, fastener-tightened structure compared to those obtained within disassembled layer
  - Sealant causes additional signal reduction; Signal-to-noise-ratio, however, is still acceptable

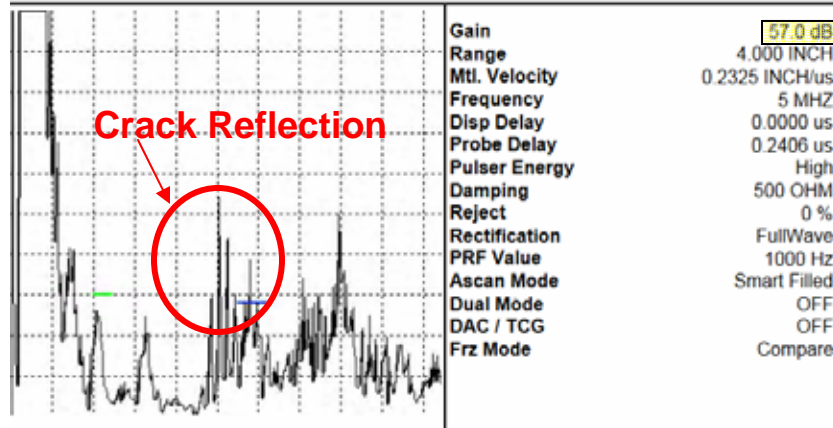
0.09" Crack from 6B – Assembled with Sealant

- Most critical inspection are the corner cracks in the Ti Safety Strap; can be detected reliably from either Hole 6B (Pos3) or 5D (Pos4)
- Cracks in Pos5 (Box Beam Fitting) can be detected reliably from all inspection holes; Failure of the Box Beam Fitting usually occurs at this location
- All crack sizes, down to or 0.06” in the Y-Fitting, could be detected
- However, at some locations crack related reflections could be identified, but it would be difficult to identify these signals as flaw indications on the aircraft
