B-1 Dorsal Longeron Repair Concept Case Study

2006 USAF Aircraft Structural Integrity Program Conference November 30, 2006 - San Antonio, Texas

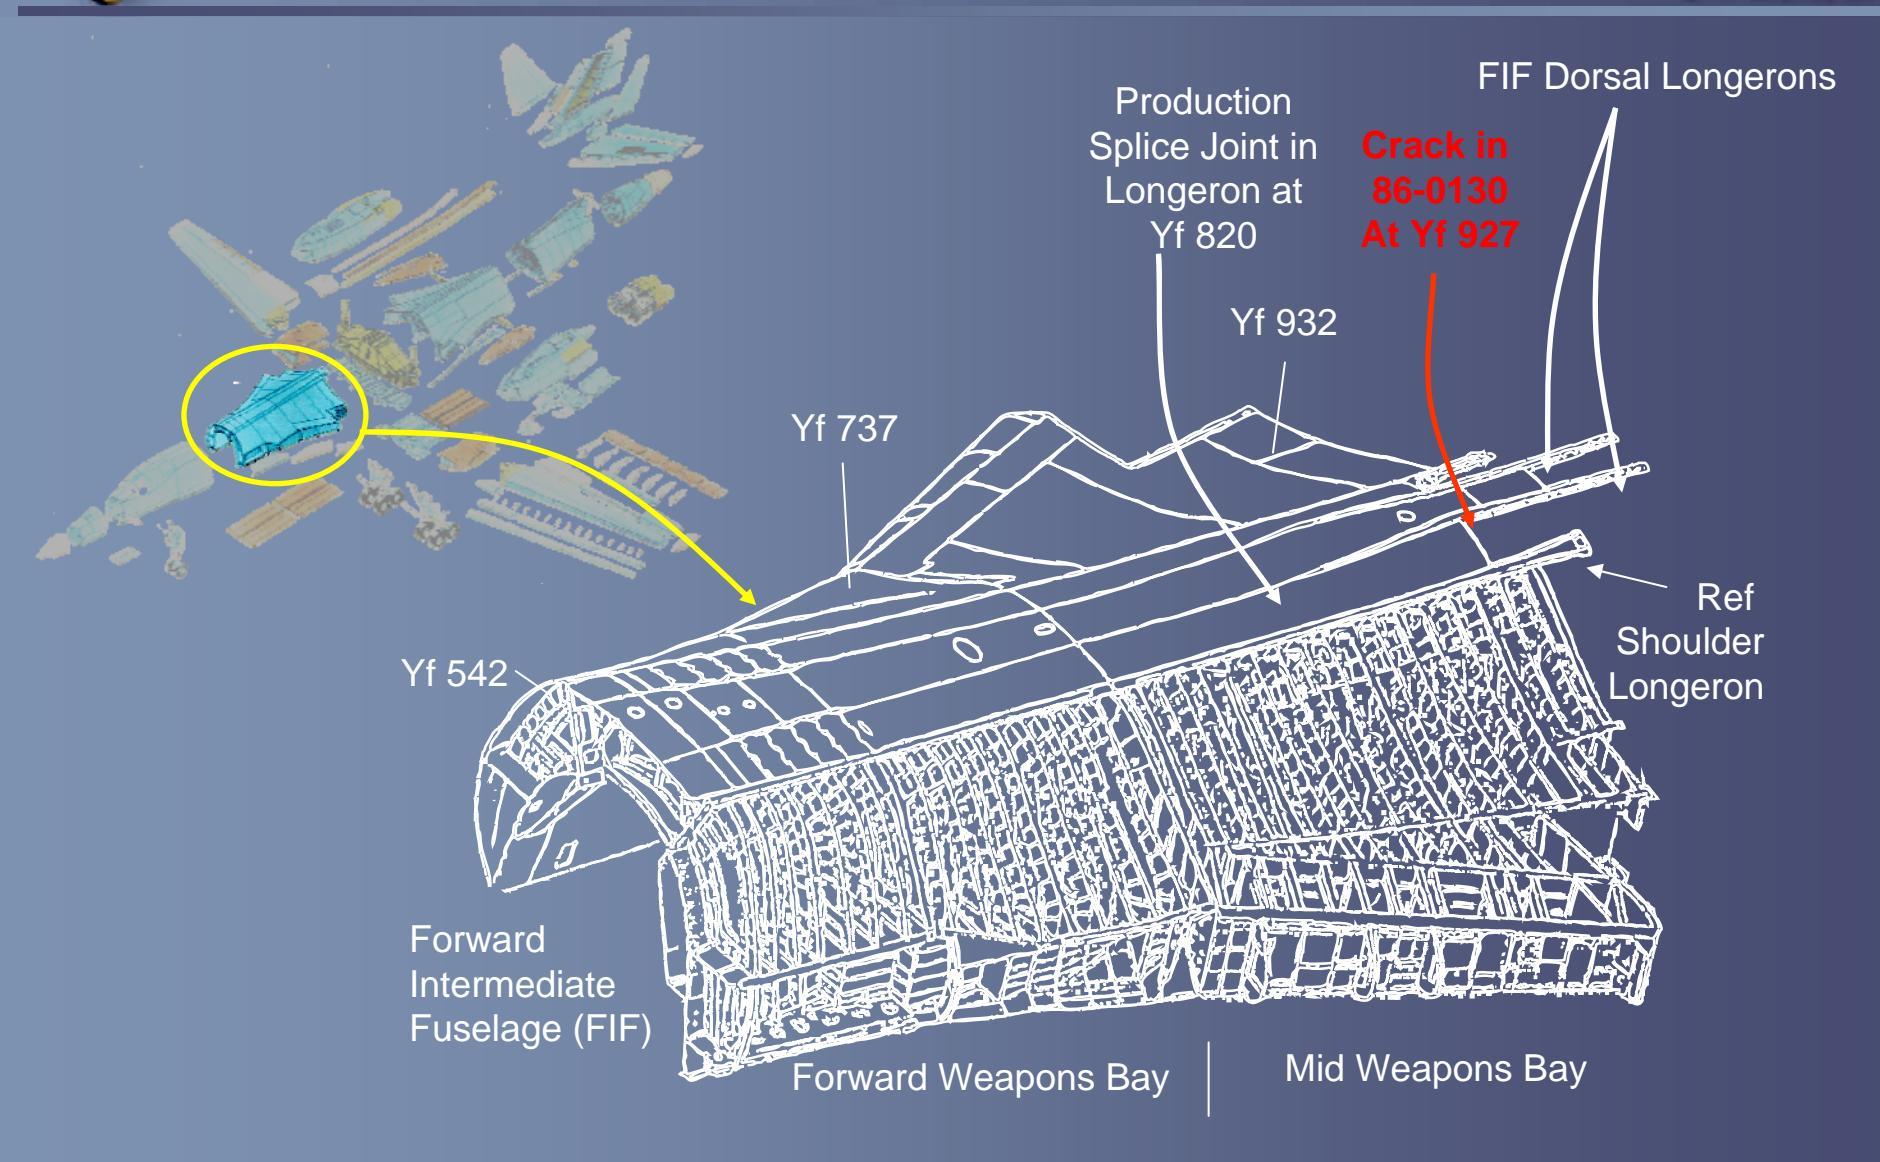
Background of Dorsal Longeron Cracks

Cracks begin at bolt hole and run to bottom of flange. Cracks growing up from bolt hole advance rapidly.

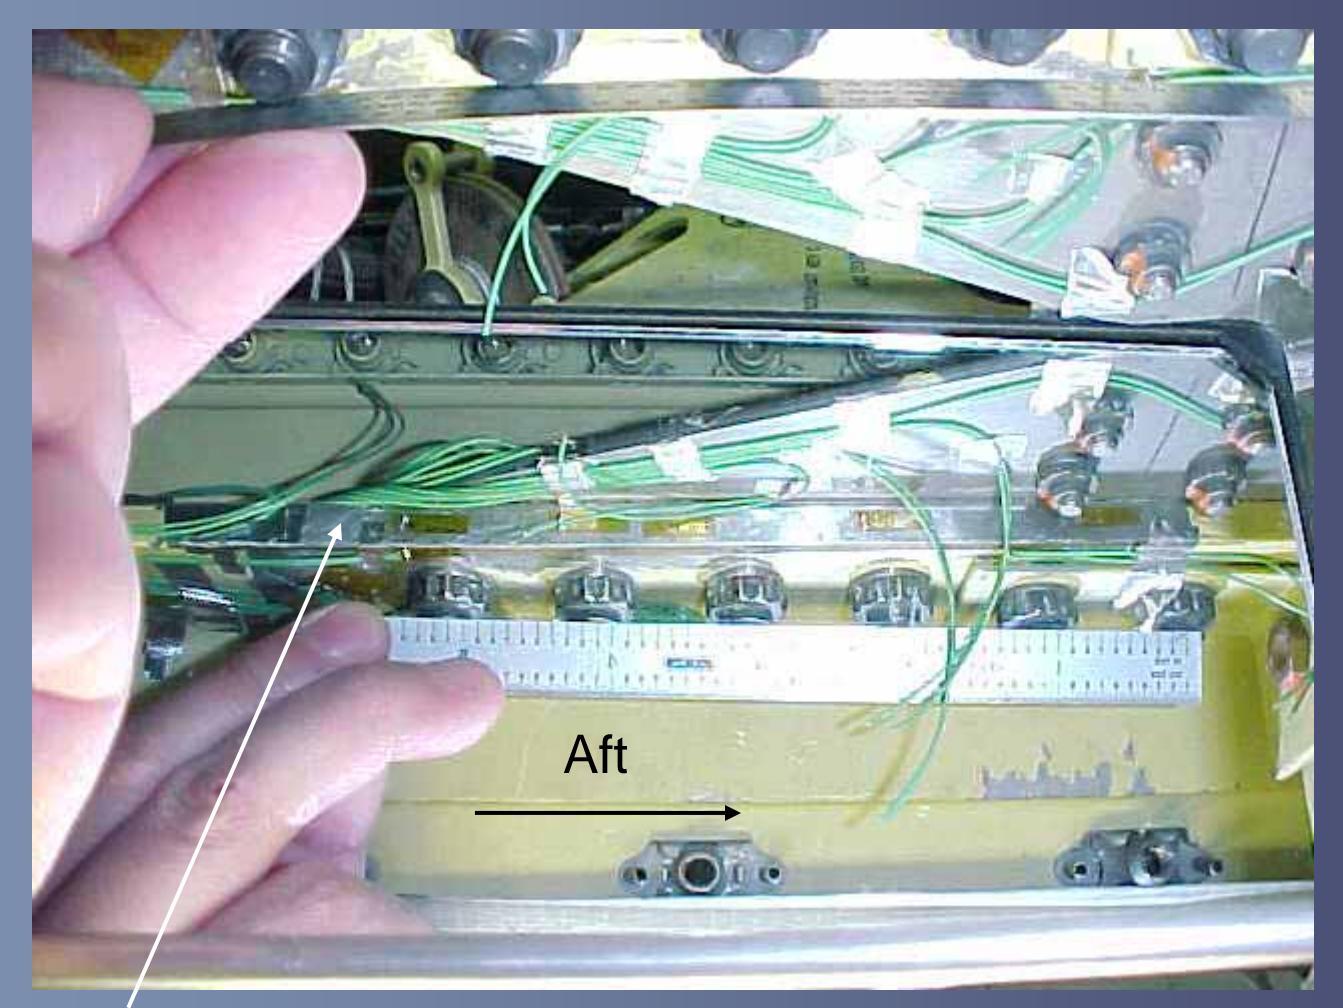
Predicted vs Measured Stresses – Gage Locations

Lower Edge Surface of Longeron Standing Leg

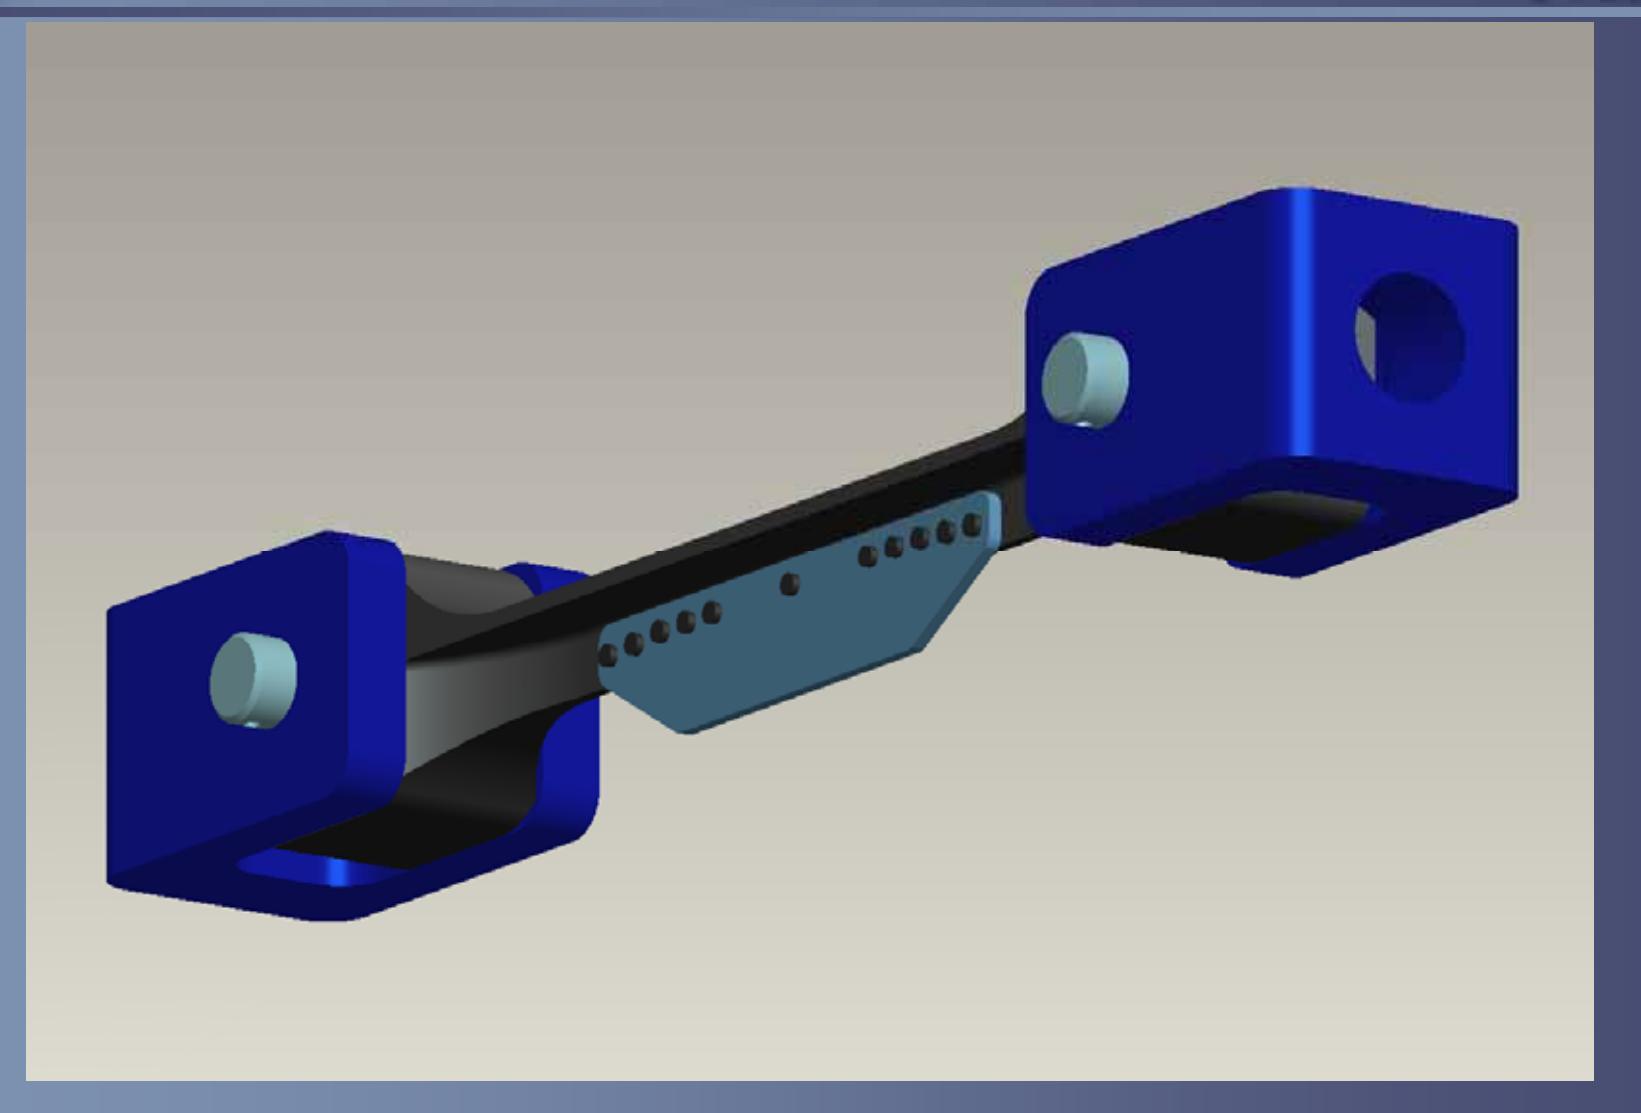
Coupon to demonstrate cause of cracking

- Demonstrate that cause of cracking is understood
- Validate models and spectra
- Baseline Test specimen
 - Simulates cracked area, match stress around 1st hole
 - Symmetric about center to obtain 2 samples of data
- Test load spectrum
 - Based on latest actual A/C usage (2003 DADTA)
 - 100 flight block
 - Very few negative loads in spectrum removed
 - Cycles with low range removed
 - Account for insignificant amount of damage
 - Reduce number of cycles needed for test
 - Minor adjustments made to remaining cycles to analytically match predicted life
- Duration 2 A/C lives or catastrophic failure
- Periodic bolt hole NDI

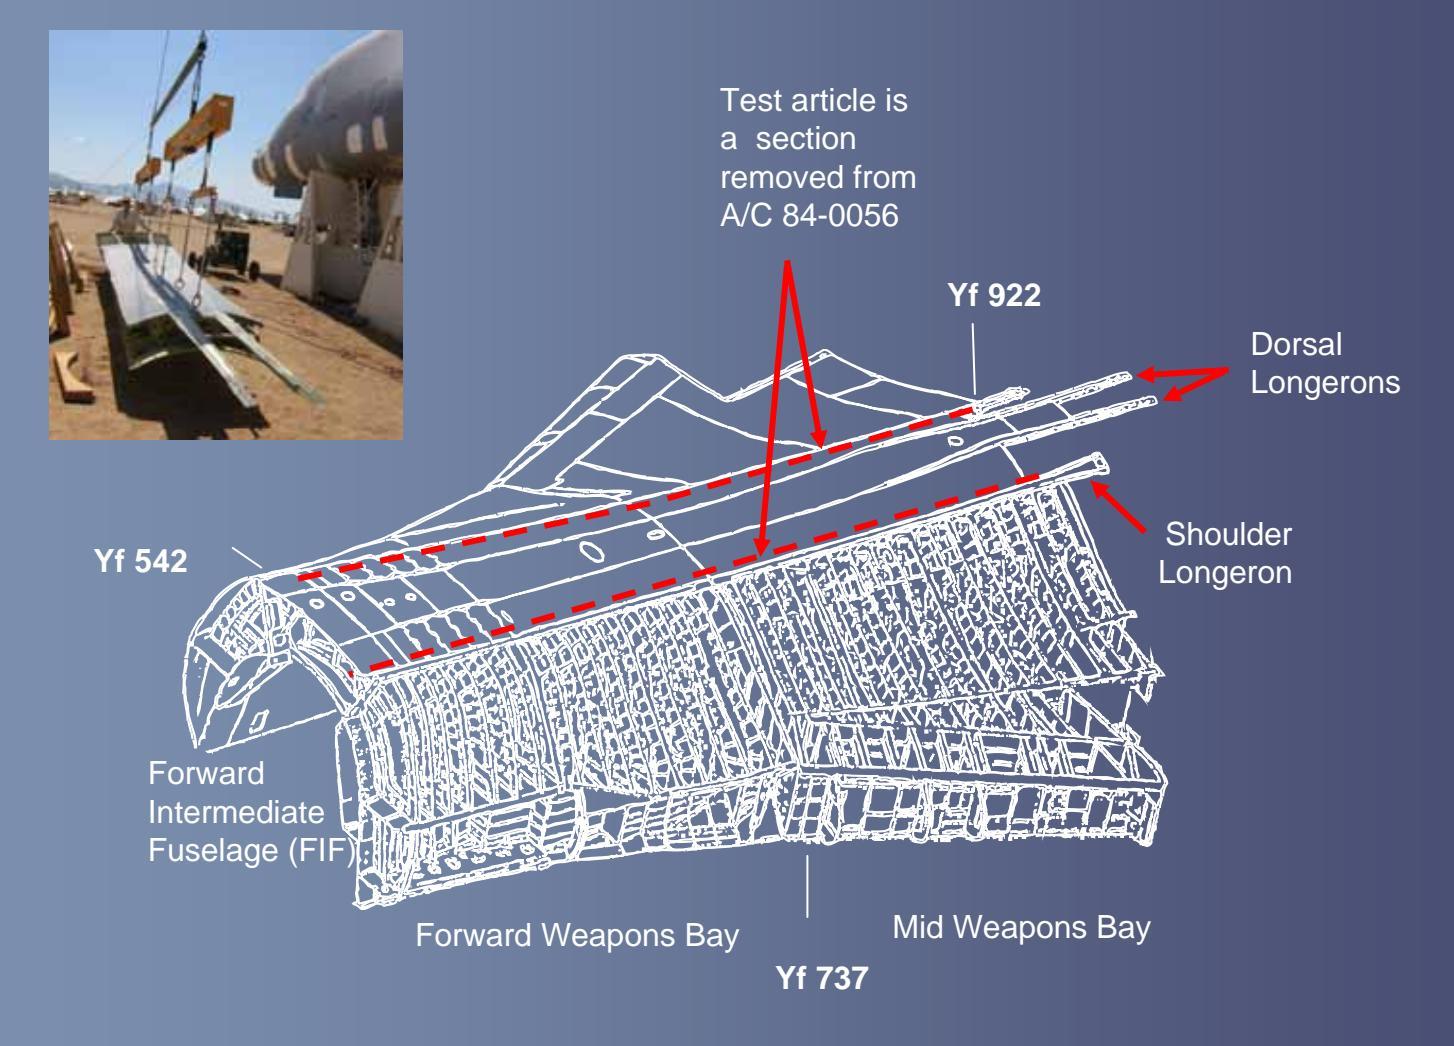
Full Scale Fatigue Test Article

Reclaimed structure from retired B-1 at AMARC

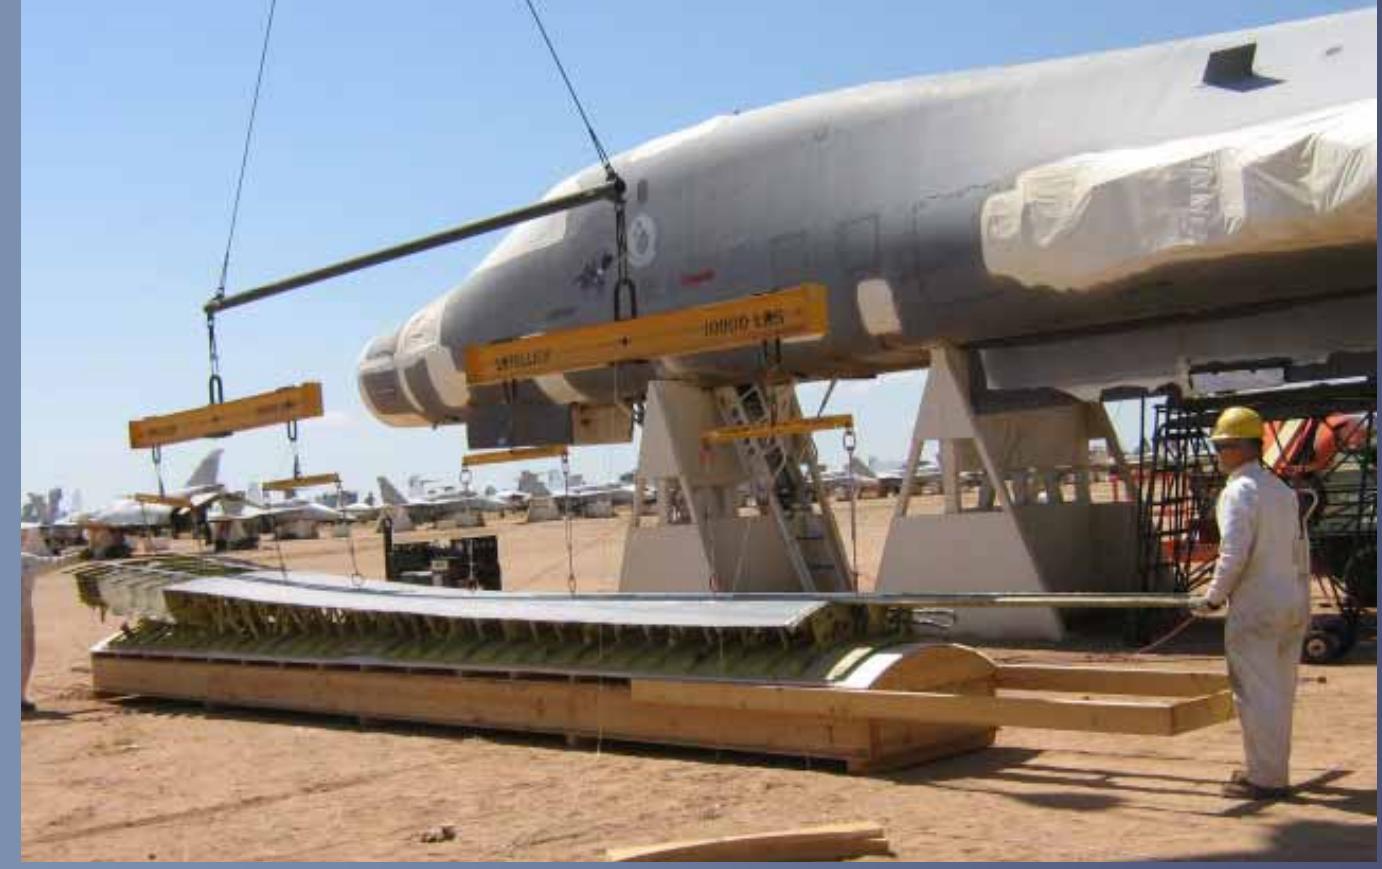
- Test article Yf 542-Yf 992, A/C 84-0056
 - No crack in either of dorsal longerons
 - Accumulated 4720 flt hrs (Fleet avg = 5556, Max = 7178, 06/2006)
