Bonded Repair of a F-16 Bulkhead Flange

David Wieland, Southwest Research Institute

Matt Malkin, Boeing Phantom Works

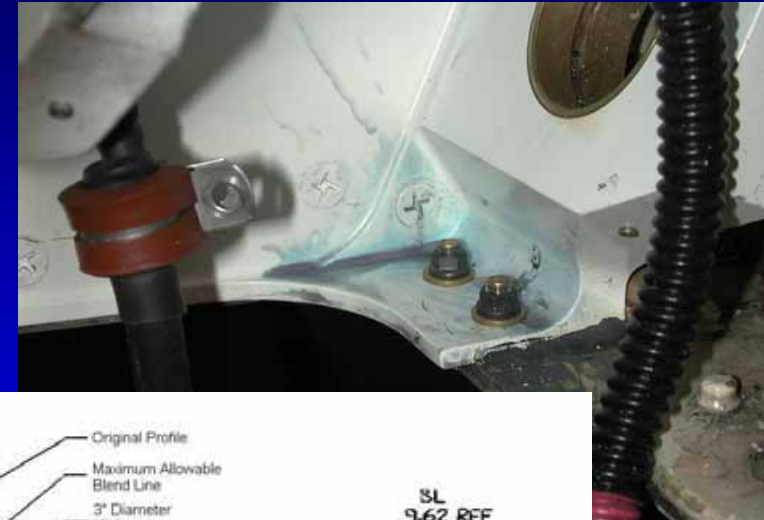
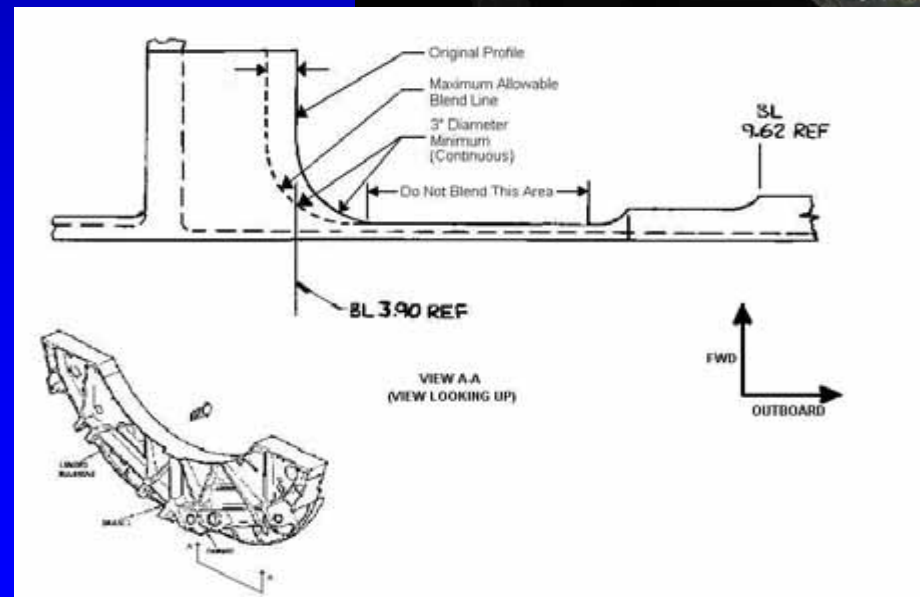
F-16 341 Bulkhead Longeron Attach Flange Radii

- Fatigue crack
- Small radii
- Current repair
 - Blend out crack
 - Replace fitting when cracks to large

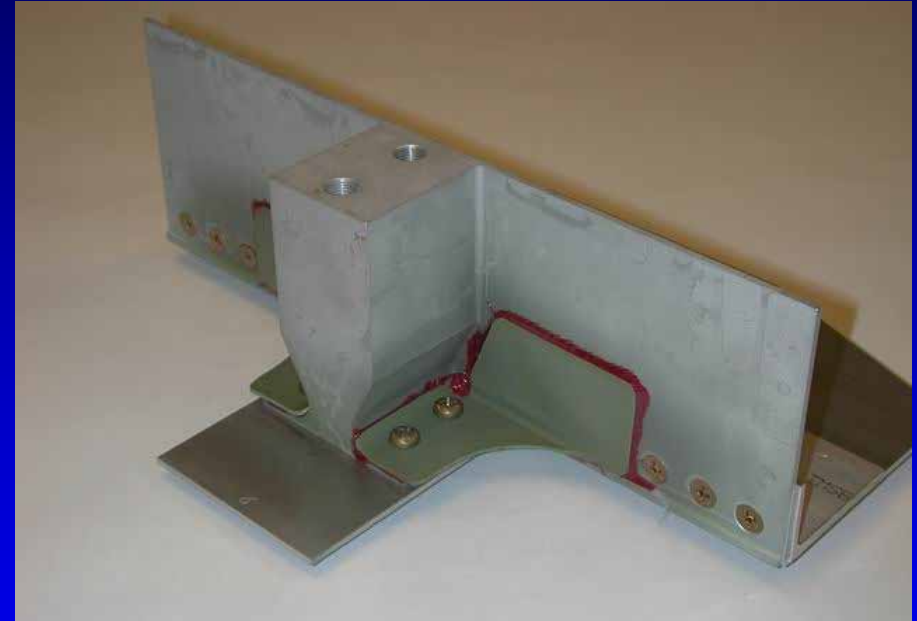
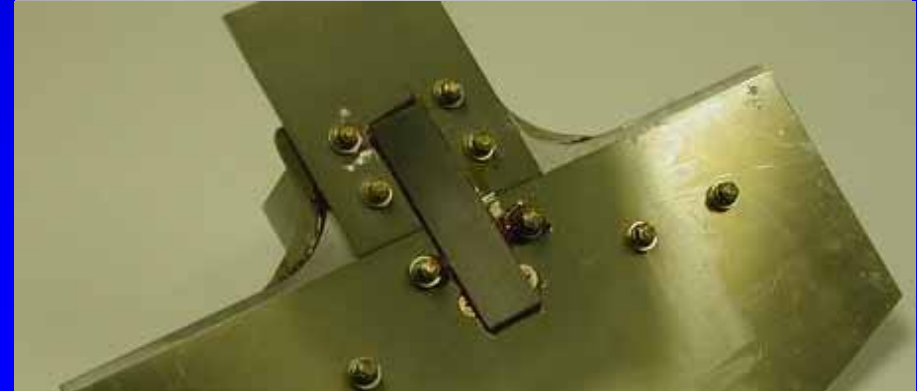
Repair Redesign Coupon

- 0.08 inch thick 2024 aluminum doubler with 1.5 inch radius
- Composite keel patch
- Surface preparation
 - Grit Blast Sol-gel
 - AC130 Kit
 - Bonding Primer
 - Cytec BR 6747-1

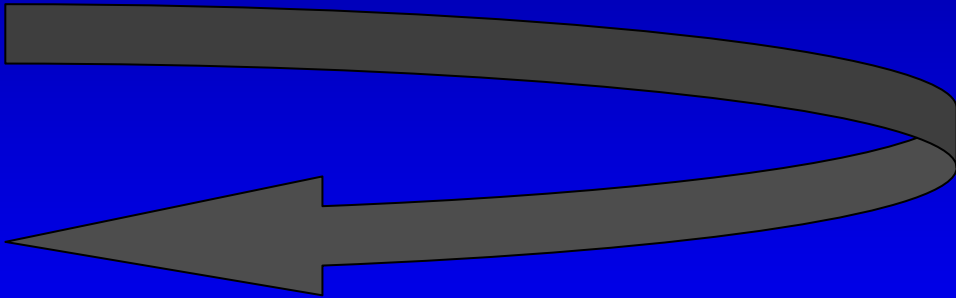
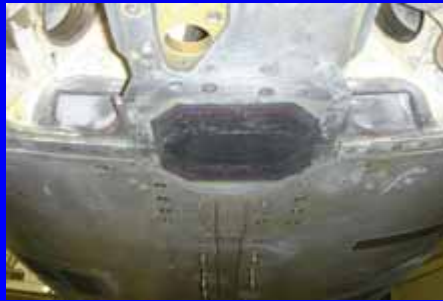
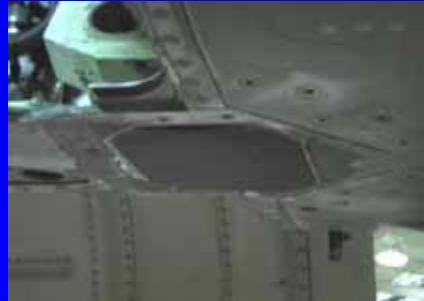
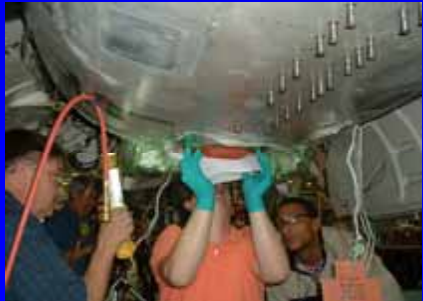
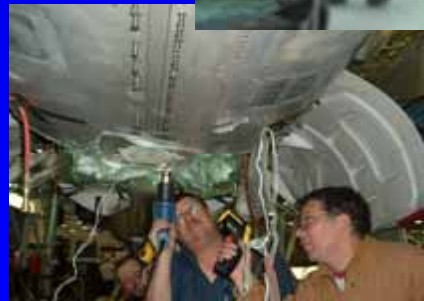
Prototype Repair Installation

- Based on analytical and test results, repair approved for prototype installation
- Repair installed at Hill AFB
- Will monitor repair performance for 12-18 months
- In active service since March 2006
