2006 USAF Aircraft Structural Integrity Program Conference

C-130 Center Wing MSD/MED Risk Analysis

28 November 2006

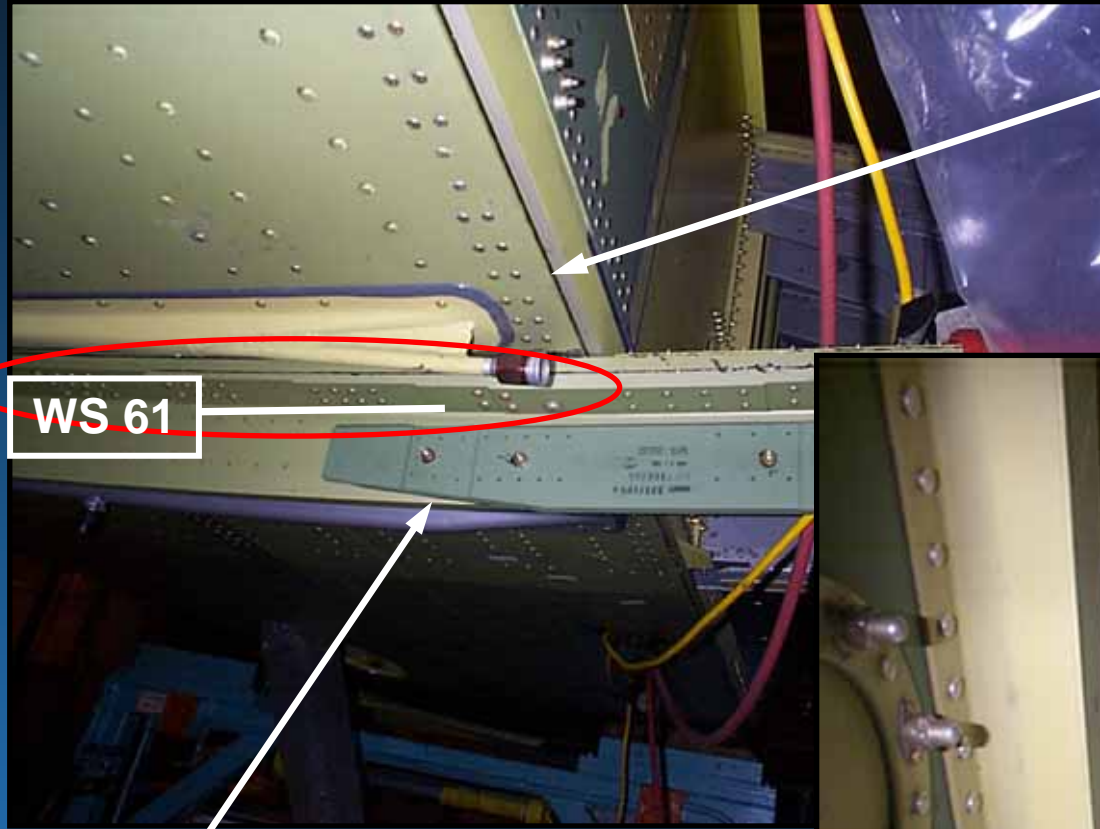
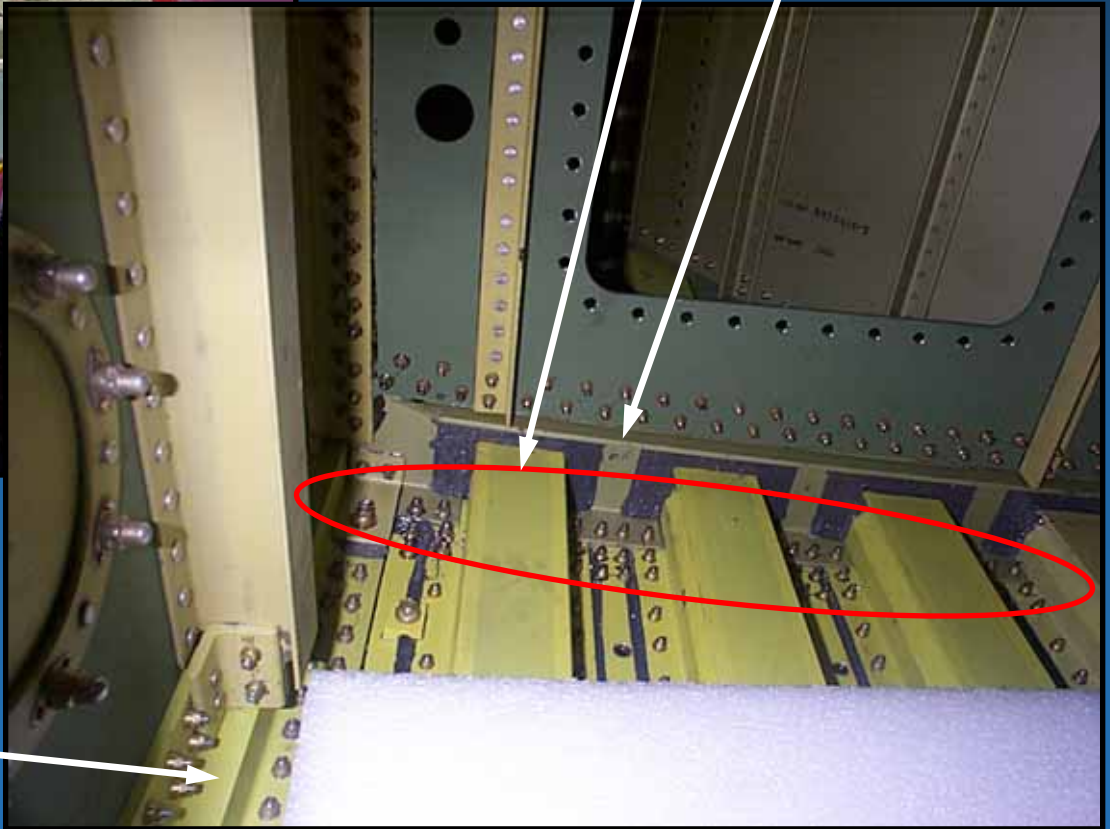
- Wing to Fuselage Attachment
- Susceptible to MSD and MED
- Difficult to Inspect (requires Bolt Hole Eddy Current) approx 300 Fasteners
- Jan '05 - 44 USAF A/C found with in-service cracking
 - Current total – 102 Cracks on 71 A/C
- Longest Service Cracks Discovered:
 - USAF 2.0 in.
 - Commercial 12.0 in.
- Critical Crack Size at Design Limit Stress = 6.5 in.

- **12 inch Fatigue Crack on L382 Commercial Aircraft:**

- MSD and MED
- 2 Internal Stringers also cracked at this location

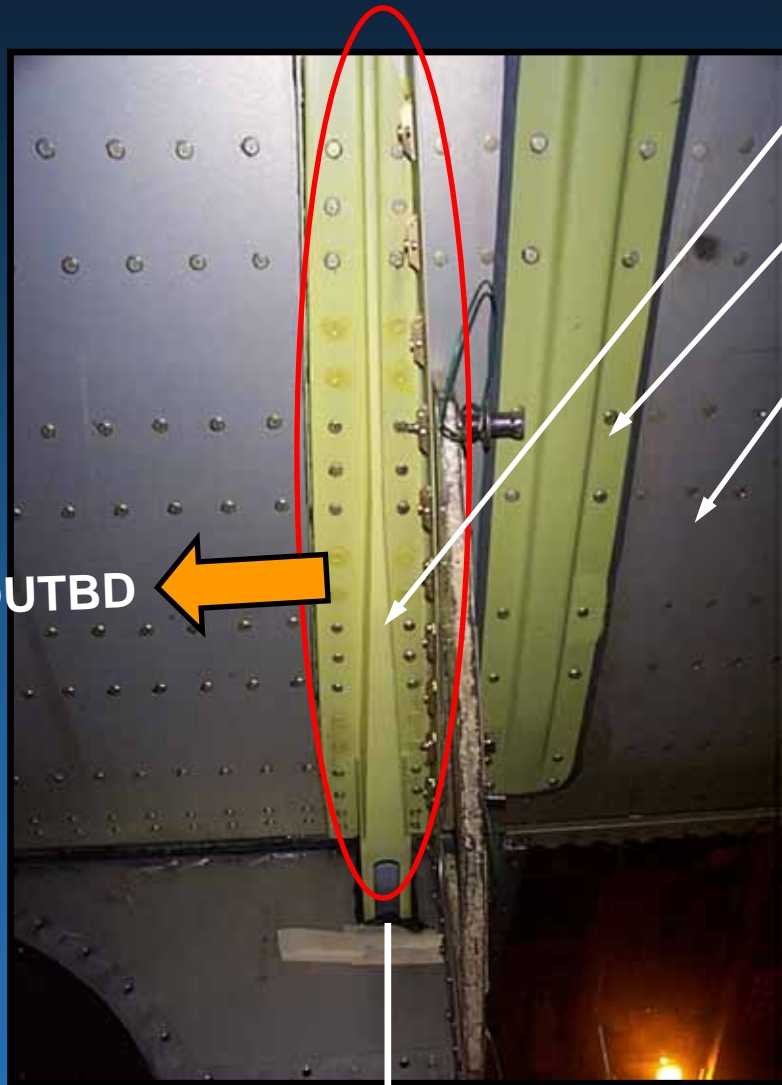
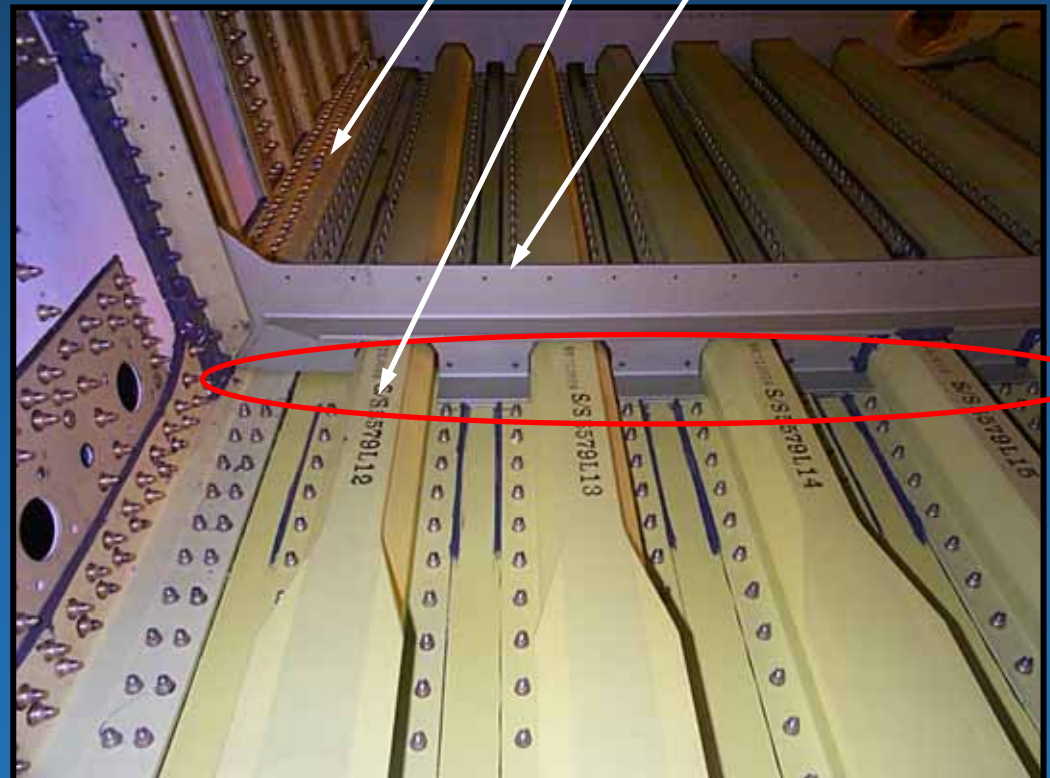
- Engine Nacelle Attachment to the Wing (WS 213 Similar)
- Requires Bolt Hole Eddy Current Inspection of approx 160 Fastener Holes
- Location of Center Wing Residual Strength Test MSD/MED Failure
- 28 A/C found with in-service MSD/MED cracking:
 - *Front Beam Cap*
 - *Skin Panel*
 - *Stringer*

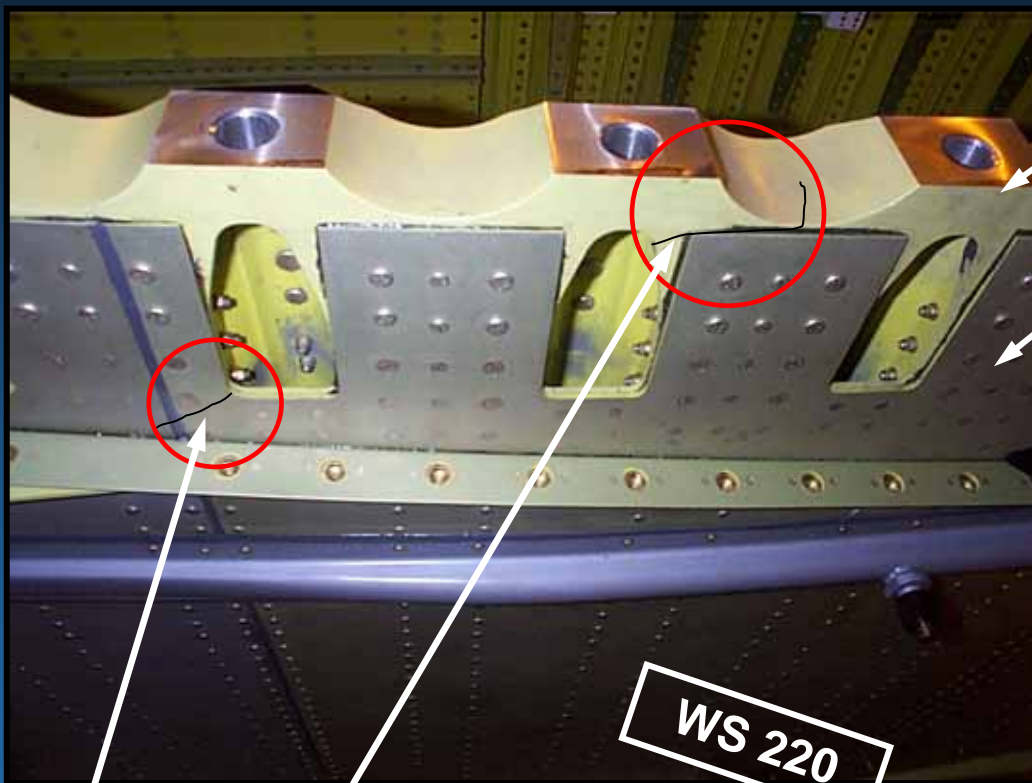
- Center Wing to Outer Wing Production Joint
- Wing Joint Fitting has 13 “Nodes”:
 - Prone to MSD Cracking
 - Short “critical” crack length (0.07 in.)
- 35 A/C documented with in-service MSD/MED cracking:
 - Multiple Node Cracks
 - Adjacent Panel Cracks
- Three adjacent Node cracks reduce strength to below Design Limit

Typical Panel Crack

Typical Fitting Crack

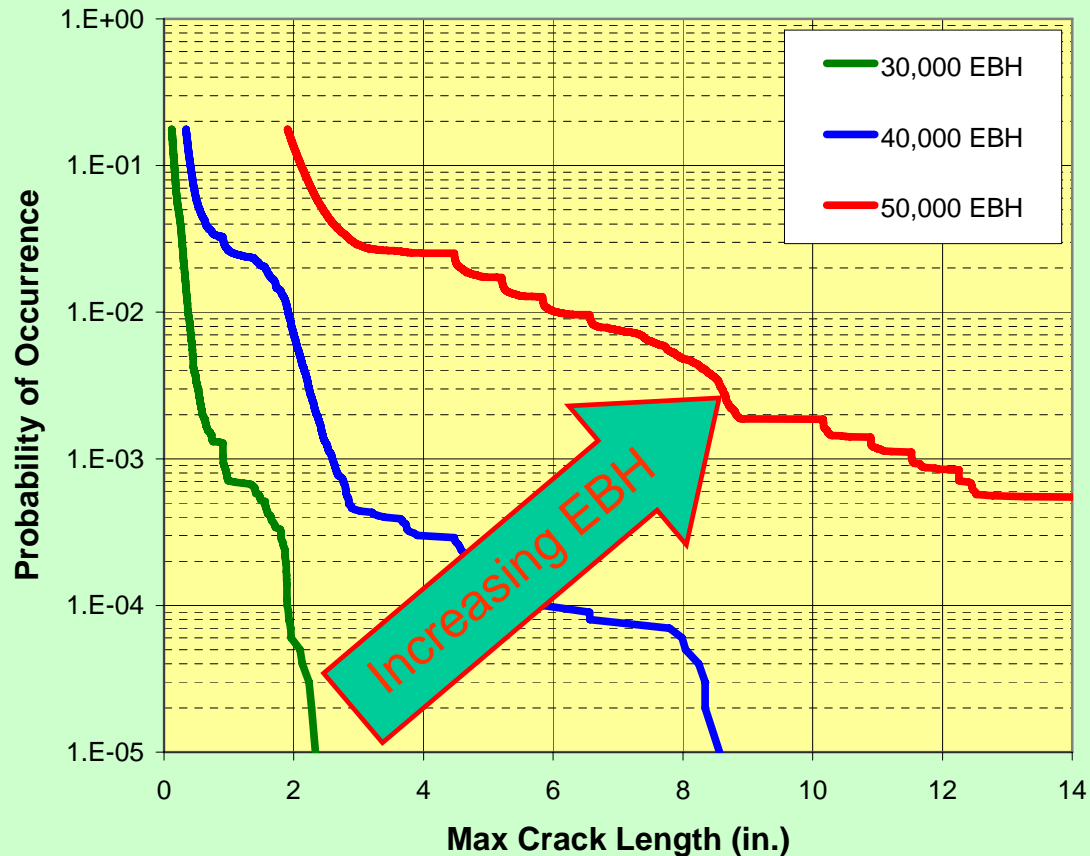
**MSD Max Crack Size Probability Distribution
Zone 1 - Lower Surface Panel at WS 61**

- Results of MSD Crack Growth Analysis
- Determines the probability of a MSD Crack of a given size in increments of approx 350 EBH
- Probability Distributions determined for No Inspection and Including Inspection

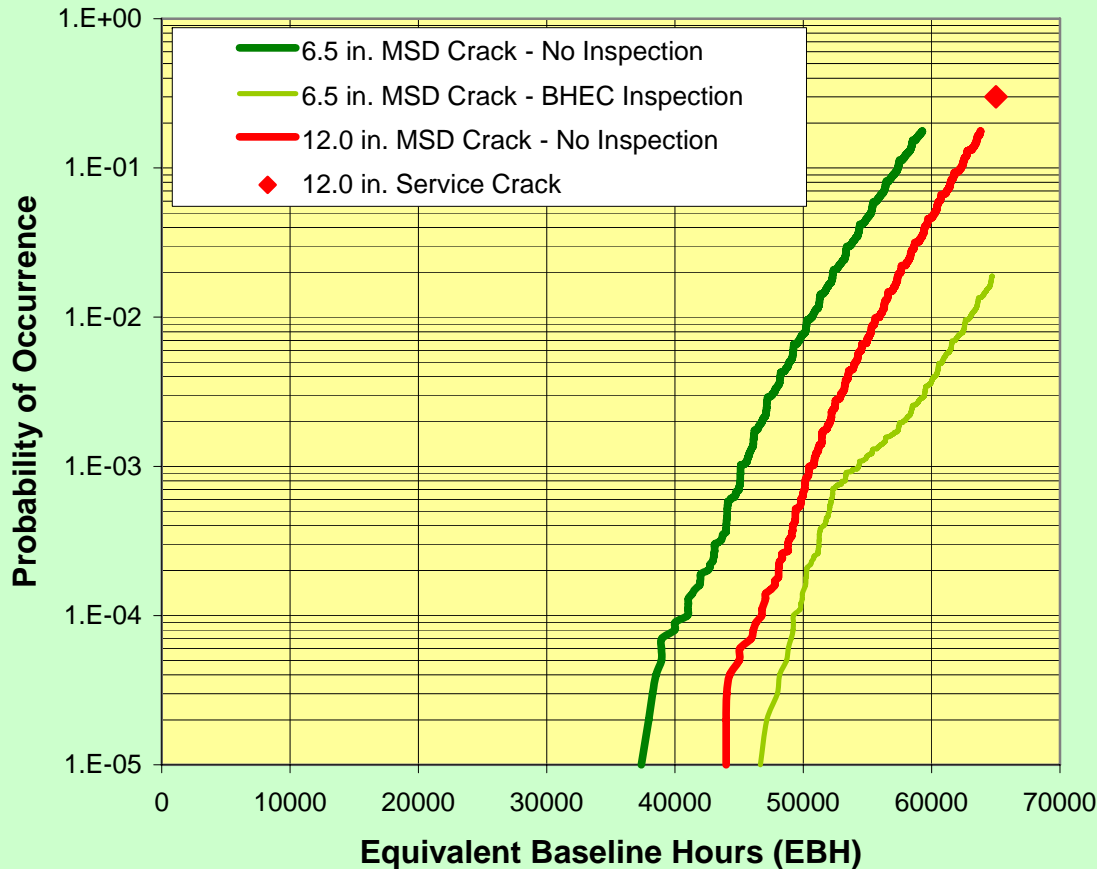
**MSD Crack Probability vs EBH Distribution
Zone 1- Lower Surface Panel at WS 61**

- Results of MSD Crack Growth Program
- Probabilities of a given crack size vs EBH
- Probability of MSD Link-up rises rapidly beyond 40,000 EBH without inspection

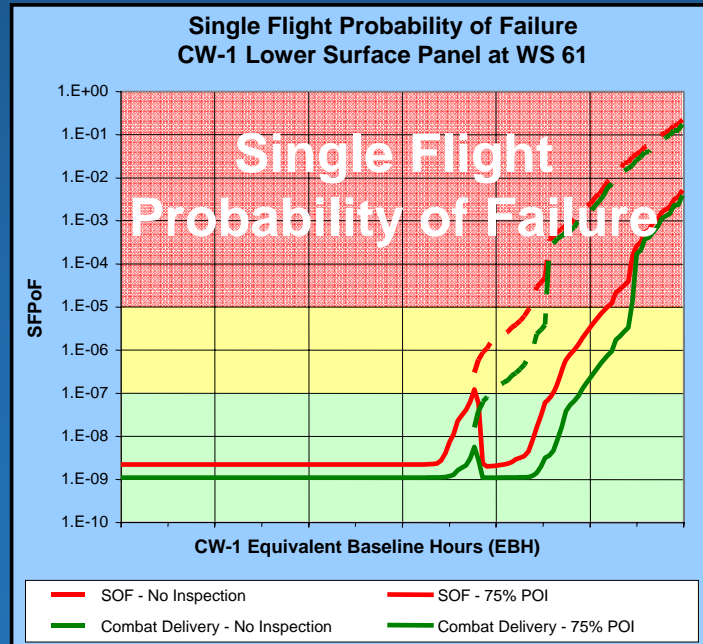
Single Flight Probability of Failure CW-1 Lower Surface Panel at WS 61

- **Conclusions of the Lower Surface Panel Risk Analysis:**
 - *MSD Cracking Scenario results in higher Risk probabilities than the single dominant fatigue crack*
 - *Mitigation by inspection is possible, but much uncertainty remains in the Probability of Detection (POD) and Probability of Inspection (POI) due to the large number of fastener holes requiring inspection*
 - *Previous discrete source damage analysis has shown that the Probability of Failure is unacceptable should a single panel fail at 35,000 EBH or higher*

Risk Mitigation Strategy Must Ensure A Panel Failure Does Not Occur

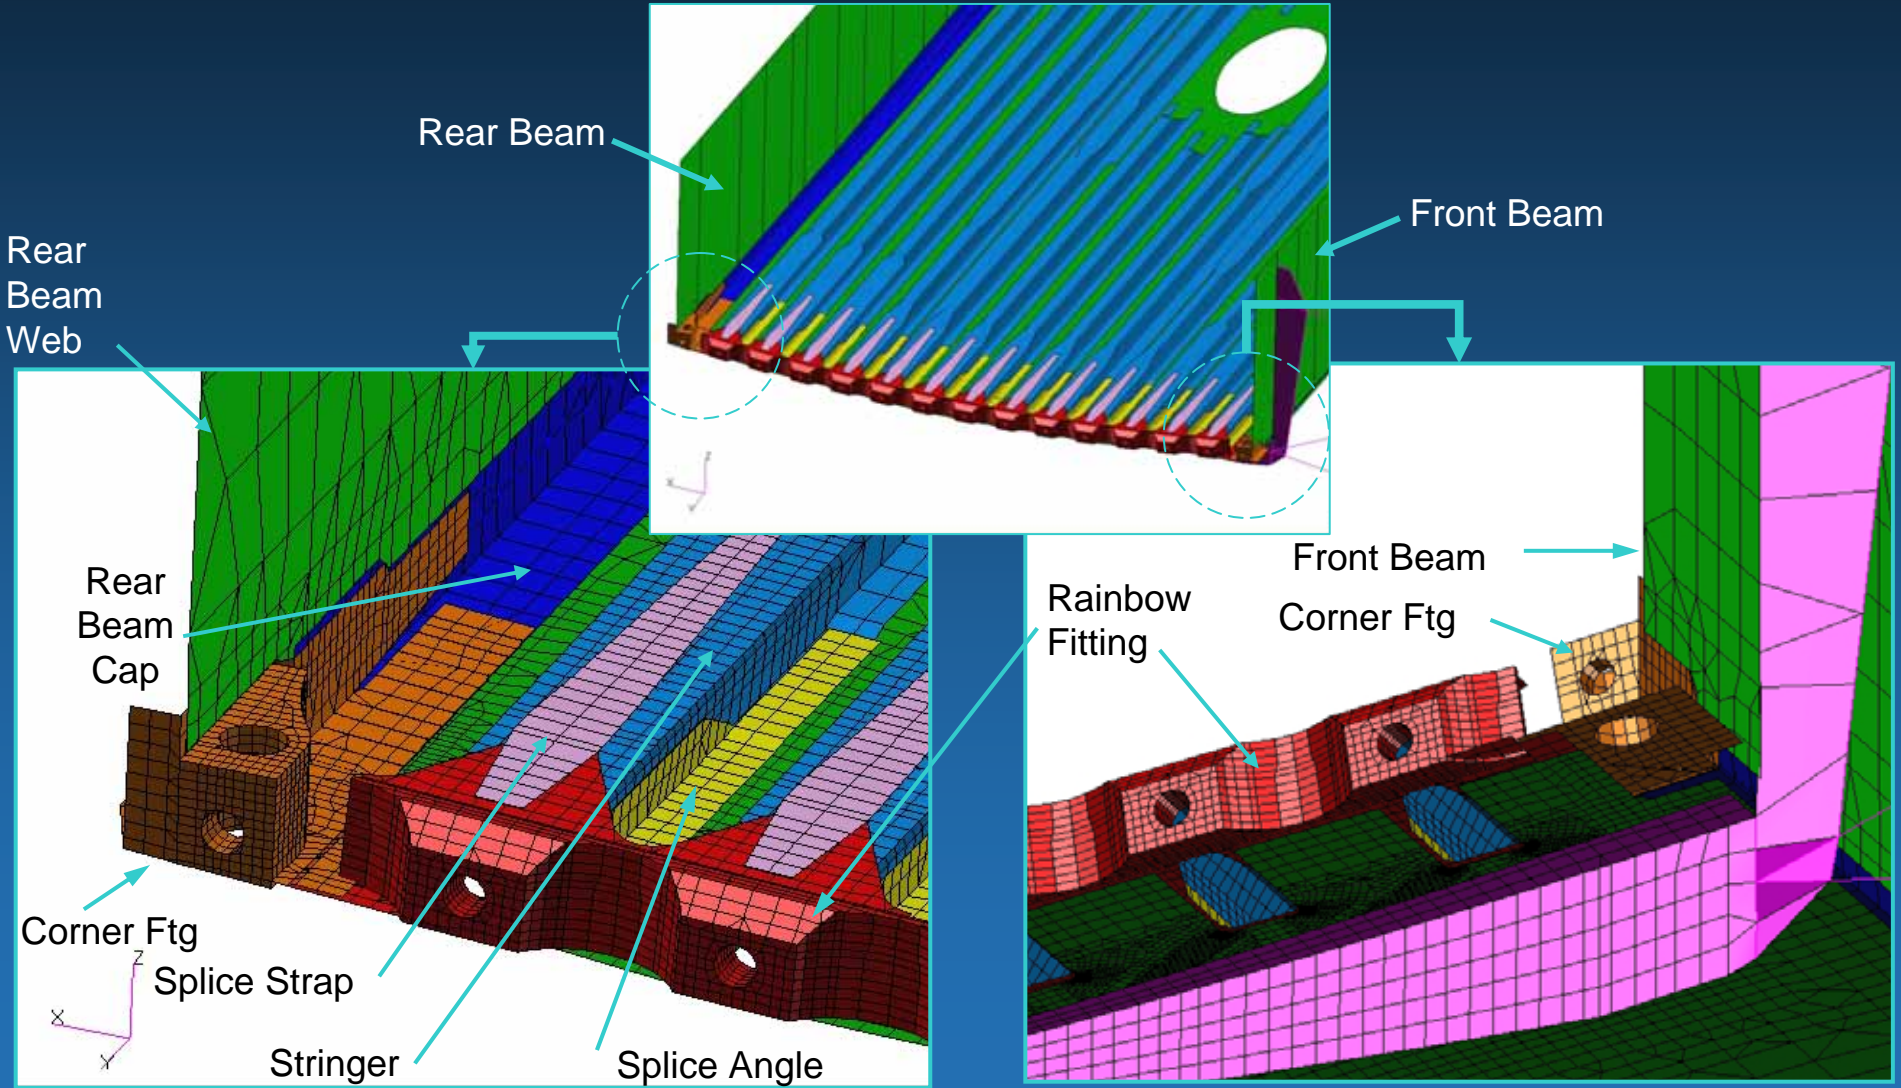
Wing Joint Area FEM

- **Conclusions of Finite Element Model Analysis:**
 - *“Critical” Crack Length in Node is short (0.07 in.)*
 - *Crack arrests up vertical face between nodes at 2.5 in.*
 - *No effect on Bolt Load Distributions until the fatigue crack fractures across the Node (i.e. is 2.5 in. in length)*
 - *At Design Limit Load, Structure can tolerate:*
 - up to 2 adjacent Nodes fractured
 - up to 5 Nodes fractured, as long as none are adjacent

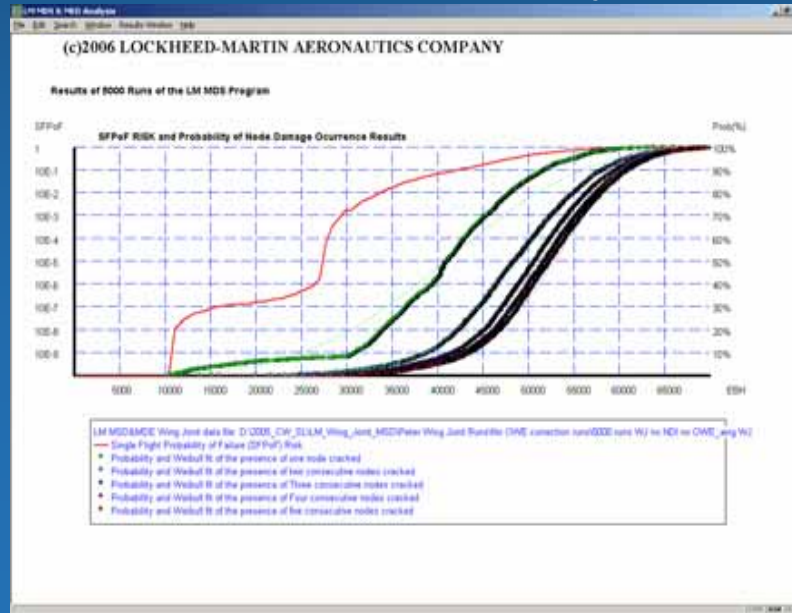
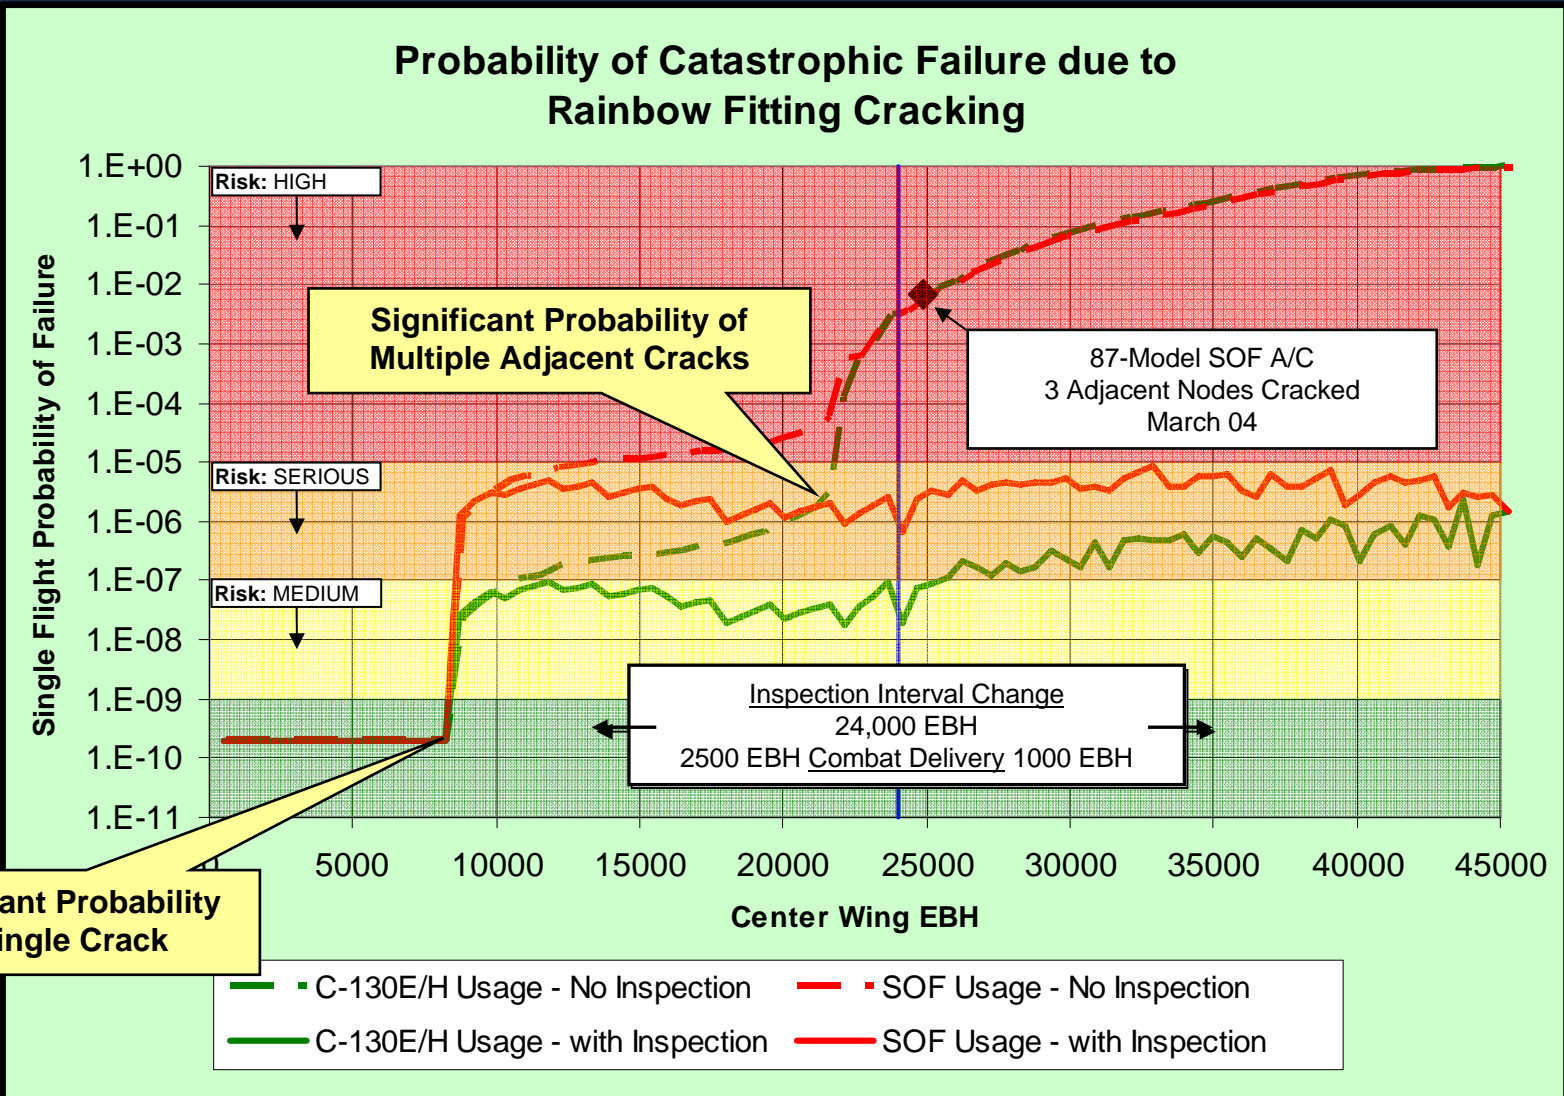
MSD Risk Analysis

- **Conclusions of Wing Joint Fitting Risk Analysis:**
 - *Substantial increase in SFPoF when one node fractures*
 - *Risk is **Unacceptable** if two adjacent nodes fracture*
 - *Risk can be Mitigated by continued Inspection, but replacement before 25,000 EBH is the preferred option:*
 - Short Inspection Interval Required beyond 24,000 EBH raises concern for NDI complacency
 - 20% Probability of at least one node fractured at 24,000 EBH

Risk Mitigation Strategy Must Include Inspection and Replacement
