# F/A-18E/F FULL SCALE STRUCTURAL FATIGUE TESTING

ASIP December 6, 2007

**Timothy N. Callihan**

The Boeing Company – Integrated Defense Systems

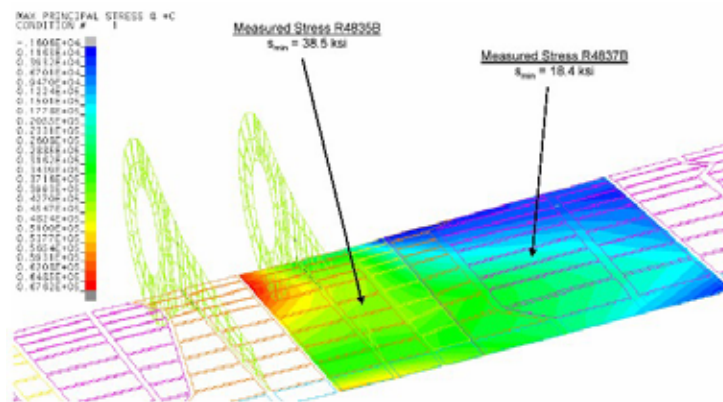
The possibility of the crack being the result of improperly applied loads was considered. However, a review of the applied loads and CDFM data showed that the applied spectrum was within the acceptable tolerance. Detailed, p-version finite element models (shown in

Figures 12 through 15) were constructed to confirm the stress state at the critical fastener holes in the failed part. The FEM results contributed to a predicted crack initiation life of 20,000 SFH and a 15,000 SFH predicted crack growth life – an indication that this was not a case of poor design or insufficient analysis. As part of the failure analysis process, the failed part was examined using a scanning electron microscope (SEM) to search for manufacturing defects or other anomalies. A 'rogue flaw' was found at the failed hole as shown in Figure 16. This flaw was determined to be a manufacturing induced scratch along the bore of the fastener hole.

Figure 12 – Strain gages were used on other test articles to validate the finite element model results
