Test Demonstrated Damage Tolerance of F-22 Wing-Attach Lugs with ForceMate™ Bushings

M. Cayton, J. Bunch, P. Walker
Boeing Integrated Defense Systems

J. Brown, T. Brussat
Lockheed Martin Aeronautical Systems

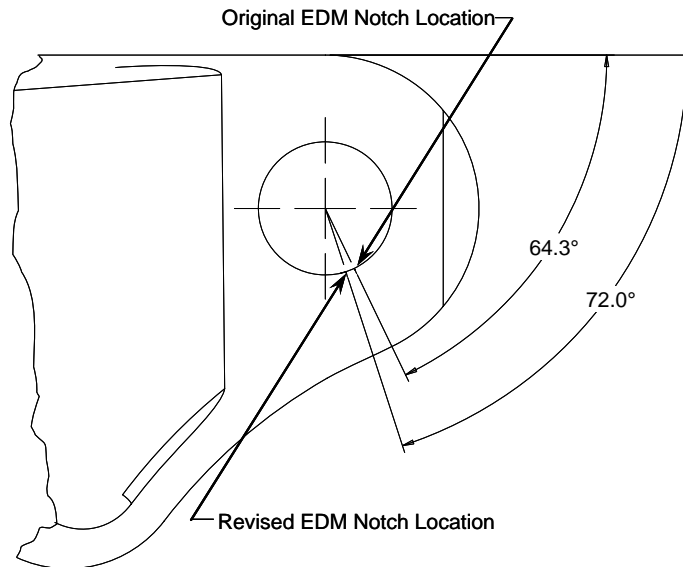
Figure 8 Location of EDM notches used to initiate the crack. The original specimen design had the EDM notch at the precise orientation as the cracking on the full scale fatigue test.

Orientation of notch is shown in Figure 8. Orientation of 64.3° corresponds to the location of cracking observed on the full scale fatigue test, while 72.0° corresponds to the location of the peak stress

This process replicates the scenario of a rogue flaw present at the time the bushing was installed into the lug, and by following these steps, a crack-like defect approximately 0.045 to 0.050 inches in size was placed into the specimen at the time of manufacture. Having a true crack like defect also provided for the most conservative test and most closely represented the analytical case.

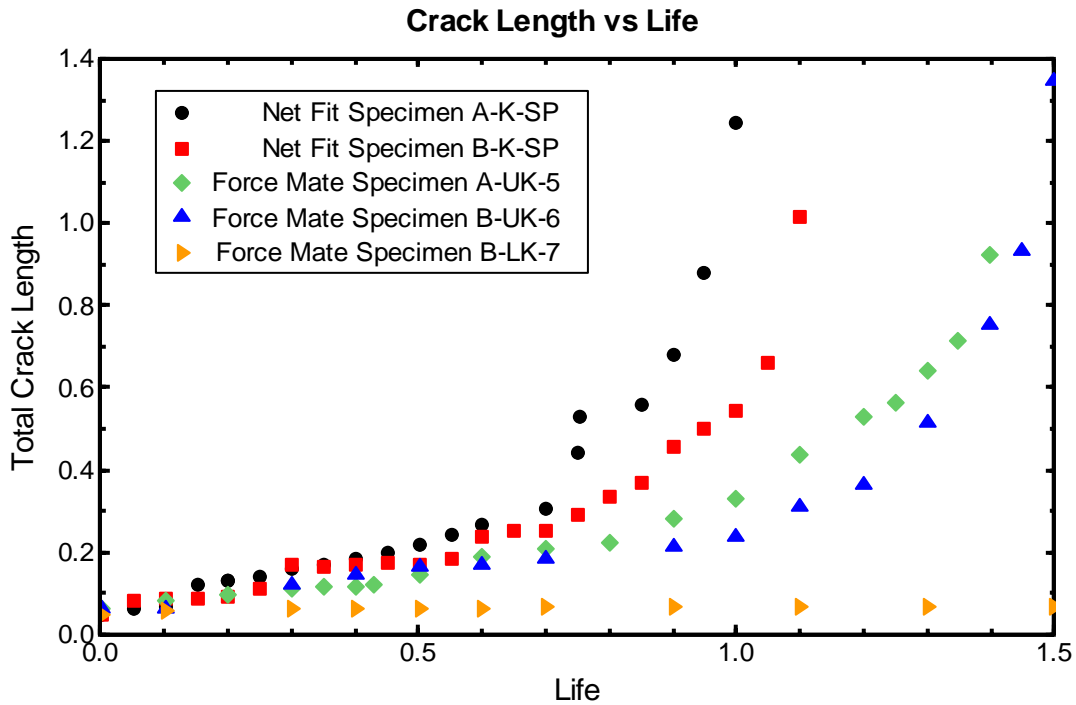
Figure 10 Test results plotted as crack length vs spectrum fatigue life

The results of the net fit bushing tests are presented in Figure 10 as a plot of crack length vs Spectrum lifetime. The test results for both A-K-SP and B-K-SP are both very repeatable when plotted in this manner and the fracture surfaces of these specimens were typical for a coarse grain titanium alloy. Most notably, failure occurred by a crack growing from the induced pre-flaw. Ultimately the specimens failed in net section yield.

Neither of the specimens B-LK-7 nor B-UL-4 failed during spectrum fatigue testing. The crack growth data obtained from B-LK-7 up to 1.5 lifetimes is shown in Figure 10. The significance of this plot is the contrast to the other specimens plotted in this figure. Whereas, each of the other specimens had failed by 2.5 lifetimes the crack in specimen B-LK-7 had grown only to a length of 0.07 inches. The crack length after 10 lifetimes of testing was 0.132 inches, still significantly short of critical crack size.

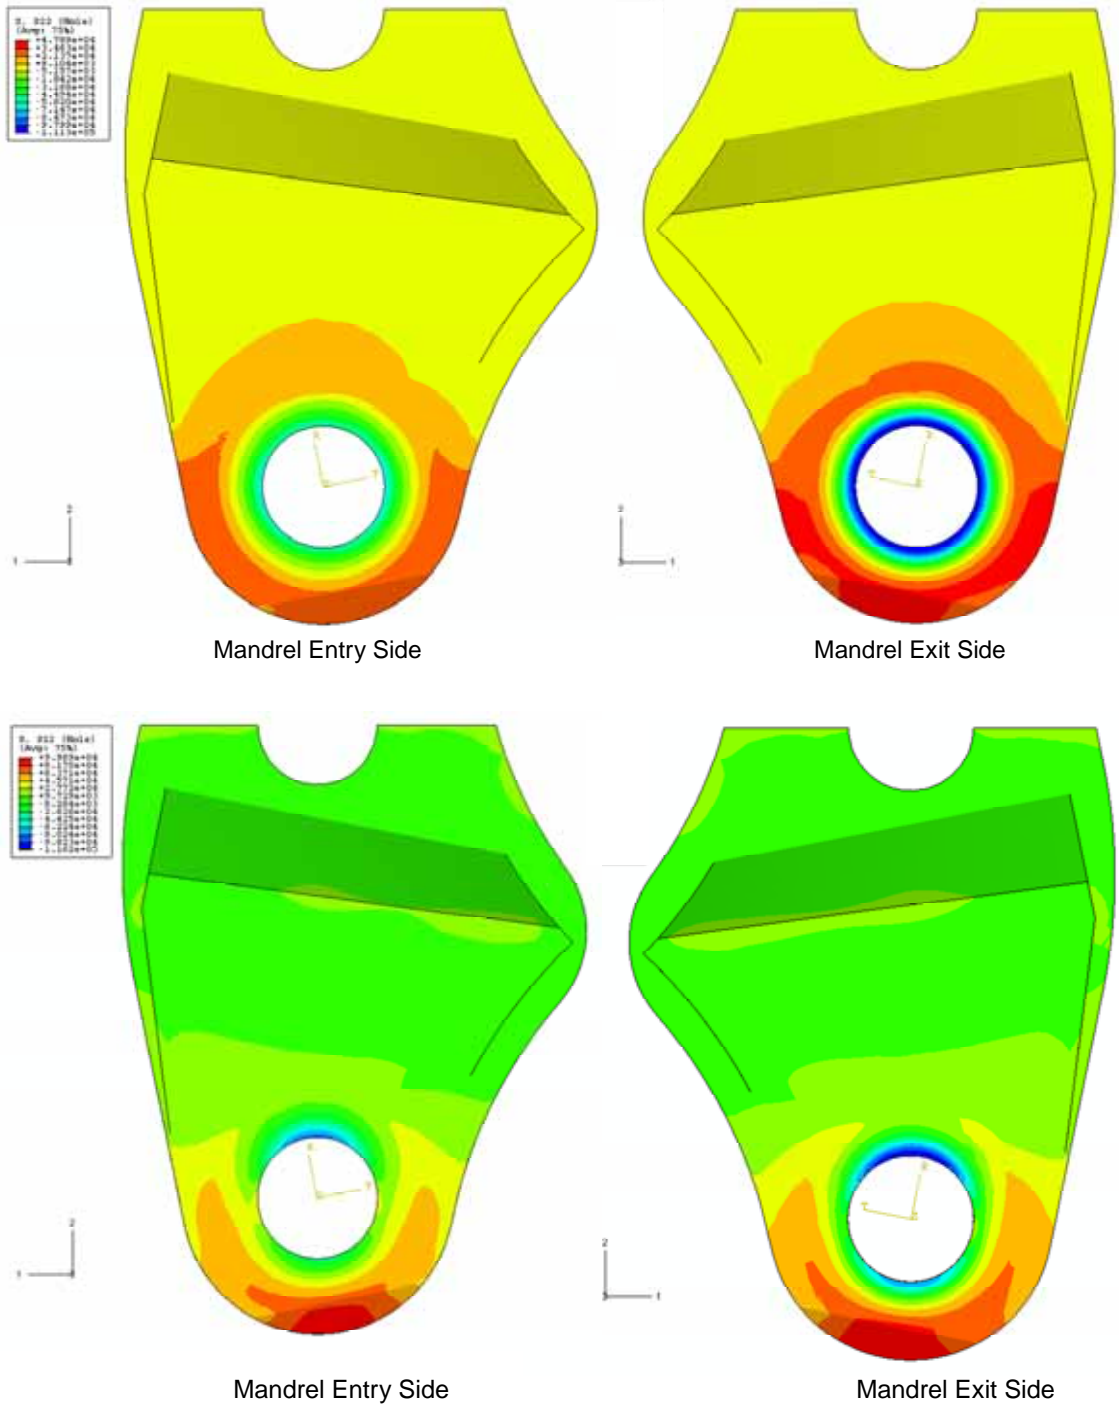
Figure 13 Finite element hoop stress contour plots with the revised bushing installed and 247 kip (1.1 MN) load applied

The values in Table 3 shown for the 3:00 position (the tip of the lug), are the lowest in magnitude. However, the lug nose is chamfered and the effect of this chamfer is to create a stress concentration. Figure 13 shows output from a finite element model created to provide additional clarification of the stress state in the test specimen with the increased expansion bushing. Regions of tension stress under applied loading are shown at the bushing on the mandrel entry side. This corresponds to the location where the EDM notch was placed in specimen B-LK-7. The peak hoop stress shown at the lug bore in for this load condition was 46.0 ksi, and the peak stress at the lug nose was 99.7 ksi. Figure 14 is a slightly different view of the finite element analysis contour plots showing how the stress locally peaks at the nose where the section is a minimum due to the chamfer. The chamfer is a necessary design feature to provide clearance into the mating clevis. The necessary tests and analysis to demonstrate that these stress levels did not create a new damage tolerance issue was performed, but is beyond the scope of this current work.

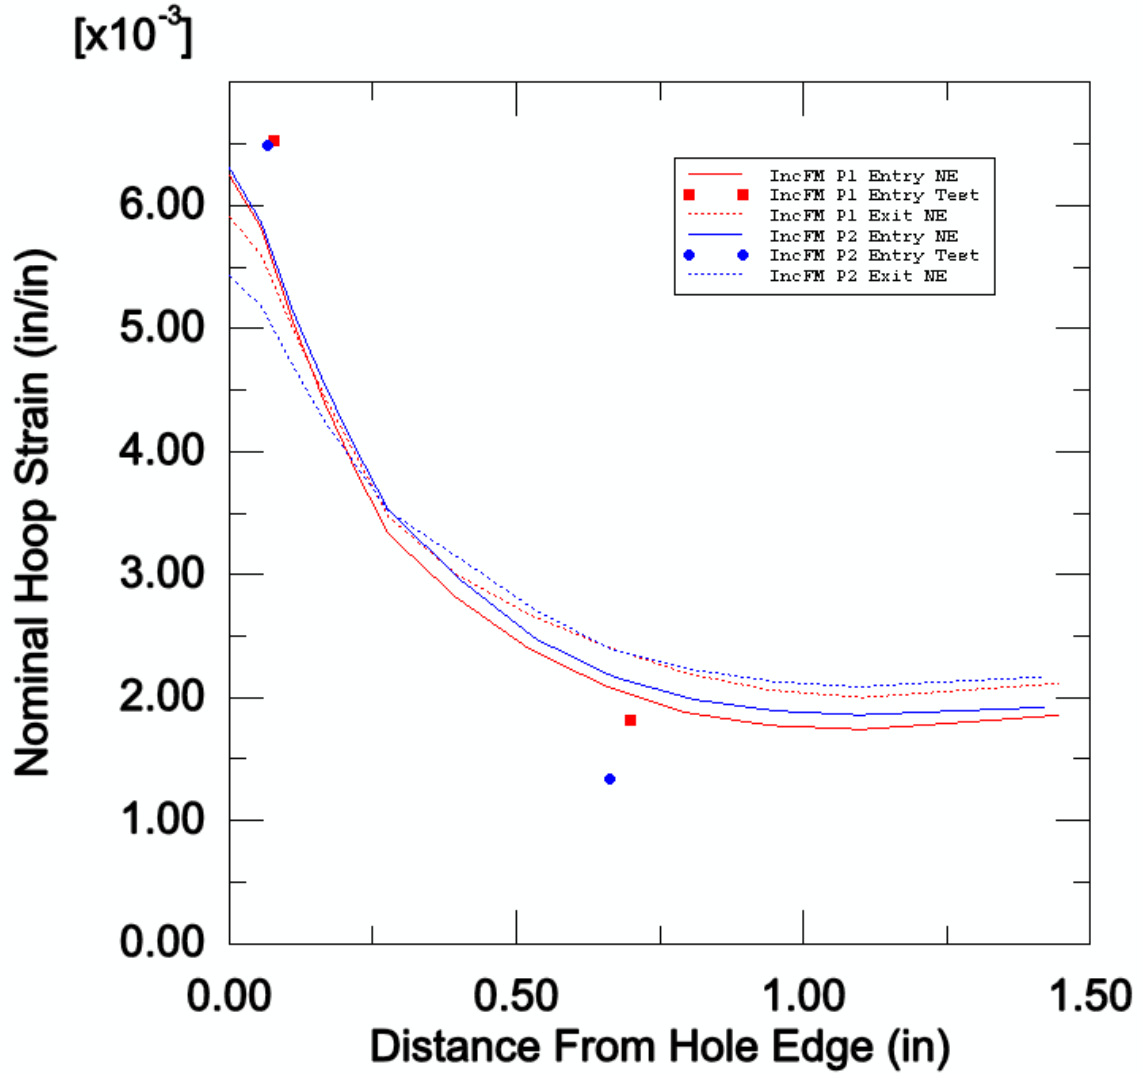
Figure 15 Increased ForceMate Bushing Installed Path Nominal Hoop Strain

The strain comparison between the FEA and the strain gages on the test lug with the revised bushing are provided in Table 4 and Figure 15. Figure 15 plots the hoop strain as radial distance from the hole edge, and the solid lines plot the strain on the mandrel entry side predicted by the FEM. The dotted lines plot the predicted strain on the mandrel exit side. The data from Table 4 is also plotted onto Figure 15, and three of the four strain gage measurements were within 20% of predicted values. The strain gage labeled number 4 in Table 4 was believed to not be accurate based on other experimental observations, but given the inherent uncertainties in strain measurements of this type, the relative close agreement between analysis and experiment gave confidence in the FEM methods used to model the process.
