# *New Structural Guidelines for Dent Allowables on Fuselages*

USAF Academy Department of Engineering Mechanics  
Center for Aircraft Structural Life Extension

# Aging Aircraft Repair Strategies Utilizing Cold Expansion Technologies

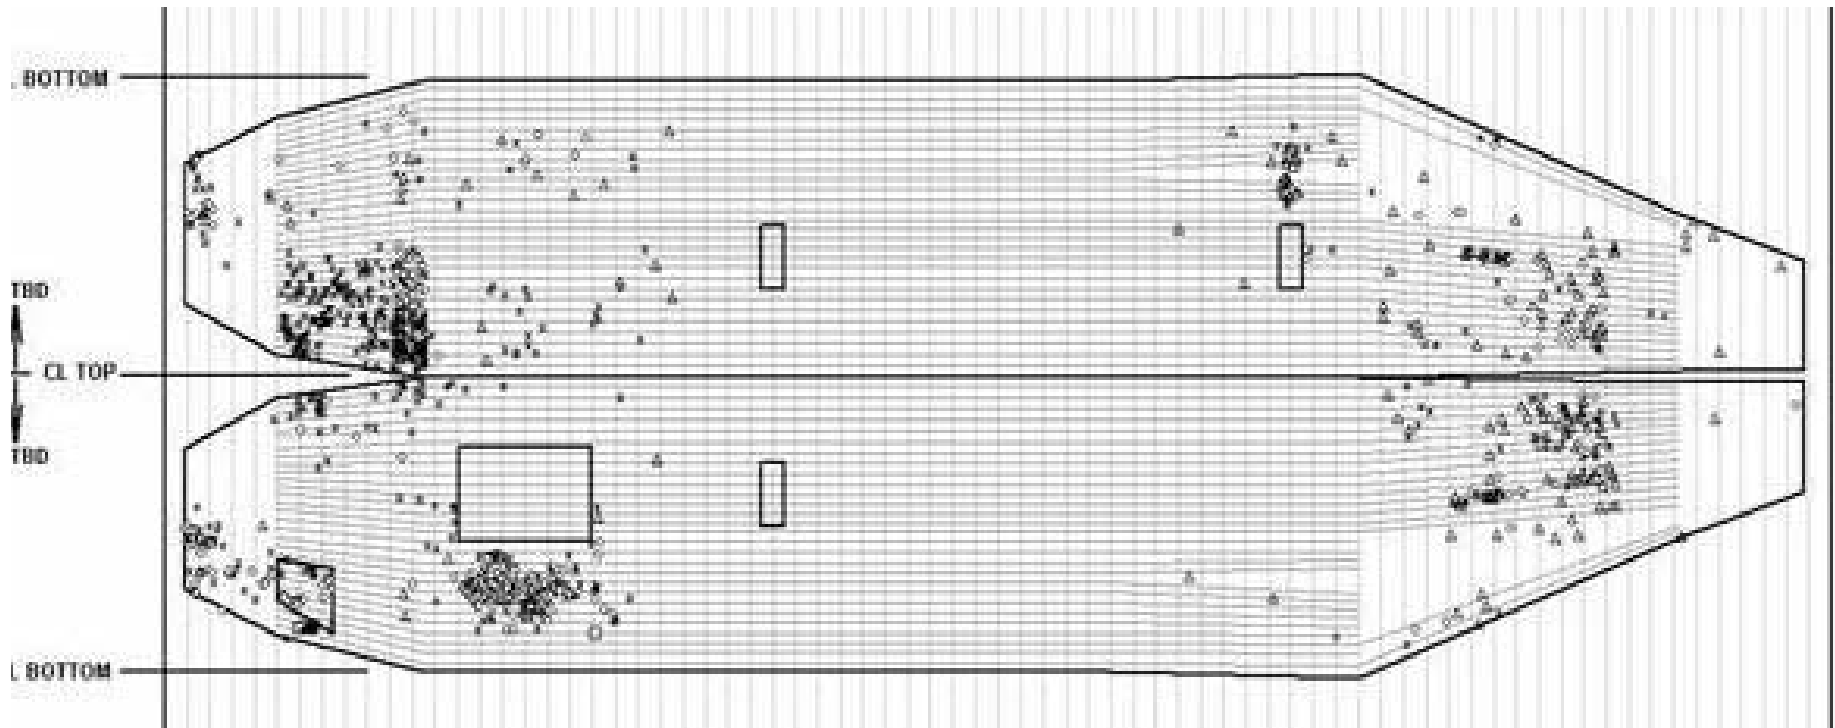
- Field survey of 27 aircraft
  - 1127 dents
    - 664 unfilled
    - 298 filled
    - 156 repairs
  - Maintenance
  - Stands
  - Hail/strikes

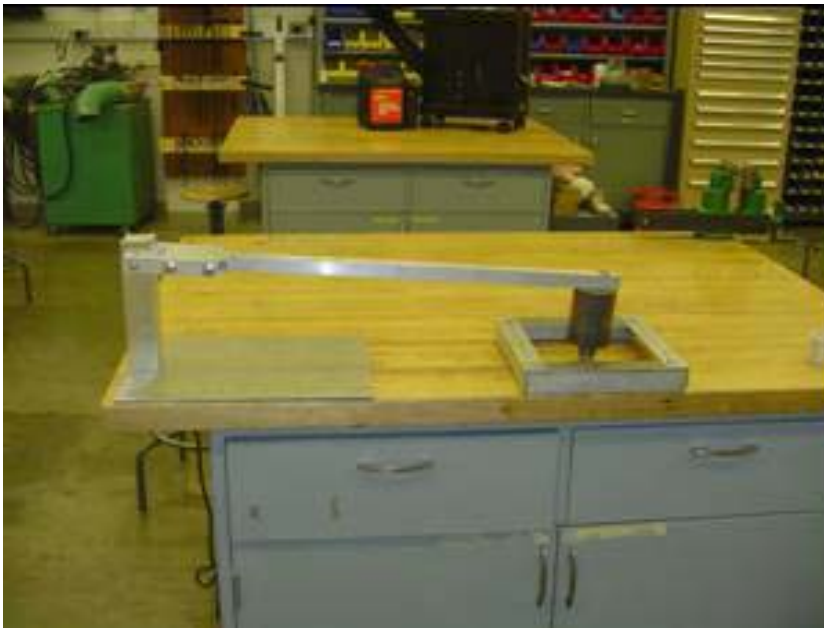
# Dent forming

- Ring support for diameter control
- Potential energy for depth
  - Weight
  - Height

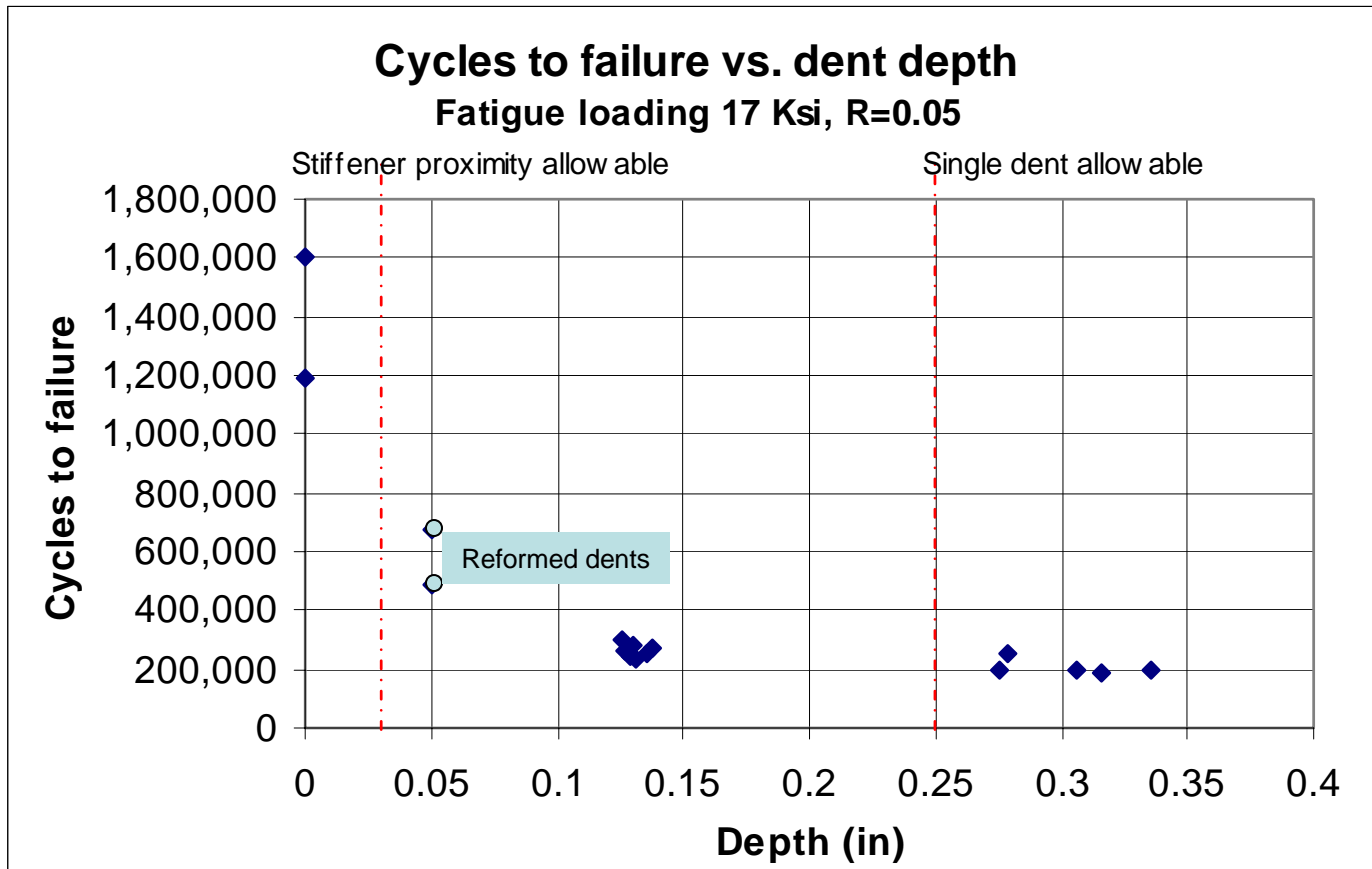
# Standardized fatigue testing

- Limited dent depth effect
- Reforming dents improves fatigue life
- Life well above service life (est. <100,000 cycles)

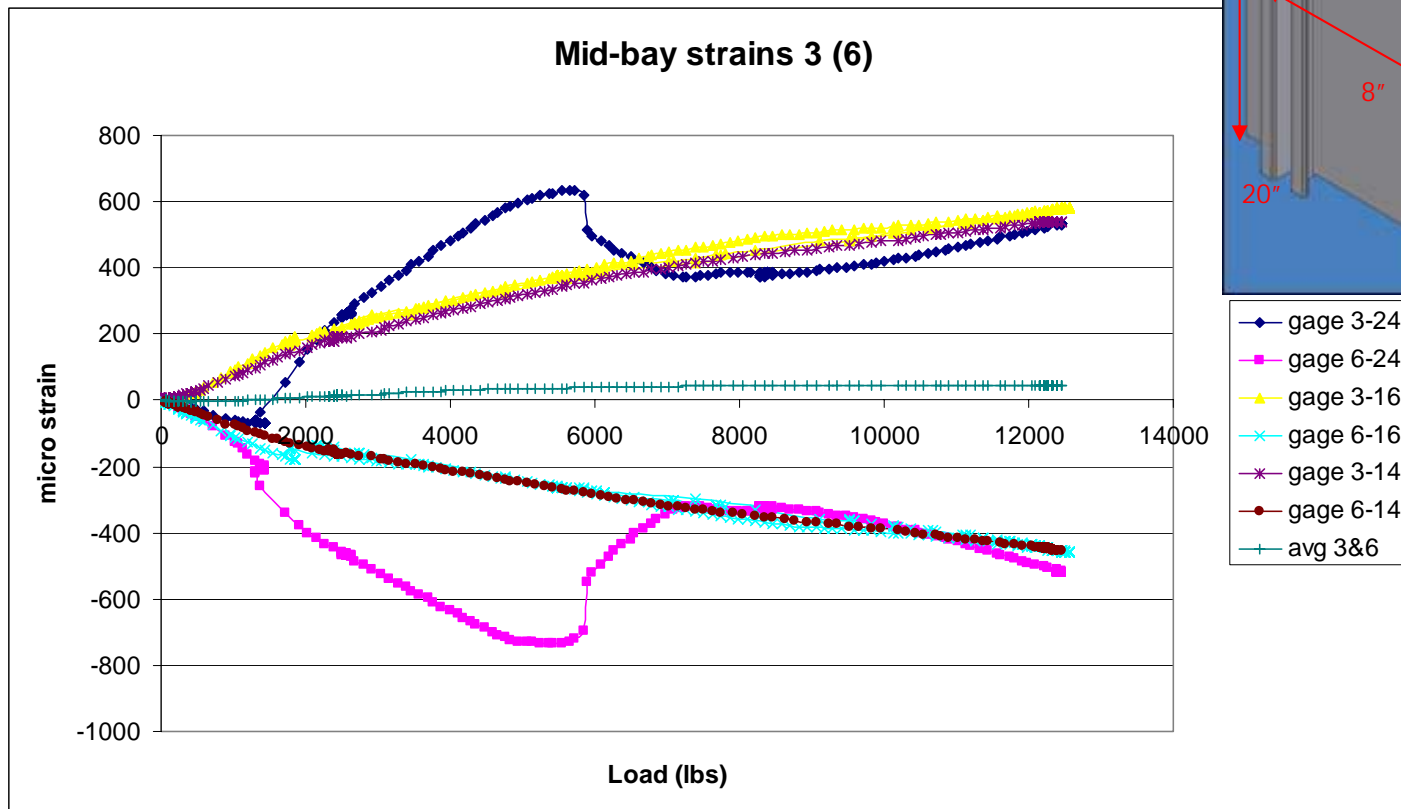
# Compression panel

- Verify proper loading
- Effect of panel width
- Non-effective skin (avg. stress)

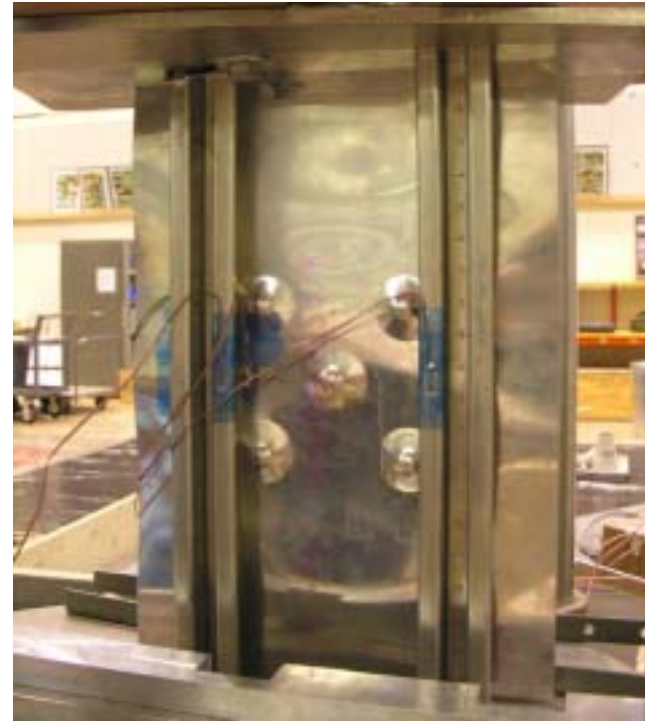
# Effect of multiple dents

- Relief from multiple dent limitation
- Effect of dents close to stiffener
- Close to effective width area

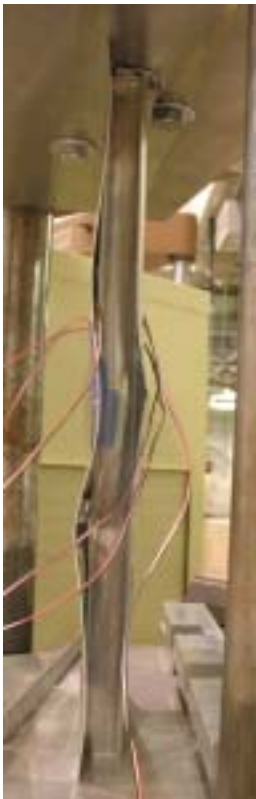
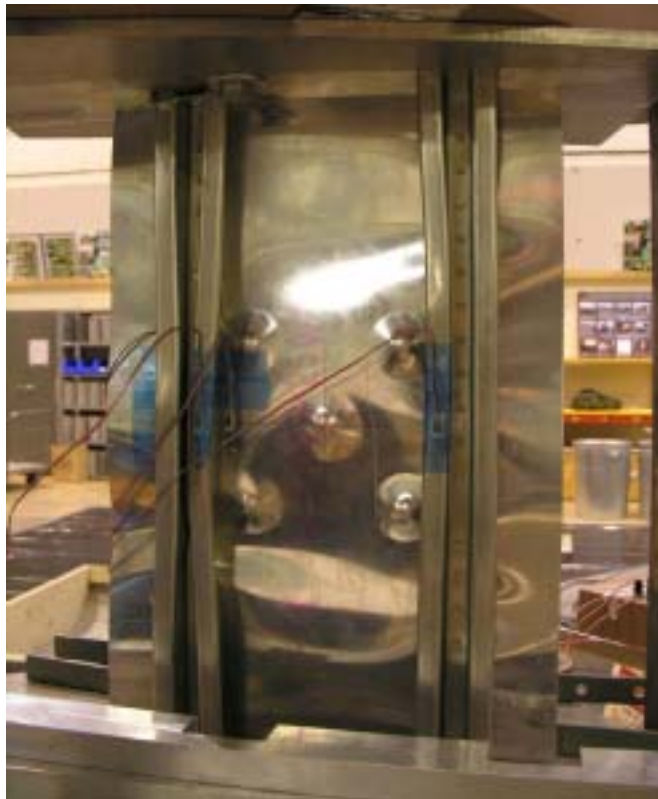
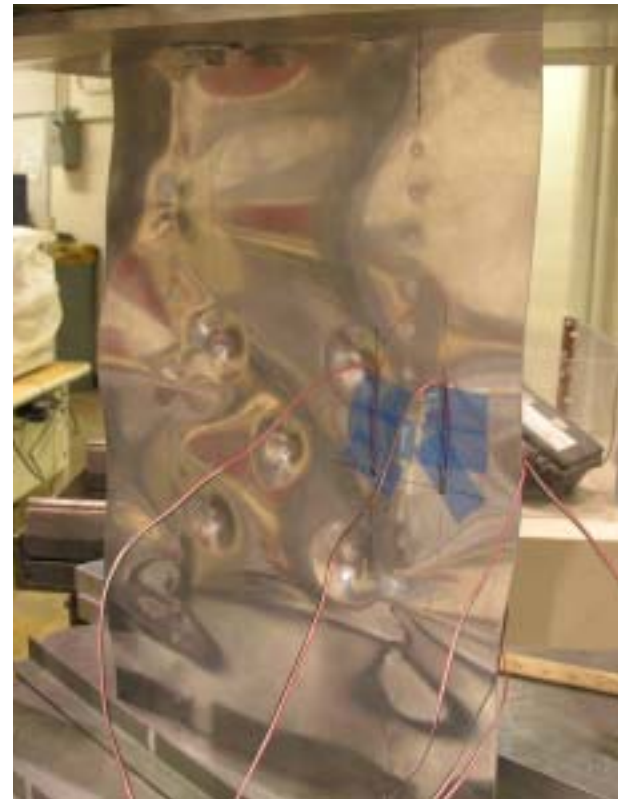
# Typical compression behavior

- Inter-rivet buckling
- Local stiffener crippling
- Skin wrinkling
- Torsional instability

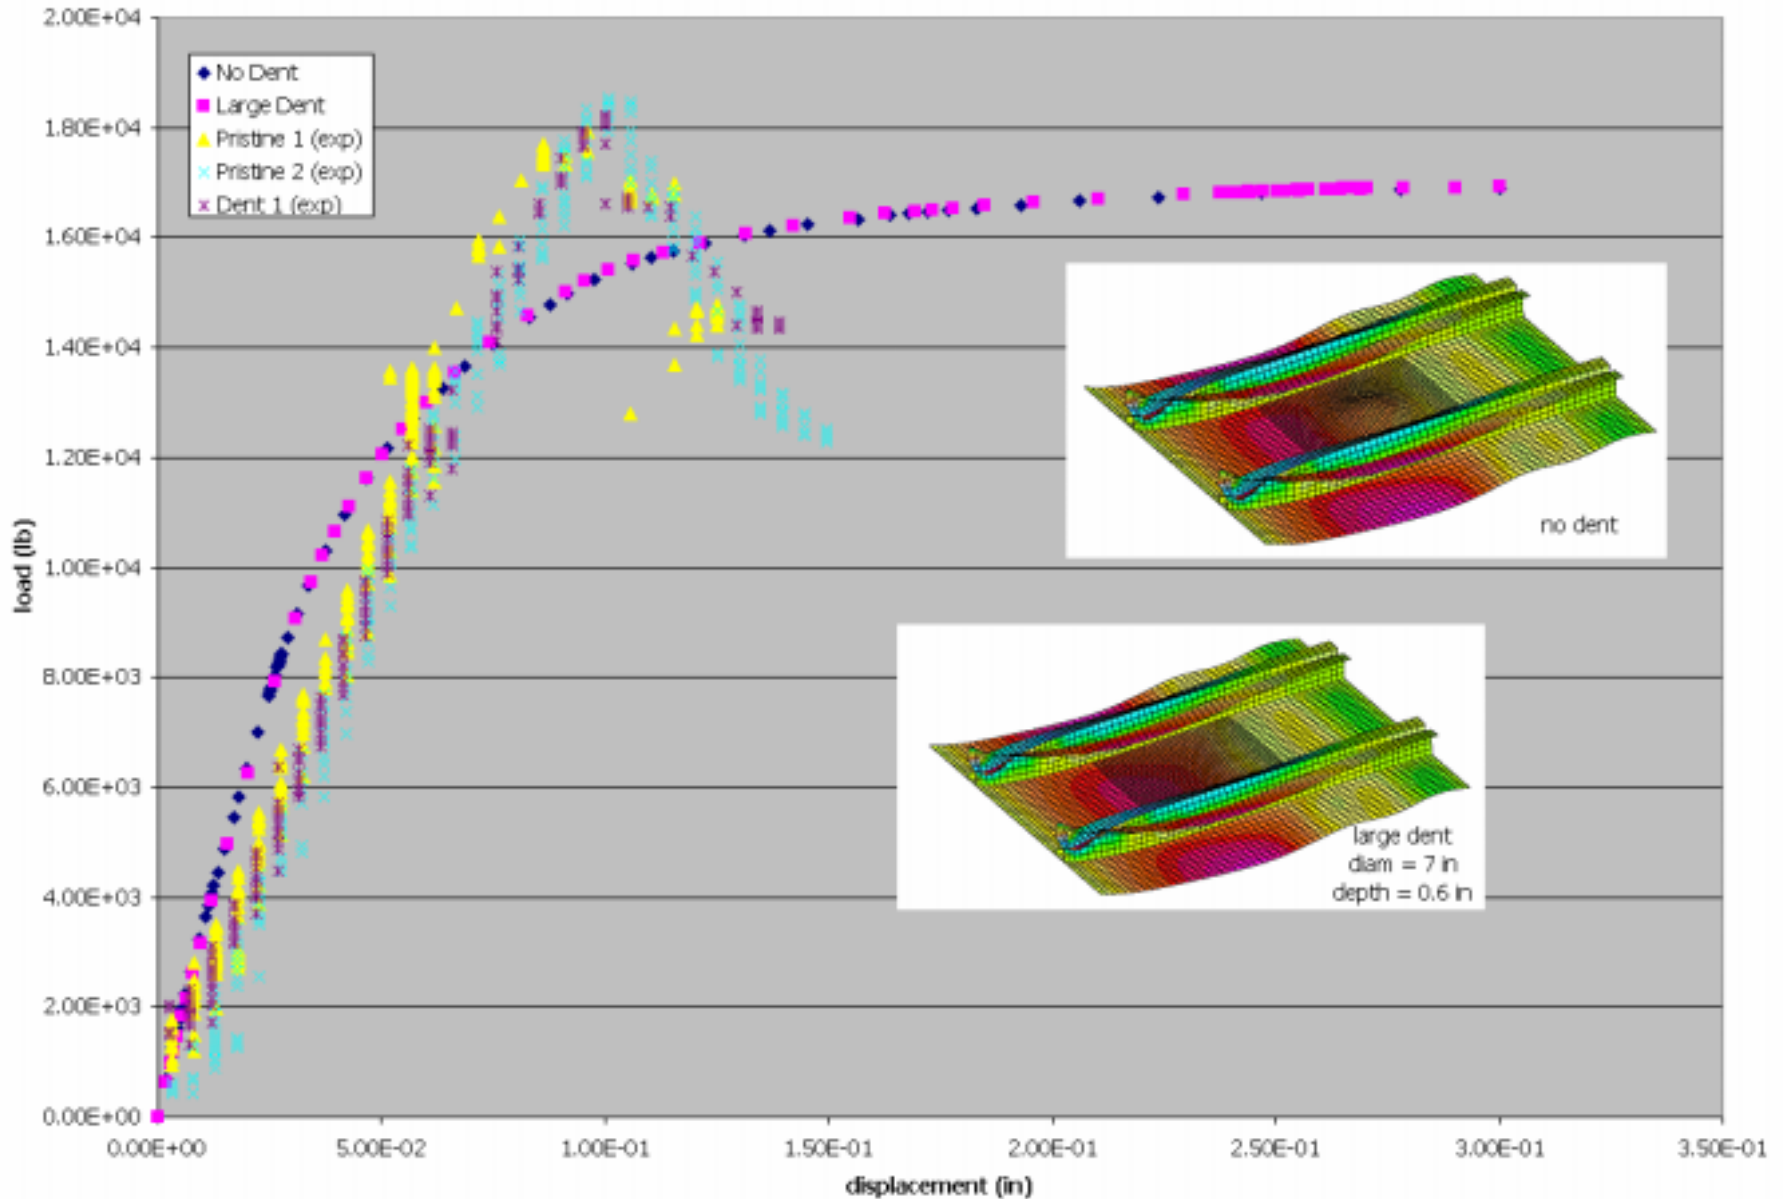
# FEM RESULTS: Compression

Analysis by Jim Greer, CASTLE

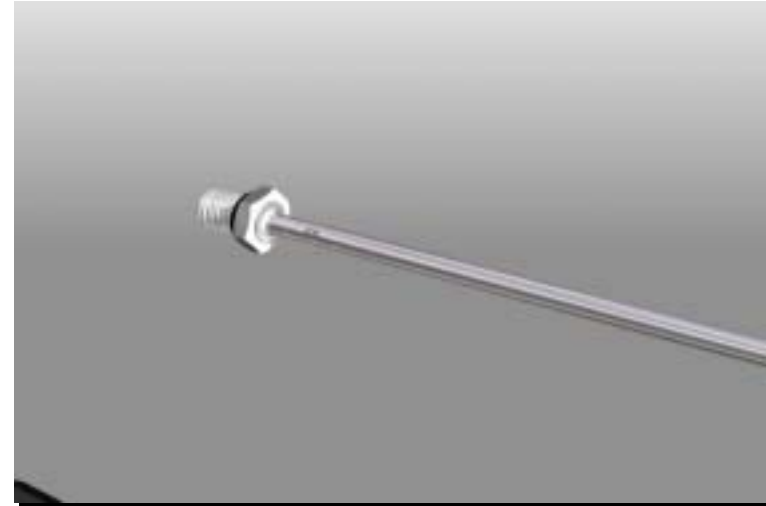
Cold Expansion (cold working) **induces a zone of residual compressive stress** around and through a hole, typically extending radially at least one radius around hole.

Hole is effectively "shielded," reducing effective stress intensity factor and therefore the propagation fatigue cracks.

Radial expansion of bushings is also effective in inducing beneficial residual stresses in attachment lugs and fittings to enhance durability and fatigue life

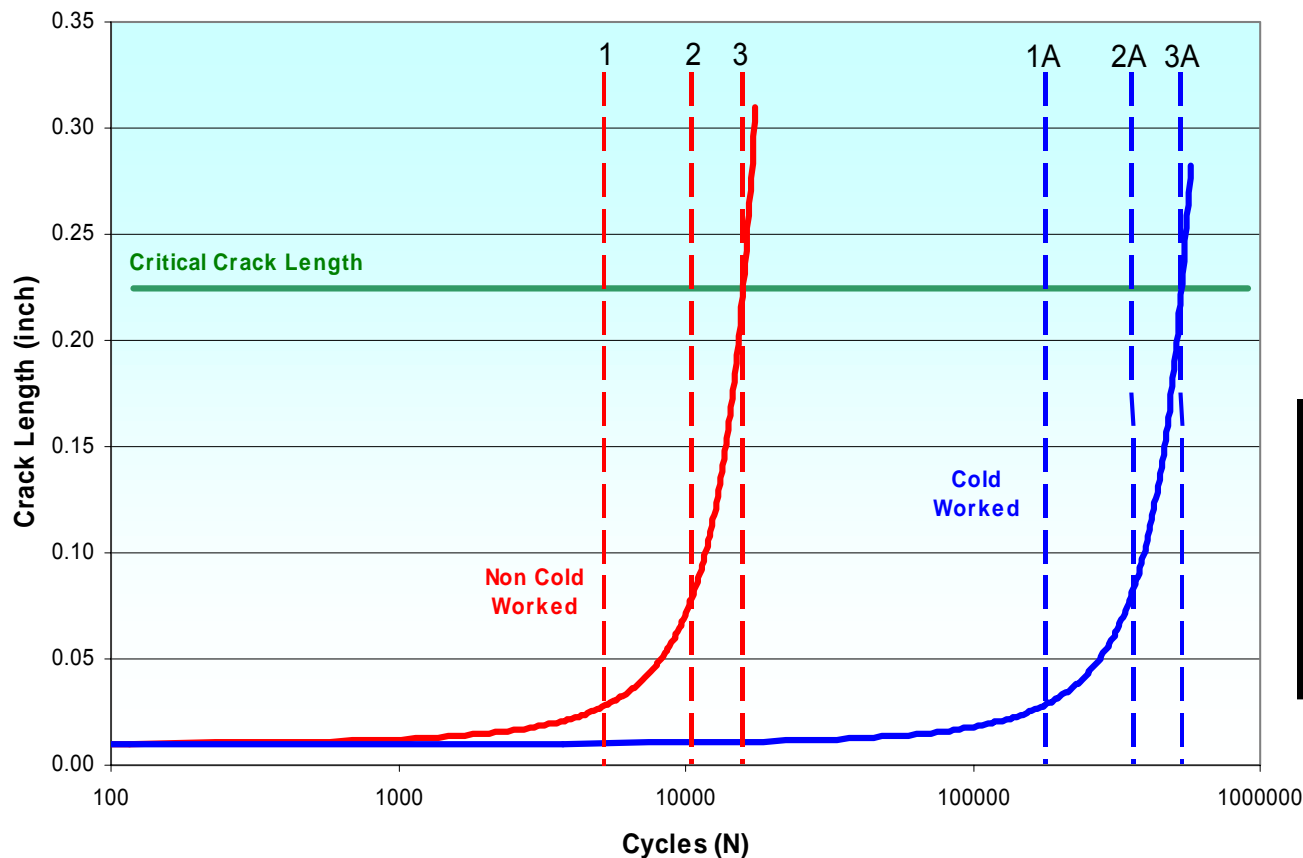
# Extended Inspection Interval with Cold Expansion

Cold expansion will often extend initial inspection threshold beyond the original economic life of the structure

Constant amplitude fatigue test  
 Material: 2024 T3  
 Hole Dia: 0.312 in  
 Stress: 25 ksi net, R-Ratio: 0.05  
 Environment: Ambient air

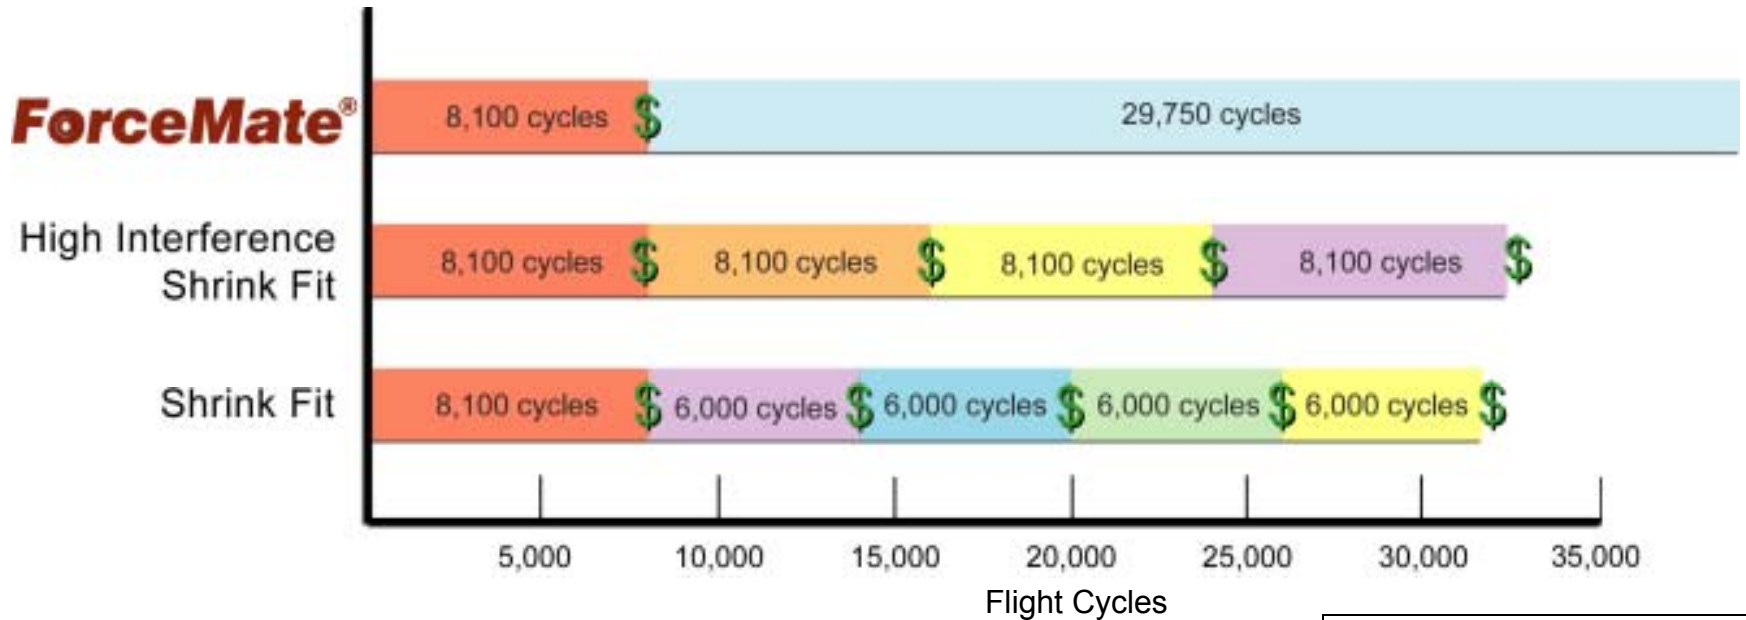
# Reduced Inspections Engine Pylon Example

**ForceMate eliminates costly inspections**

- ForceMate bushings replaced shrink fit plus roller-swage bush
- Rework time cut to hours rather than days
- Most significant was extended inspection intervals

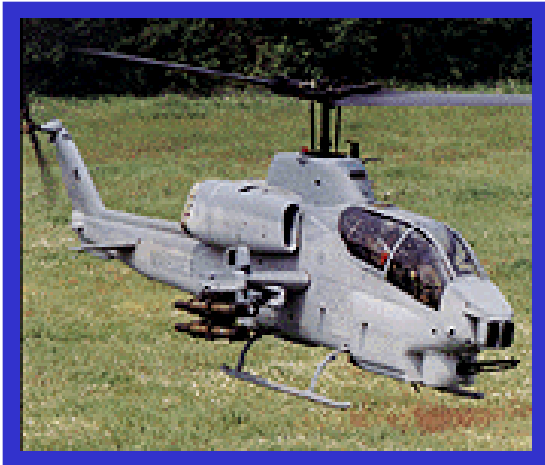
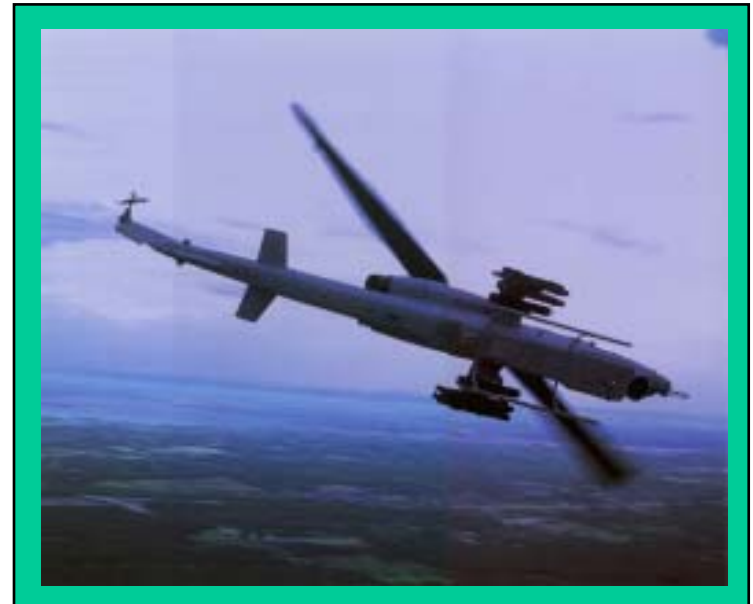
## Stub Wing Lug Attachment

- Production and overhaul retrofit to increase fatigue life of wing from 1500 to 4000 hours
- Use of ForceMate bushings realized operating and support cost savings of \$24.1 to \$44.3 million

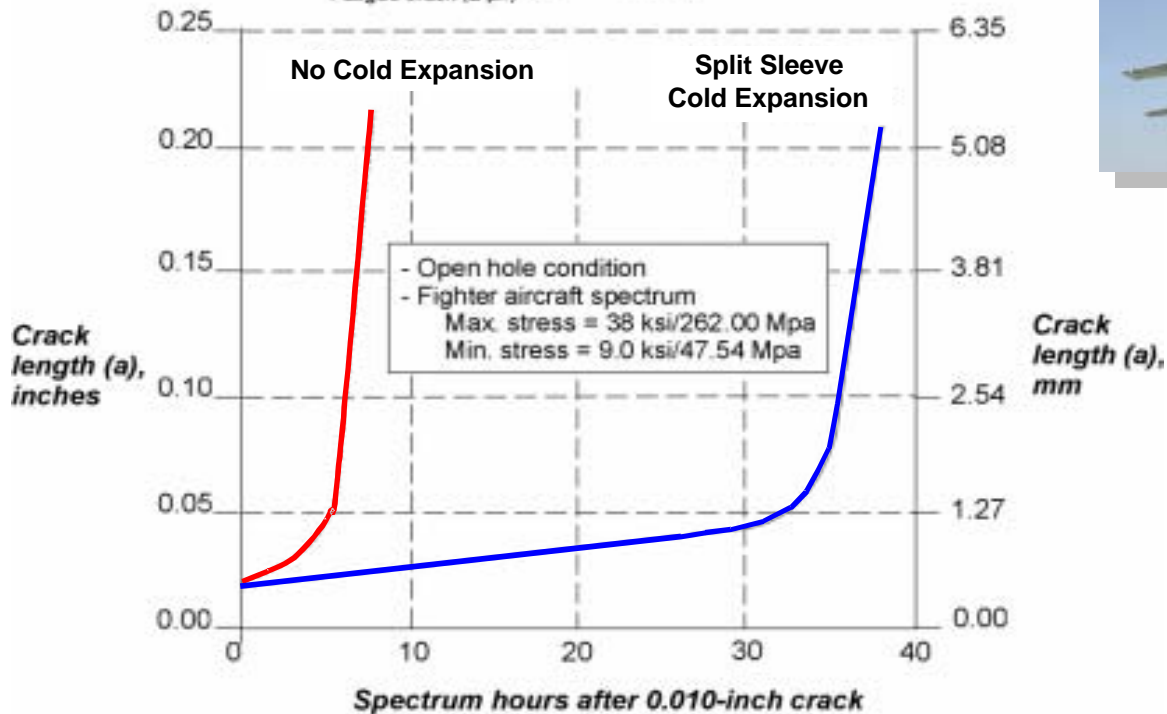
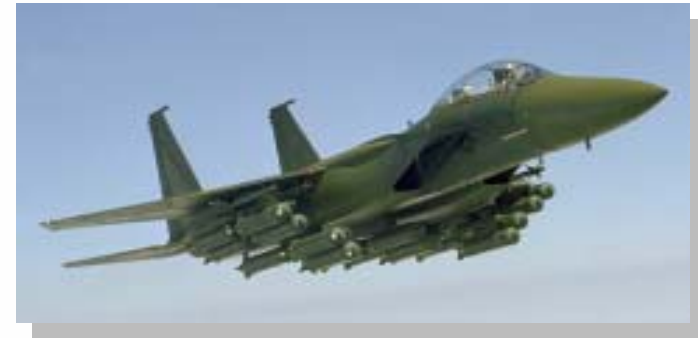
# Damage Tolerance Benefits; Fighter Aircraft Study

Ref: Rich, D. L. and Impellizzeri, L. F., "Fatigue Analysis of Cold Worked and Interference Fit Fastener Holes," ASTM STP 637 1977

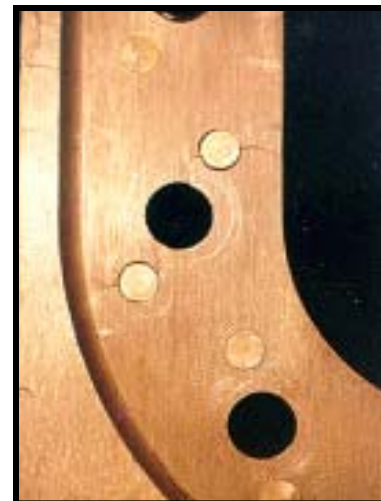
Upper Fuselage Skin Access Panels

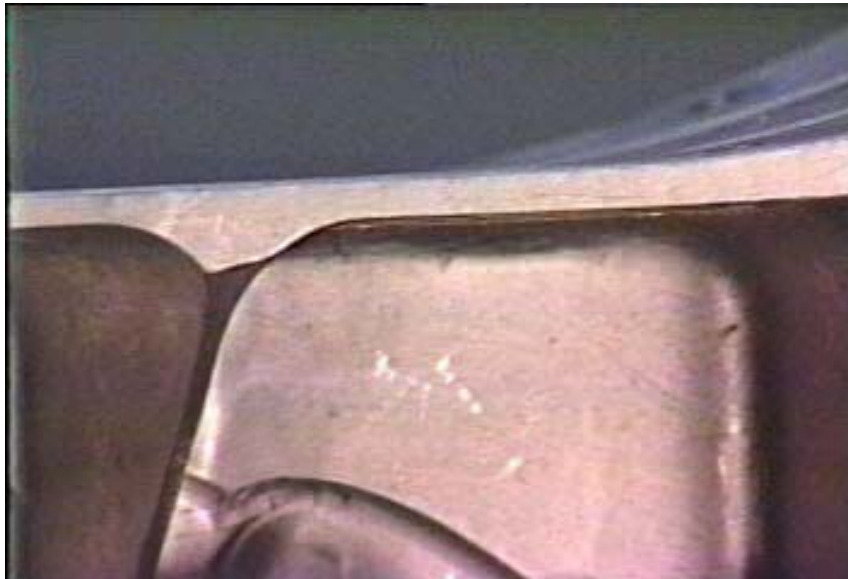
# Fatigue Test Results

Sealed ForceTec  
Rivetless Nutplate  
Installation

Home Plate Specimen

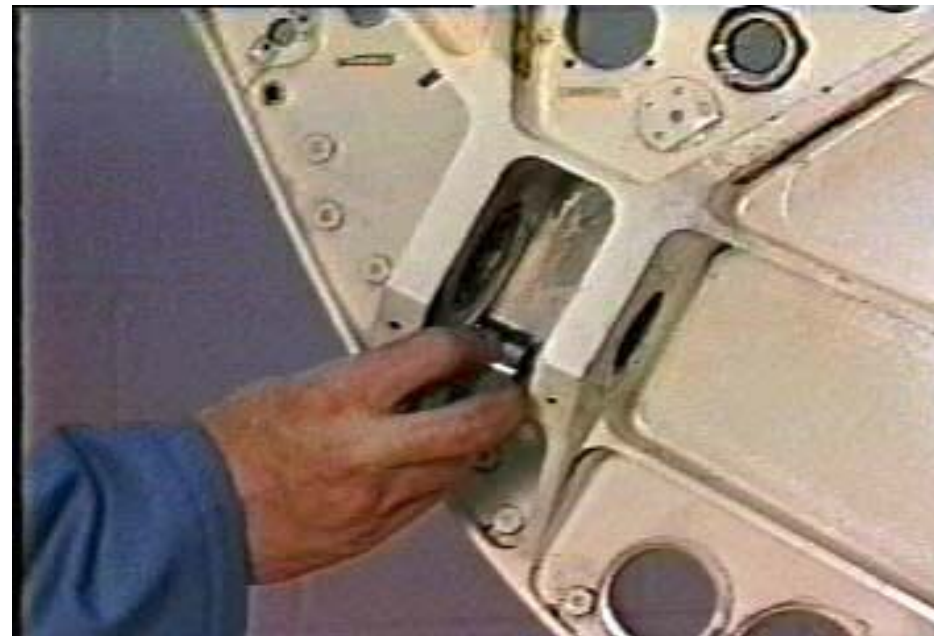
- Cold expansion does not stop corrosion however, it can mitigate the damage in holes if not too severe by allowing removal of damage and installation of oversize fasteners
- ForceMate bushings can repair/resize the hole to nominal size

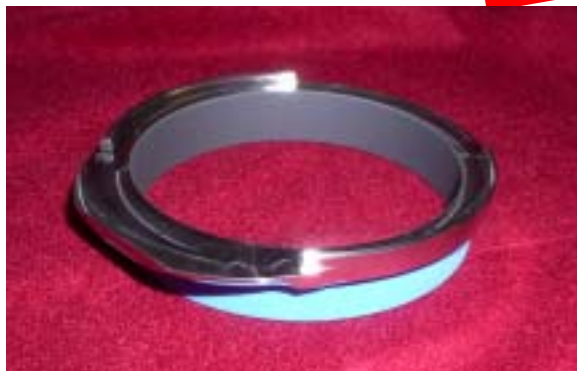
# ForceMate Solution Wing Weapon Pylon

- FTI ForceMate solves bushing corrosion problems
  - Large 5 ½” bushing
  - “BlueCoated” for anti-fretting

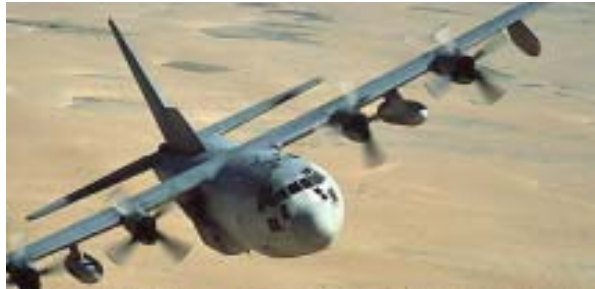
# ForceMate Bushing to Repair Rainbow Fitting Corrosion

**Most common cause of fitting replacement is corrosion. USAF ForceMate allows fittings to be repaired on aircraft versus being scrapped**

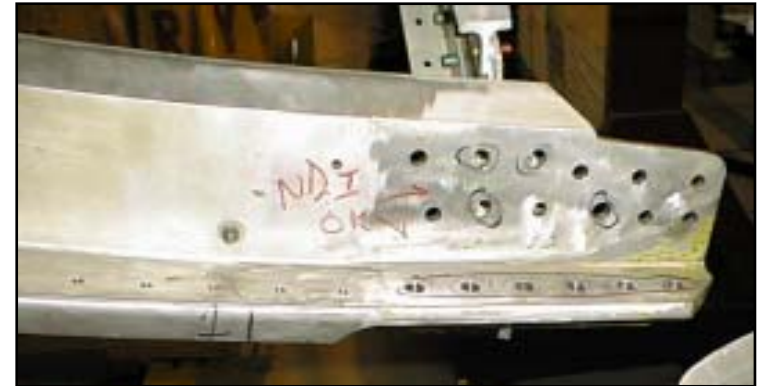
- **Problem:** Corrosion in attachment of sloping longeron typically requires longeron replacement
- **Solution:** Corrosion in holes removed and holes restored using expanded bushings
- **Savings** exceed \$75,000 per fitting restored

Corroded fitting

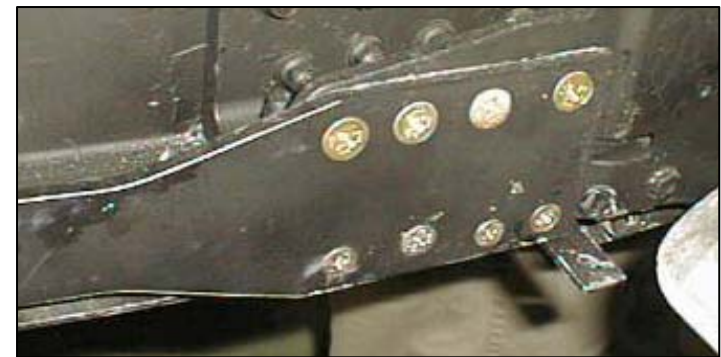
Repaired fitting

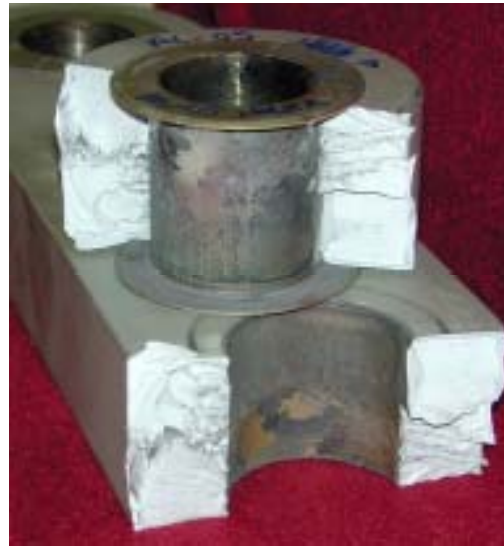
- **ForceMate® Induces beneficial residual stresses in parent material**
  - Increased fatigue life & damage tolerance
- **Consistent high interference fit**
  - Provides greater resistance to rotation, fretting and push-out

Typical lug failure from fretting induced fatigue  
**100,000cycles @ 17 KSI**

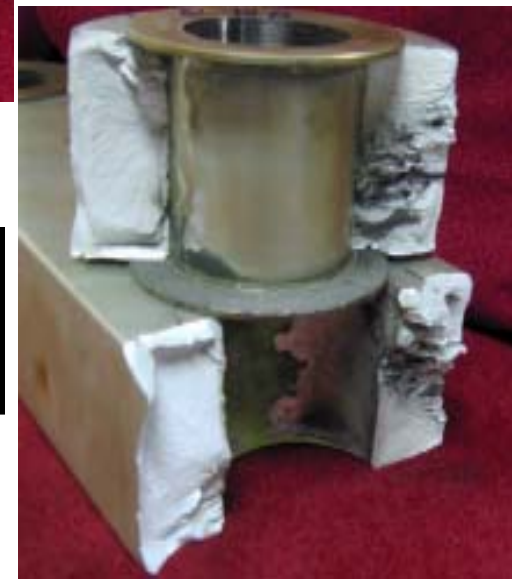
Same bushing installed using ForceMate  
**1,000,000 cycles @ 21 KSI**

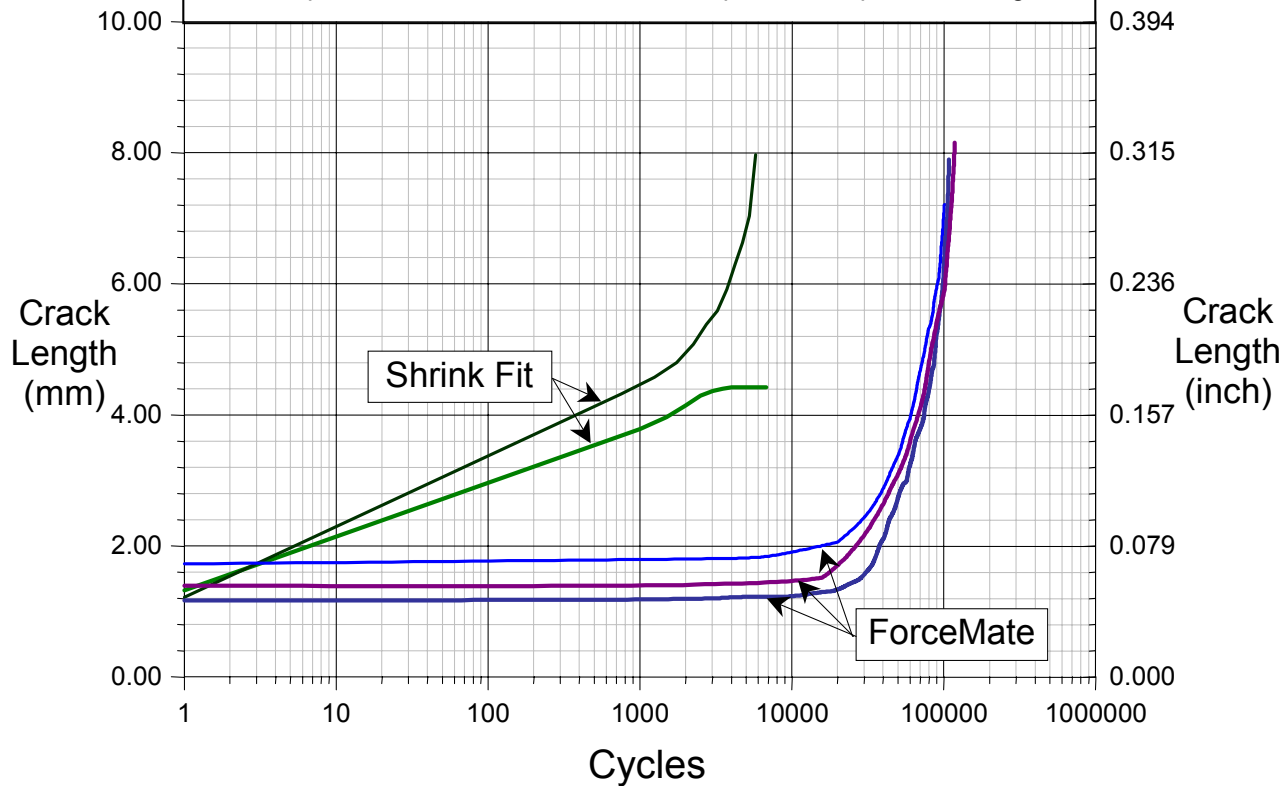
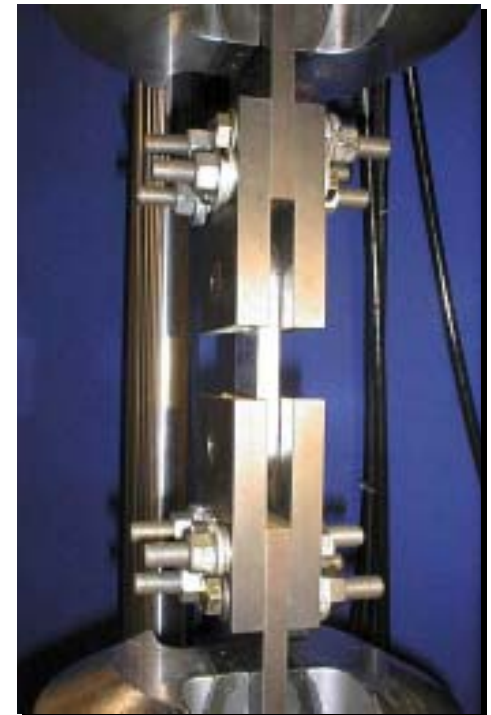
# ForceMate Bushing Damage Tolerance

100% Load Transfer Axial Fatigue Technology Inc.  
 Material: Titanium  
 Maximum Load: 90 kN (20 Kip), R-Ratio: +0.10  
 Frequency: 20 Hz, Environment: Ambient Lab Air  
 Note: All specimens were corner notched and precracked prior to testing.

- **17-4 stainless steel ForceMate bushings**
  - 28.5 mm (1-1/8 inch) pin diameter
- **Titanium lug specimens**
  - Pre-cracked with corner flaw in hole
  - Two lugs with outer edge cracks

**ForceMate crack growth life improvement - 20:1**

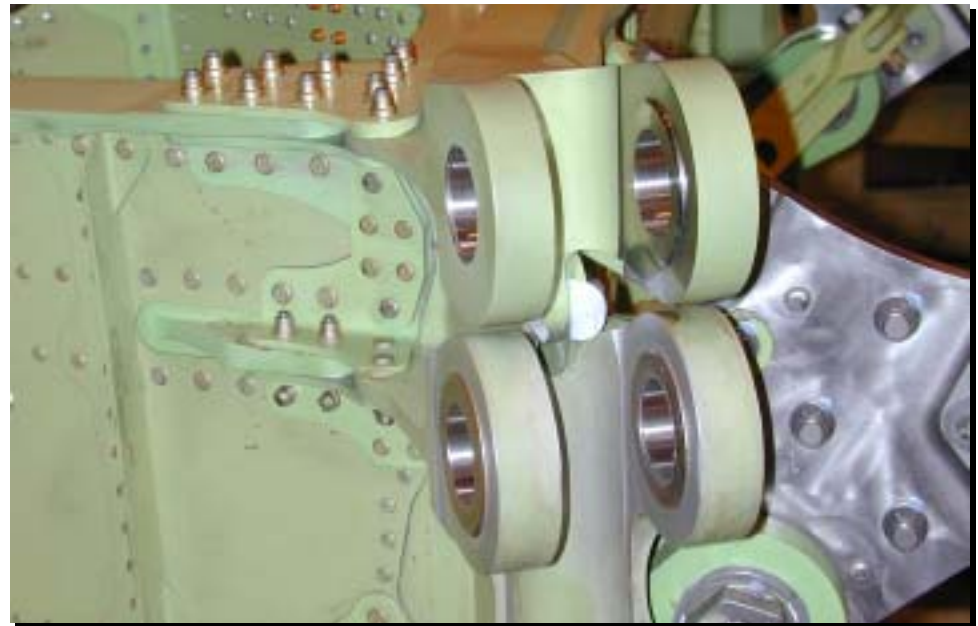
# Horizontal Tail Attachment Lugs

## Bushing migration and subsequent corrosion

- Migrating bushings
  - Sealant bond breaks
  - Corrosion results
  - Old process was recurring inspections, and fitting replacement when beyond limits
- ForceMate repair
  - Migration is eliminated
  - Sealant bond remains
  - Corrosion in lug bore is eliminated

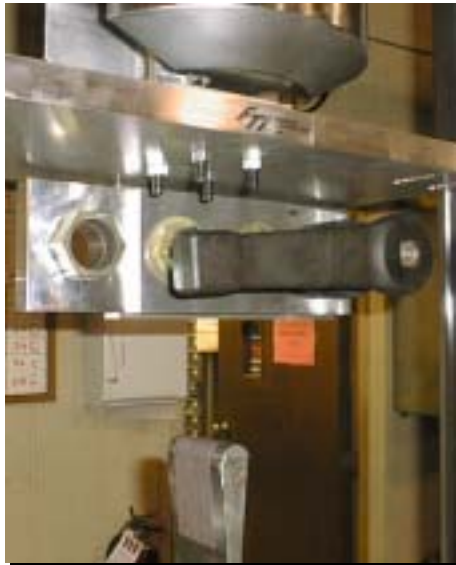
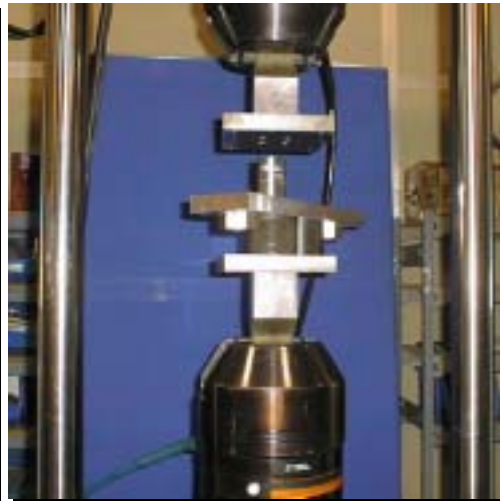
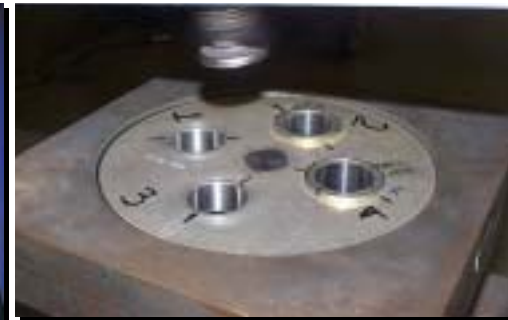
# Comparative Performance to Shrink-Fit Bushings

Torque

Fatigue

Vibration

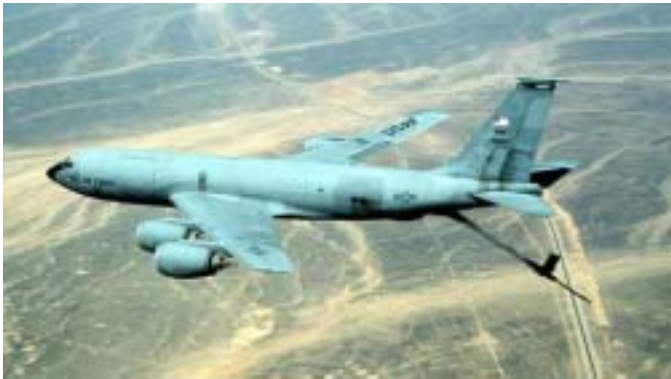
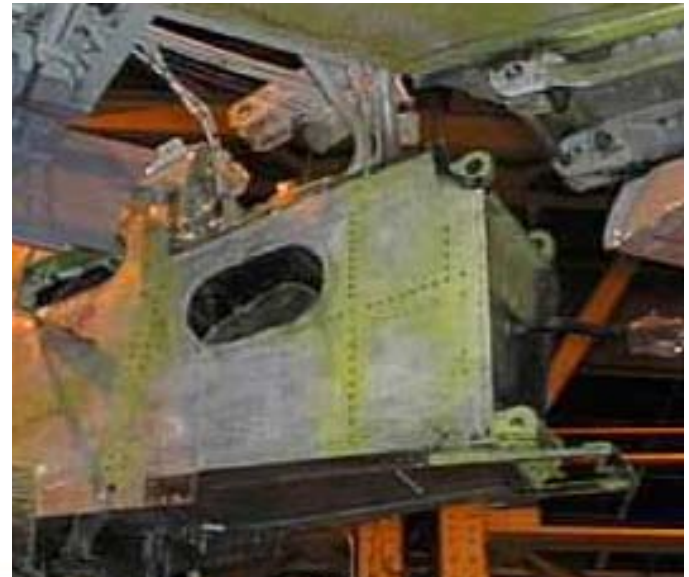
# Engine Strut ForceMate Modification

- B-52 fleet has been modified
- KC-135 modification in-work

**• Modification eliminates fatigue inspection of strut attach locations**

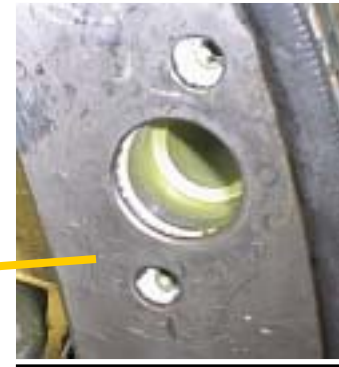
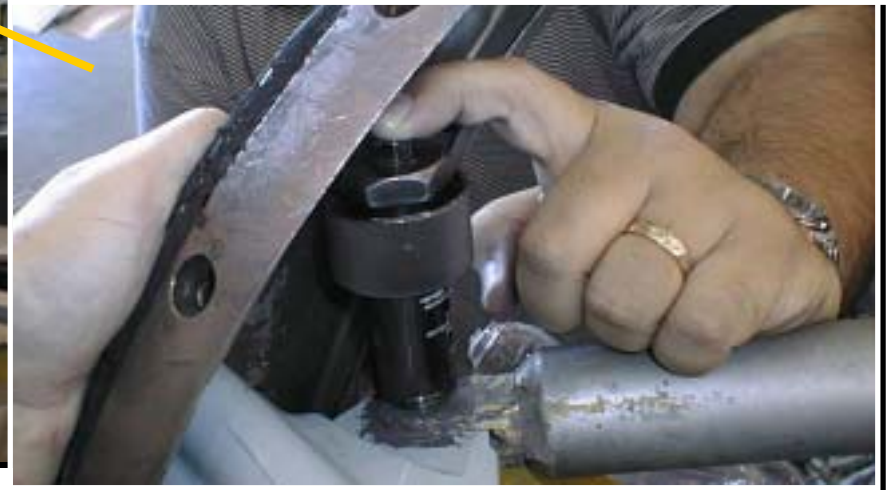
# C-130 Truss Mount Cone Bushing Hole and Sway Brace Attachment

ForceMate  
Bushings saved  
150 maintenance  
man-hours per  
truss

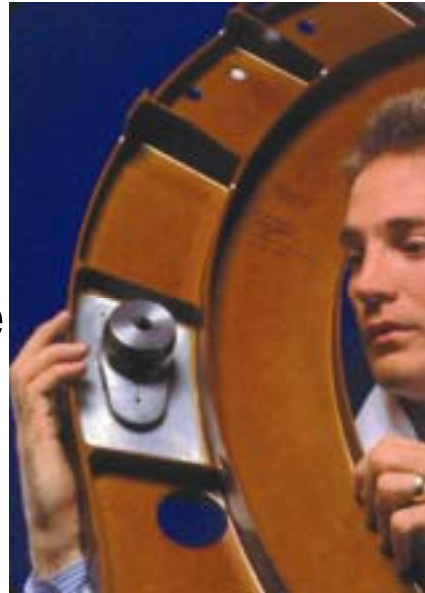
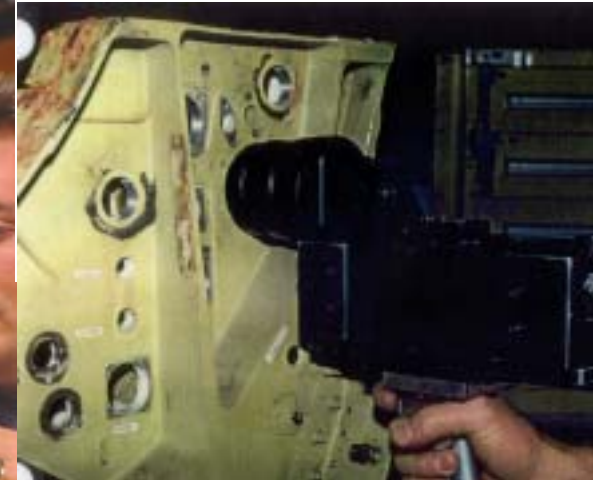
# F-16 Falcon UP

- F-16 Wing carry through bulkheads
- Fatigue cracks found in the durability test, and in the field
- Next Best Alternative – replace bulkheads
- Falcon UP = Split Sleeve Cold Expansion to size, less than 10% of the cost

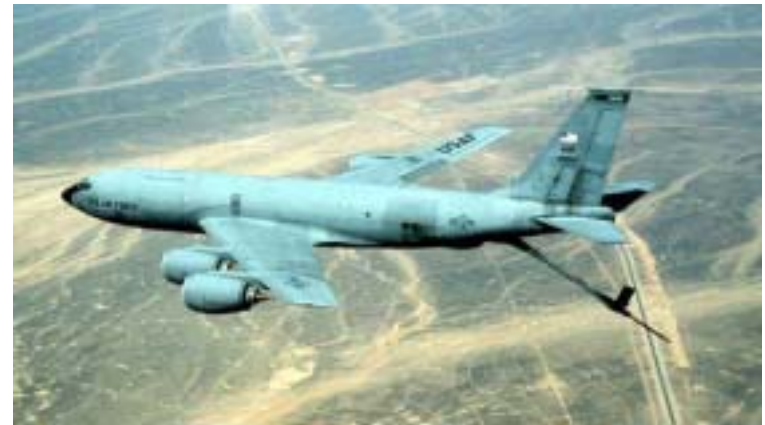
# KC-135 – ECP-484

- Lower wing skin cracking in the outboard wings
- **Option**: Skin or wing replacement
- **Solution** – Split Sleeve Cold Expansion to size – Less than 1/4 of the cost to implement

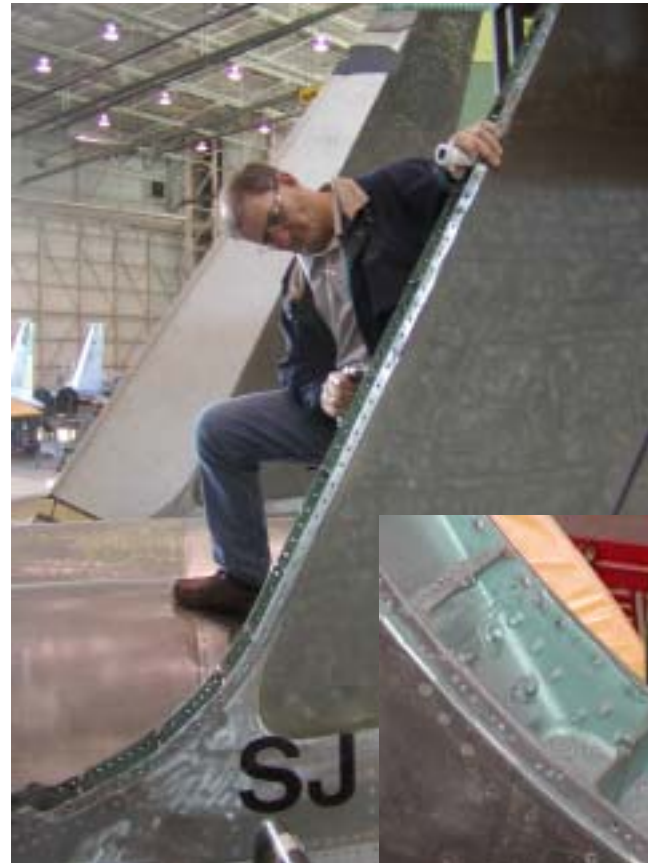
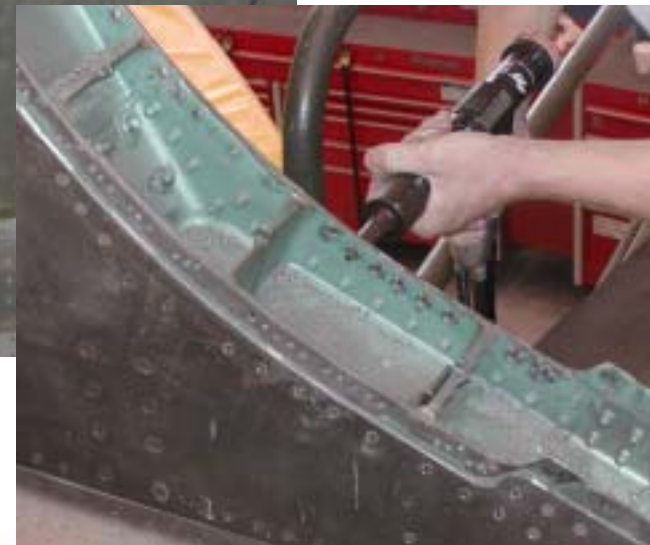
# ForceTec Riveted Nut Plate Replacement

Leading Edge attach holes damaged and ovalized

- Need to install new LE
  - Current method would require over sizing holes to match damaged holes in LE spar
- ForceTec repairs and resizes holes in one operation
- Solves Edge Margin concerns in repair

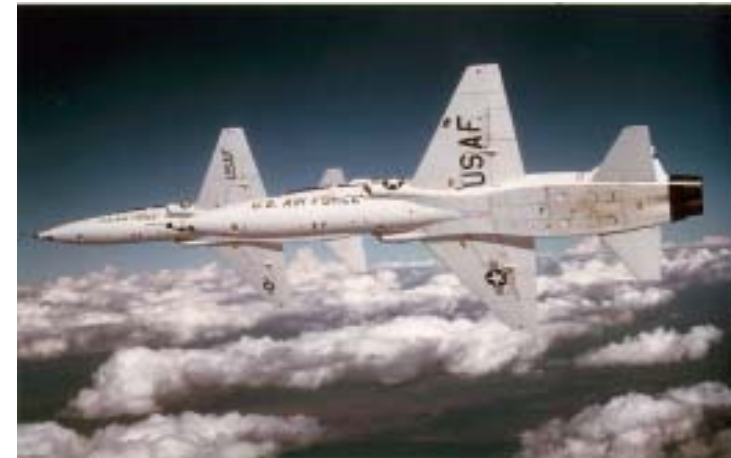
T-38 Lower wing skin  
 Countersink Cold Expansion of  
 200 fatigue critical holes  
 ForceMate repair of D-panel  
 existing riveted nut plate holes
