# *New Structural Guidelines for Dent Allowables on Fuselages*

USAF Academy Department of Engineering Mechanics  
Center for Aircraft Structural Life Extension

# Aging Aircraft Repair Strategies Utilizing Cold Expansion Technologies

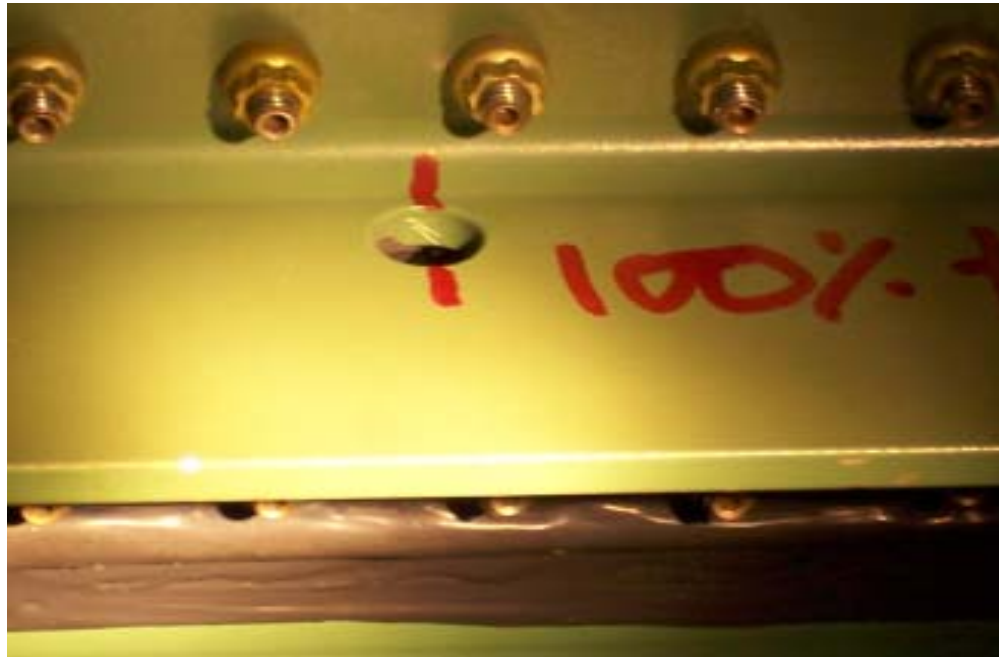
# Upper Cover Cracking

- Cracks form on upper and lower sides of holes
- Average of 16 holes per aircraft are found cracked
- Maximum of 64 holes found cracked on one aircraft

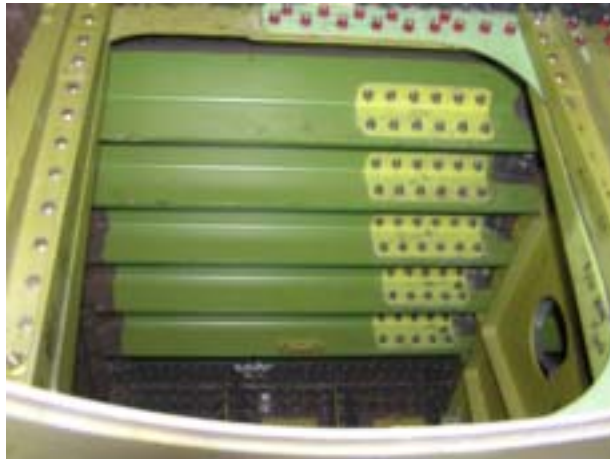
# Original Repair

- 2 nested back to back L-angles
- 18 new fastener holes
- 9.5 hours labor and fabrication

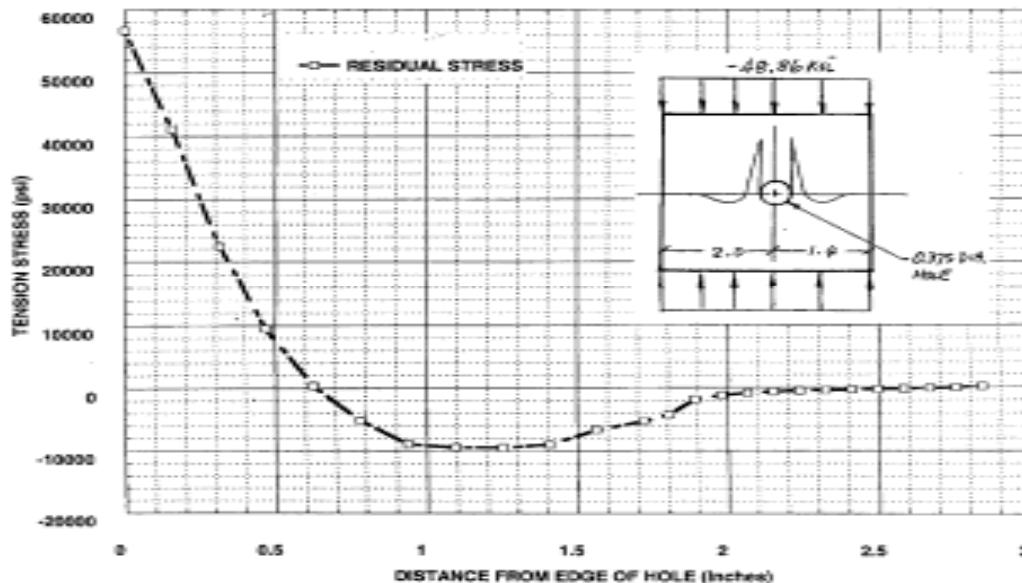
Figure 6-2 Northrop Grumman Report SA220R0438

- **Compression dominated spectrum which also includes some tension loads due to negative bending increases stresses amplitude**

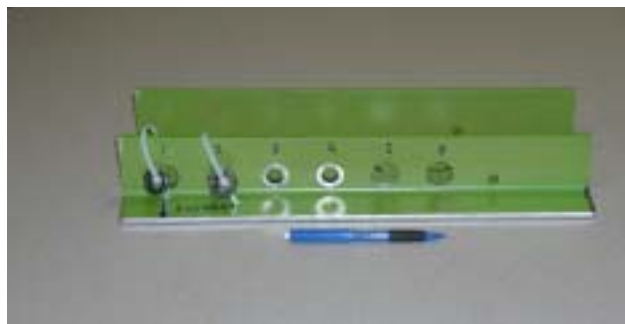
**ForceMate**<sup>®</sup>  
Bushing Installation

## ■ Installation test

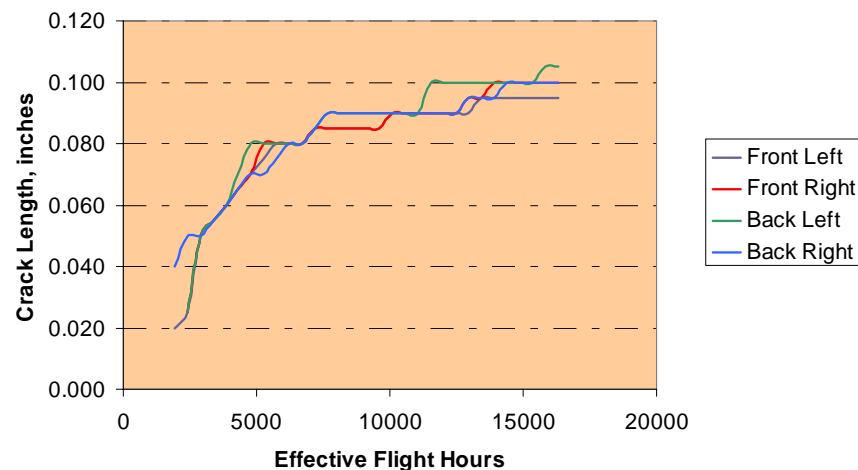
Flat Plate Coupon- 3/8" Cold Worked Hole

- Cold Worked 3/8" hole showed similar crack growth to Original 3/8" hole configuration. No benefit in compression dominated spectrum
- .500" ForceMate coupon showed no cracks

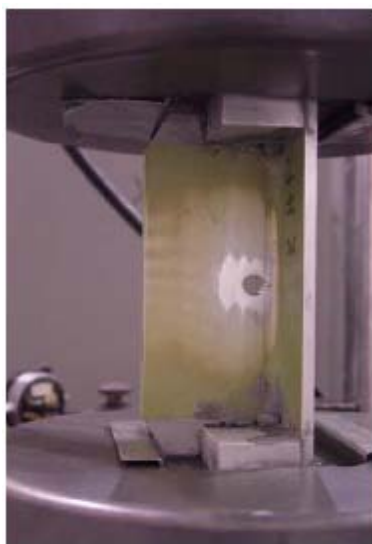
- Components came from actual aircraft wing with 5832 flt hrs
- 3- original .375" baseline holes
- 3- .500" ForceMate bushed holes
- 3- 1.000" ForceMate bushed holes

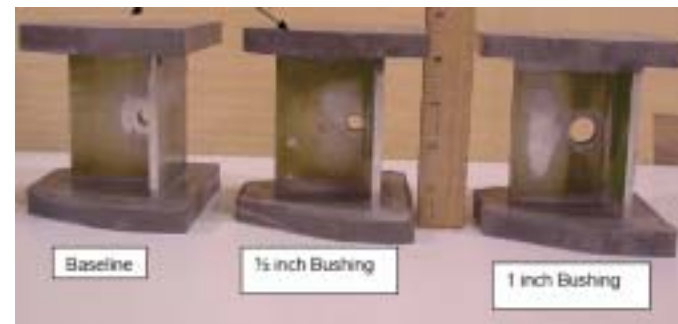
Semi-Component Static Compression Test

- 3/8" Baseline Hole
- 1/2" ForceMate Bushing
- 1" ForceMate Bushing

- **Wing Fatigue Test showed similar cracking to semi component tests**
  - **Fleet cracking has shown larger crack sizes**
- **Semi Component Static Compression Test**
  - **Original 3/8" hole configuration**
    - **Baseline data**
  - **1/2" ForceMate Bushing Installation**
    - **No loss in crippling strength**
  - **1" ForceMate Bushing Installation**
    - **No loss in crippling strength**

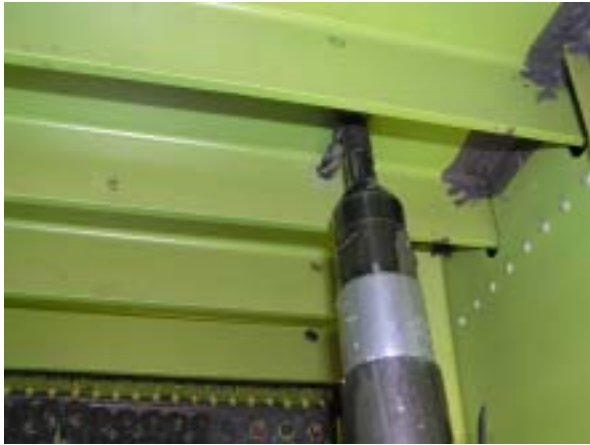
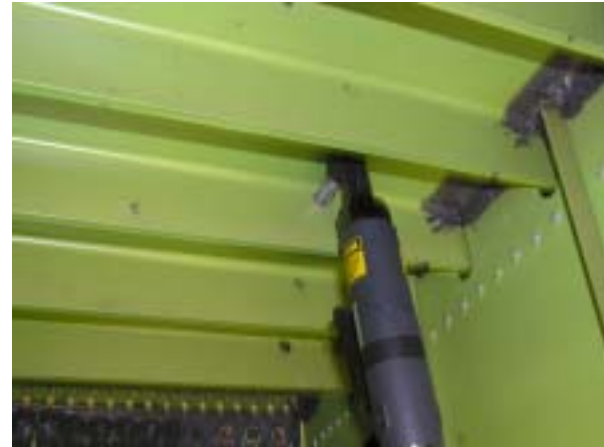
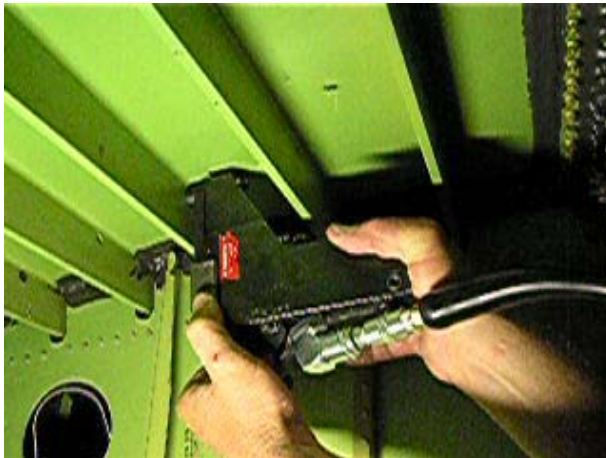
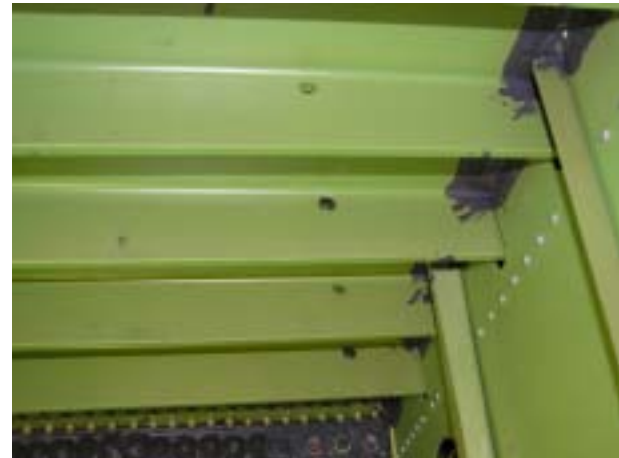
## ■ Repair Steps

- 1.Ream hole with pre-reamer
- 2.Ream hole with starting reamer
- 3.NDI to ensure no cracks
- 4.Install bushing using offset puller and hand pump
