ASIP 2006

Lower Layer Crack Detection in Thick Complex Aerospace Structures Using FG_RFEC Technique

Capt DJ Butcher, Canadian Forces Aerospace and
Telecommunications Engineering Support Squadron (ATESS)
Mr. Yushi Sun, Innovative Materials Testing Technologies (IMTT)

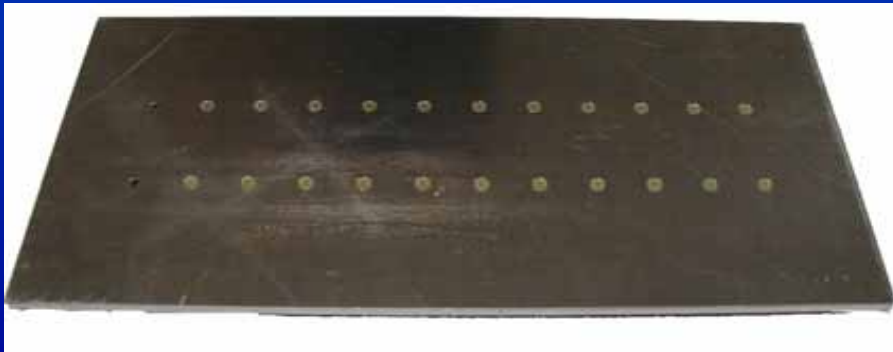
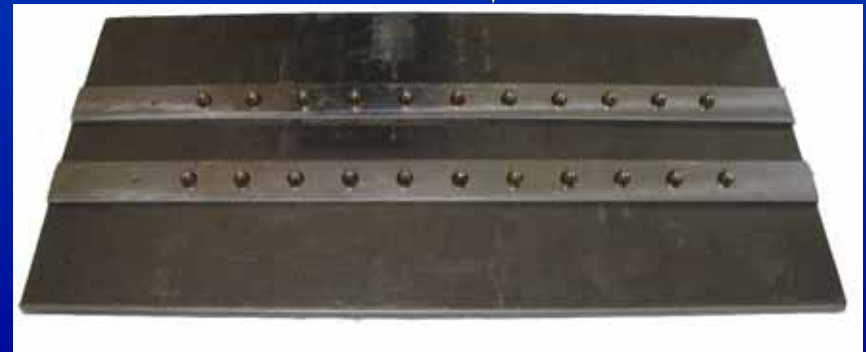
Problem #1 – CC130

- Each lower surface of the CC130 CW box is comprised of 3 skin panels ranging in thickness from 0.150" to 0.575" fastened to hat sections of approximate thickness 0.140"
- Test Piece represents the skin and stringer (skin Al 7075-T7351 0.250" thick, stringer feet same material 0.140" thick with ferrous fasteners)

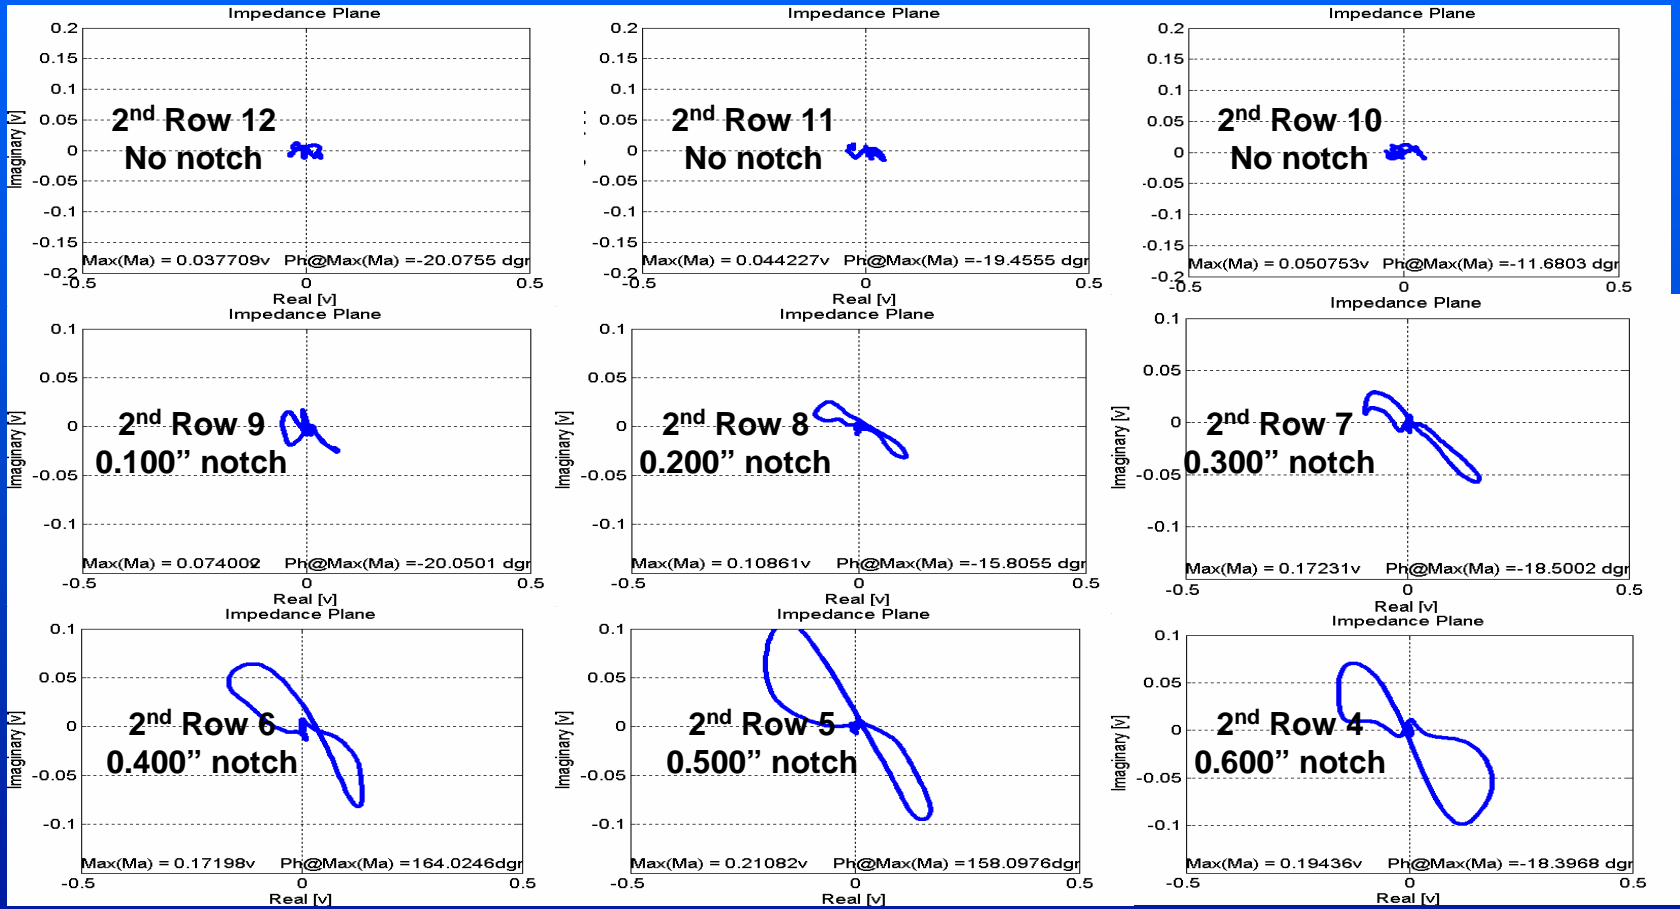
Illustration of Impedance Planes for 2nd Layer Defects In the CC130 Test Piece (Through Notches)

Again note the rotation of phase and increase in amplitude with increasing EDM size

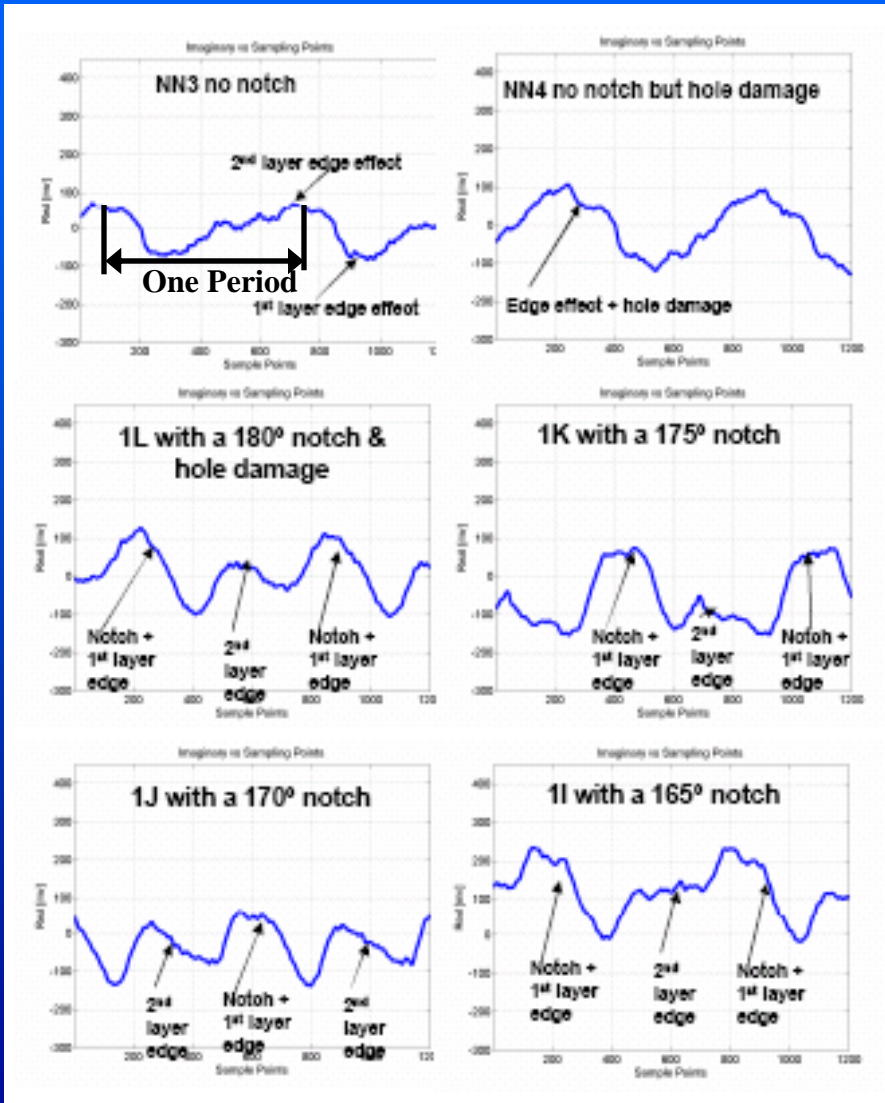
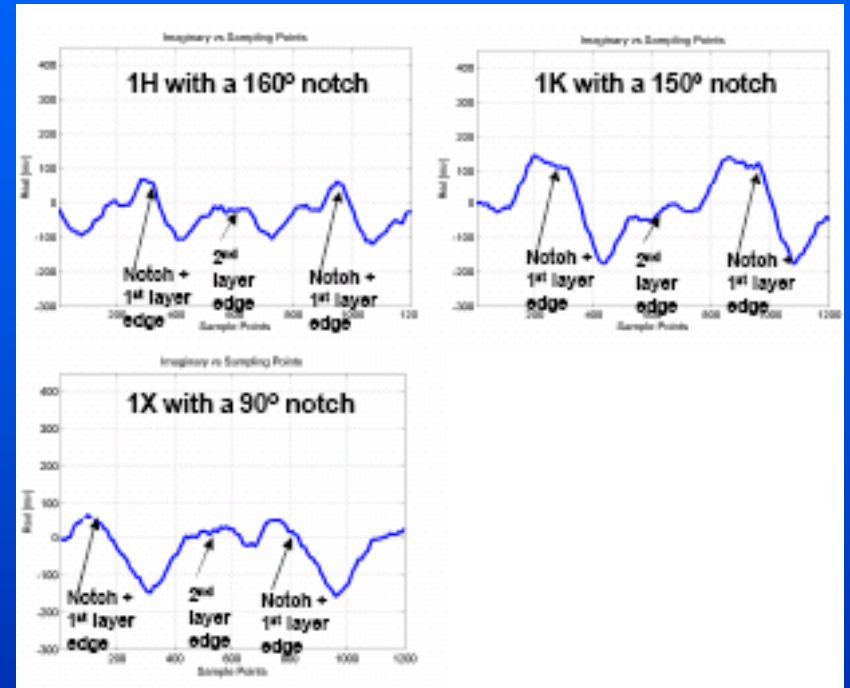
Imaginary Component of Impedance Planes for 2nd Layer Defects in the P3 Test Piece (Corner Notches)

All the EDM notches are the same size. Variances in signals occur to the notch proximity to the 1st and 2nd layer edges. Note the increase in amplitude and increase in slope for the notched holes

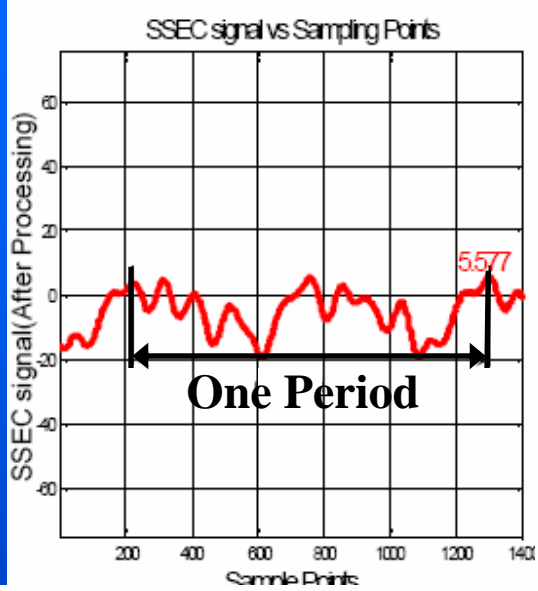
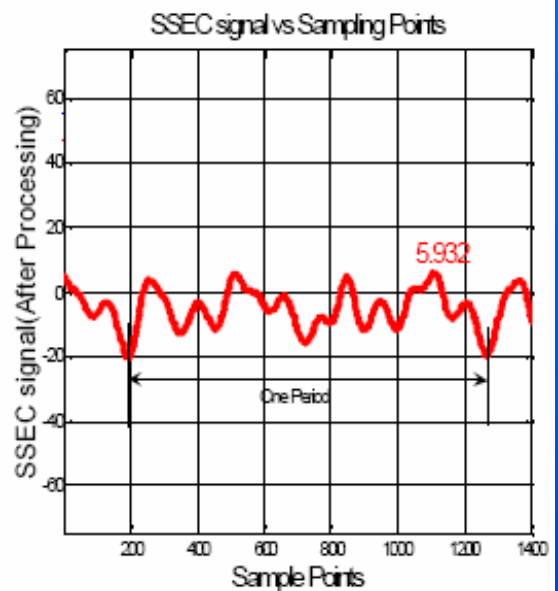
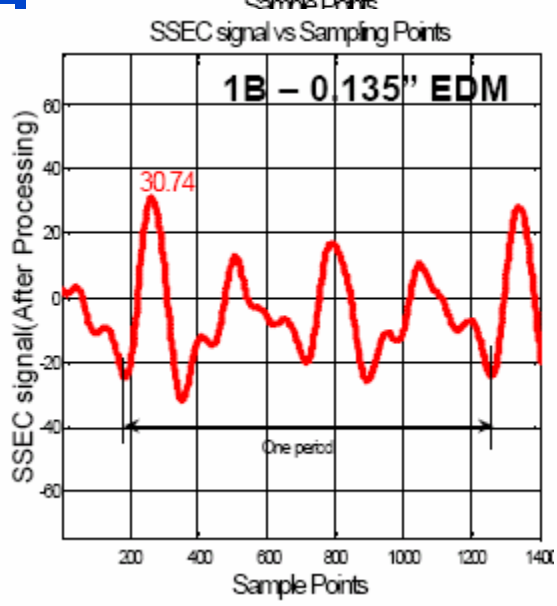
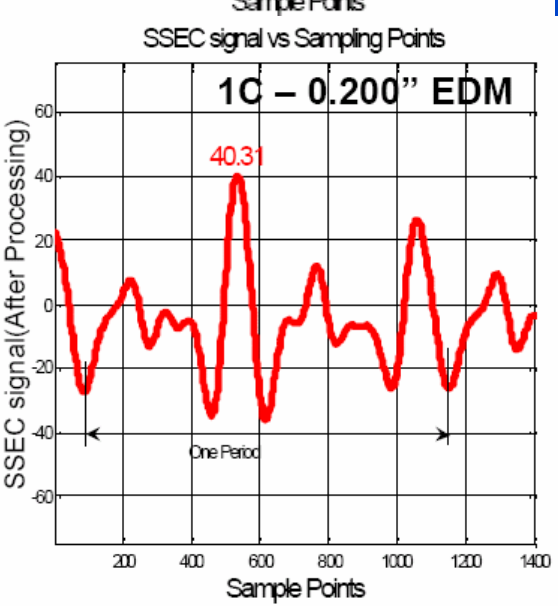
Imaginary Component of Impedance Planes for 1st Row Defects in the F18 Test Piece (Through Notches)

- After post acquisition signal analysis EDM notches as small as 0.135" were detected in 0.160" aluminum through 0.750" of composite material with an S/N > 3.
- Test results were influenced by nearby fasteners and the sealant grooves (edge effects) in the second layer
 - Can be overcome by probe offset or probe enhancements

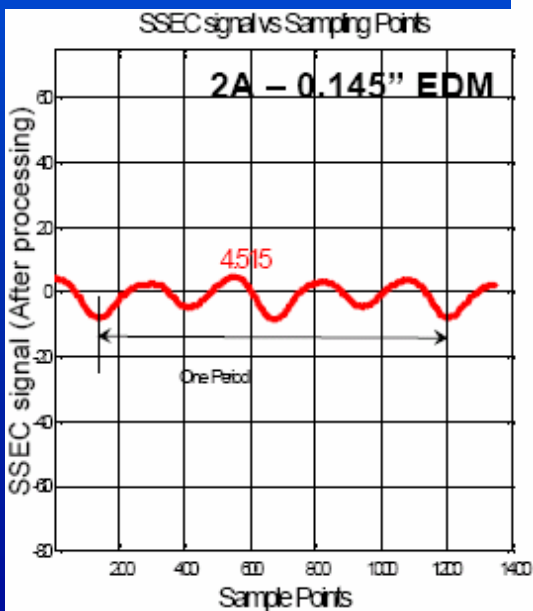
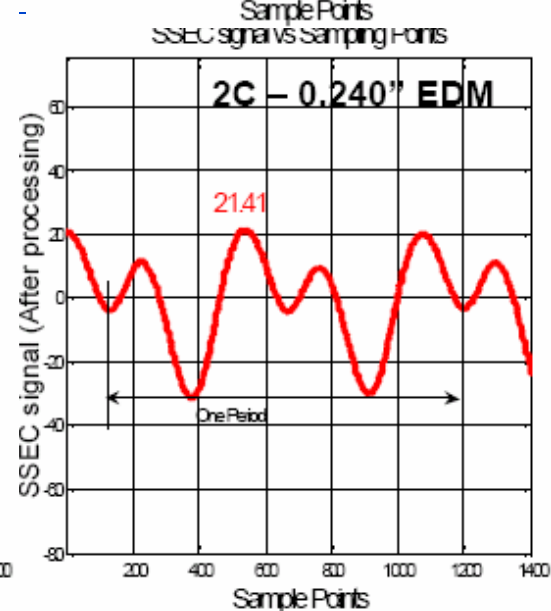
Imaginary Component of Impedance Planes for 2nd Row Defects in the F18 Test Piece (Through Notches)
